GEOTECHNICAL INVESTIGATION: REVISION 1
Cache Slough Mitigation Bank
SOLANO COUNTY, CALIFORNIA

Subject: GEOTECHNICAL INVESTIGATION: REVISION 1, CACHE SLOUGH
MITIGATION BANK, SOLANO COUNTY, CALIFORNIA

We performed a geotechnical investigation for the Cache Slough Mitigation Bank in Solano County, California in accordance with the proposal dated January 11, 2023. The results of the investigation are presented in the attached report.

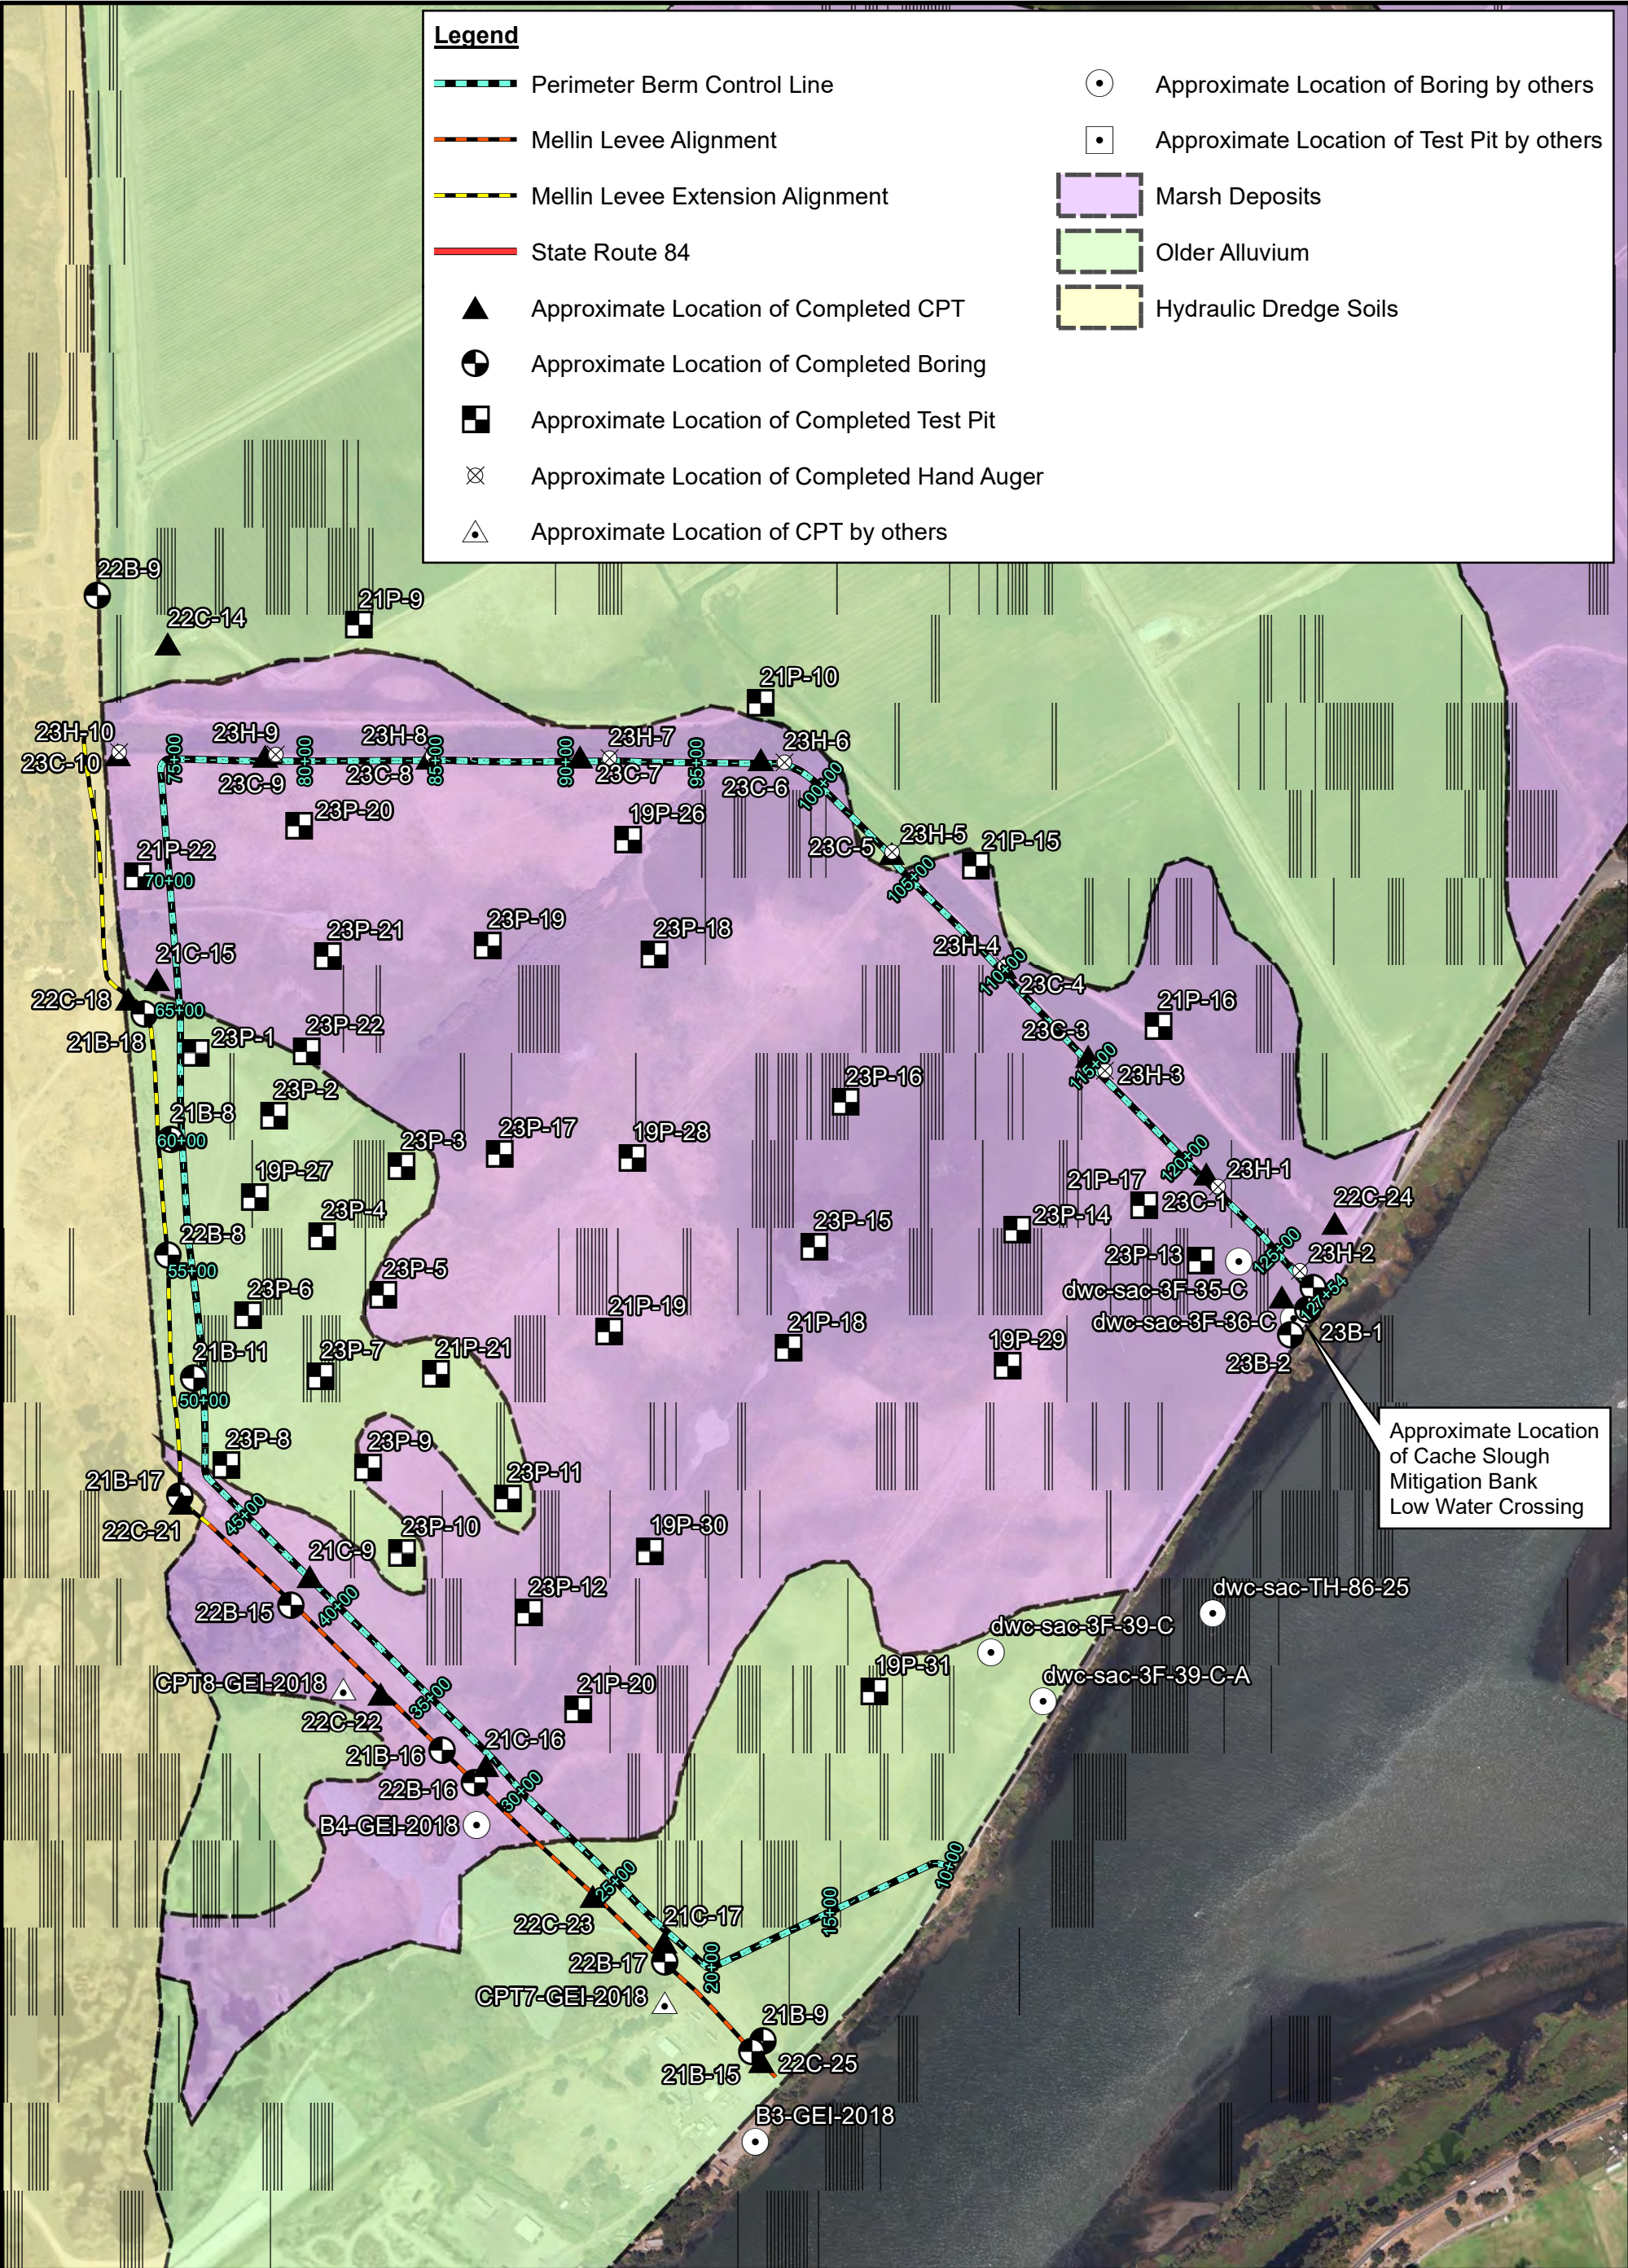
FIG. 5

SITE GEOLOGY MAP

We have grouped the subsurface soils encountered at the proposed project site into four geologic units which include embankment fill, hydraulic dredge fill, marsh deposits, and older alluvium. The units are described below. The subsurface conditions beneath the proposed perimeter berm alignment are represented graphically on the idealized subsurface profiles presented in Appendix A and the idealized subsurface cross sections shown in Appendix B. We did not collect data between Stations 10+00 and 20+32 and have not included them in the idealized subsurface profile. Based on our review of the geologic conditions at the site, we infer that the subsurface conditions from Station 10+00 to 20+32 are similar to the conditions shown between Stations 20+32 and 25+00. Our interpretations of the surface geology based on our exploration are presented on Figure 5. The main

difference between Figure 5 and the Atwater Geologic Map on Figure 3 is that we interpreted the marsh soils to have a greater extent within the parcel than the extent shown on the Atwater Geologic Map.

The near-surface soil conditions are depicted on Figure 5. In the areas denoted with marsh deposits, high plasticity and often organic-rich soil was encountered at the ground surface or buried beneath a relatively thin layer of hydraulic dredge fill. We did not drill borings in the parcel interior and therefore have limited data regarding the depth of the marsh deposits in the parcel interior. Based on the borings and CPTs along the perimeter of the parcel, we estimate that the base of marsh deposits is at least 30 feet at the deepest locations within the parcel interior. Based on our perimeter borings and the geologic mapping, we estimate that the marsh deposits may be deepest in the southeast corner of the site. The marsh deposits are generally underlain by stiff older alluvium that consists of clay, silt, and sand.

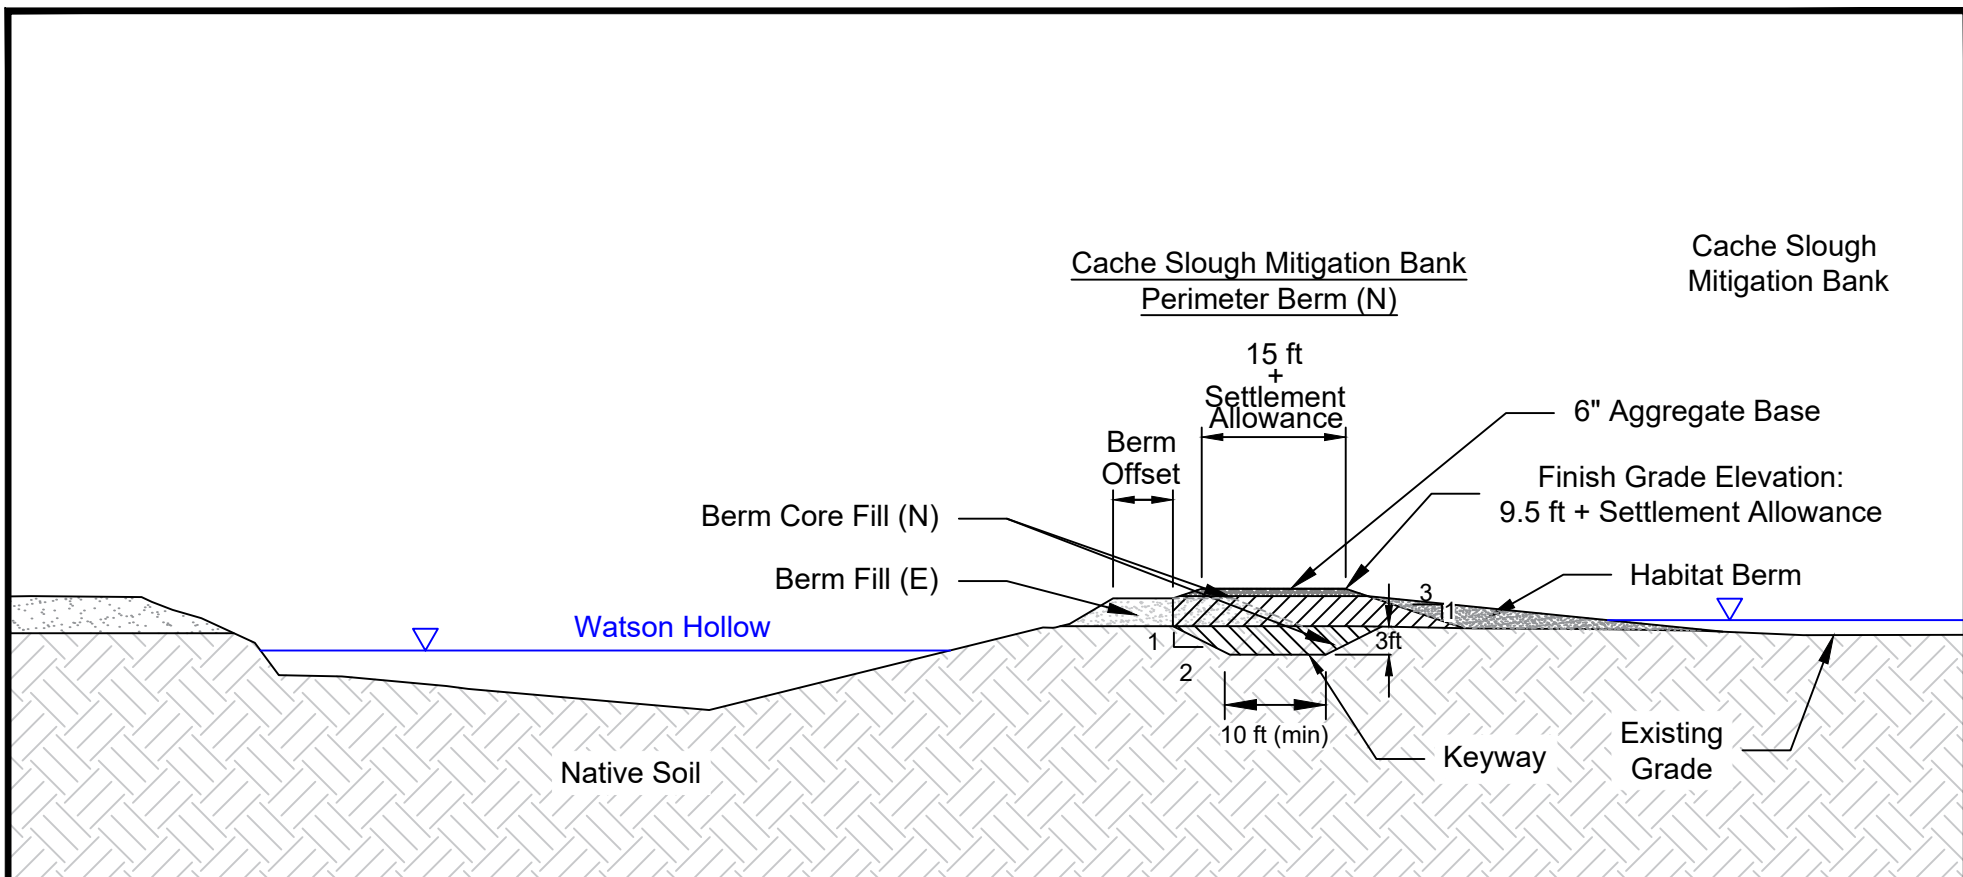
Notes:

1. Remove existing berm fill within new berm prism.
2. Excavate keyway at least 3 feet deep and 10 feet wide with side slopes 2:1 (H:V) or flatter.
3. Scarify and recompact the upper 8-inches of existing soil within berm footprint.
4. Fill for the berm core should be obtained from designated borrow areas.
5. Aggregate base should meet Caltrans Class II Specifications.

We recommend that the perimeter berm should generally conform to the details shown on Figures 7 and 8. The section includes a 15- to 20-foot-wide crest, 3H:1V or flatter slopes, a

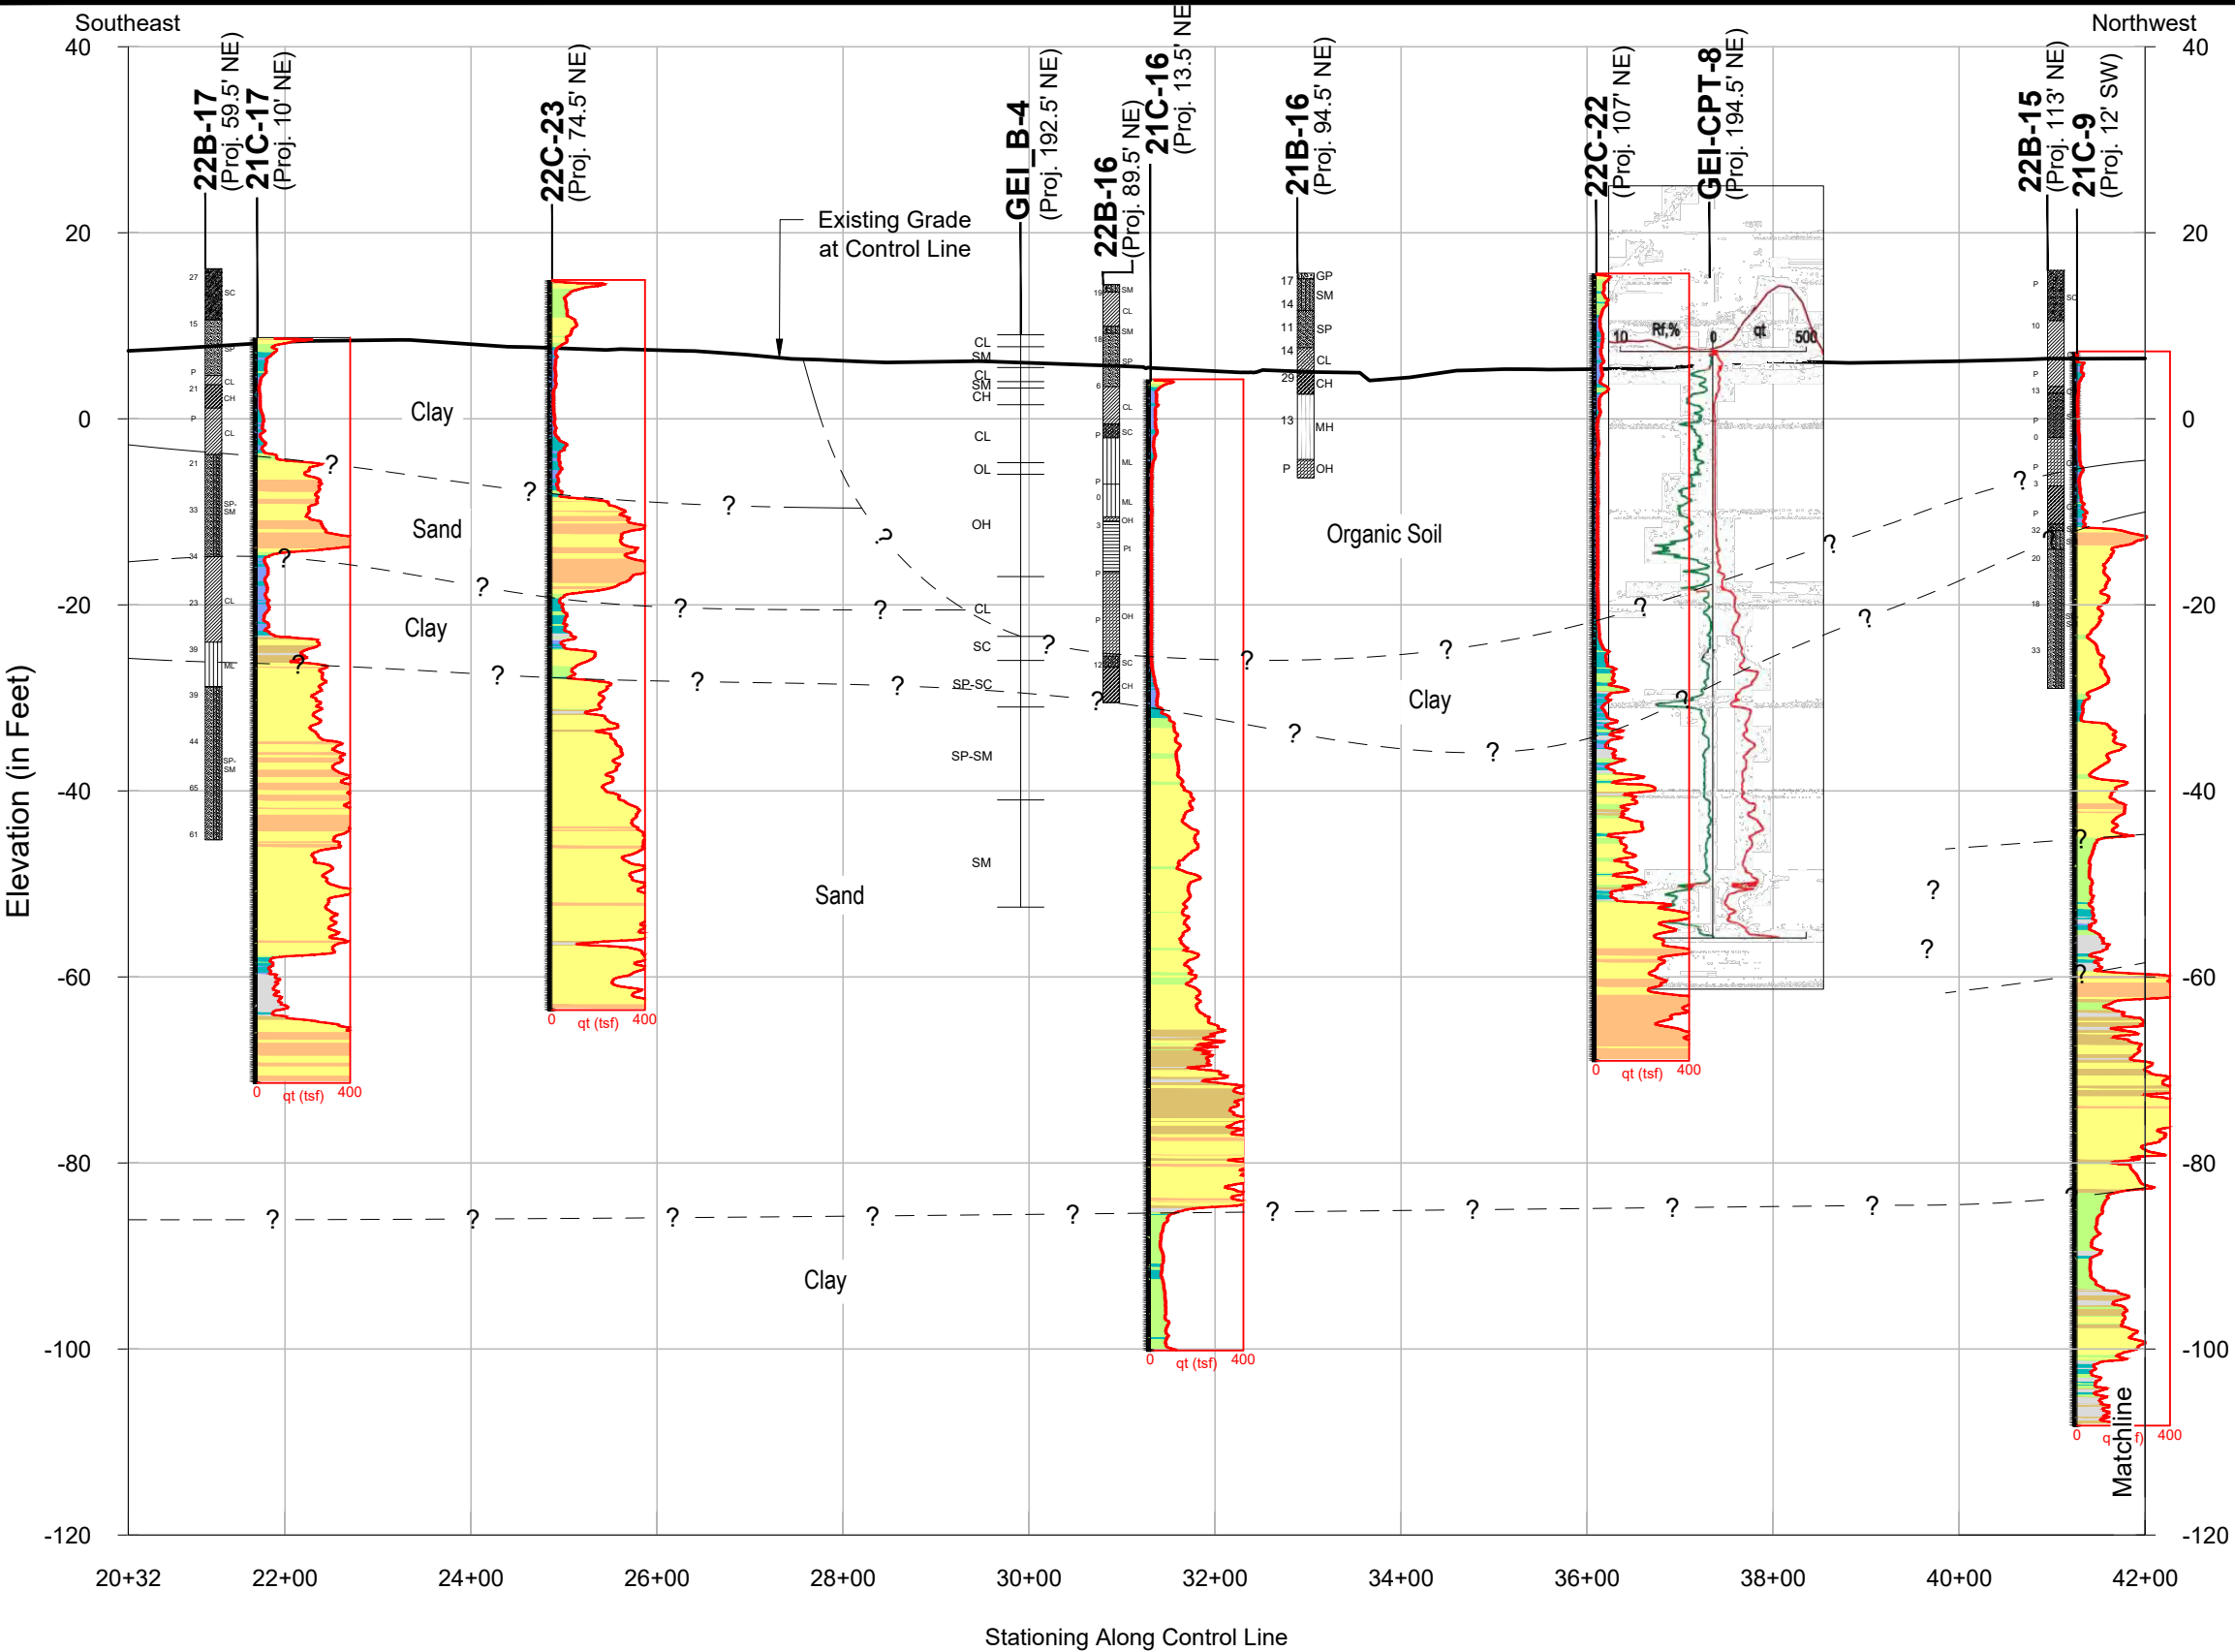
Cache Slough Mitigation Bank Solano County, California	
IDEALIZED GEOLOGIC PROFILE CACHE SLOUGH MITIGATION BANK STATION 20+32 to 42+00	
April 2024	110926
SHANNON & WILSON, INC. GEOTECHNICAL AND ENVIRONMENTAL CONSULTANTS	FIG. A-2

The subsurface conditions beneath the proposed perimeter berm are depicted in Appendix A. Idealized subsurface cross sections for seven stations along the alignment are presented in Appendix B.

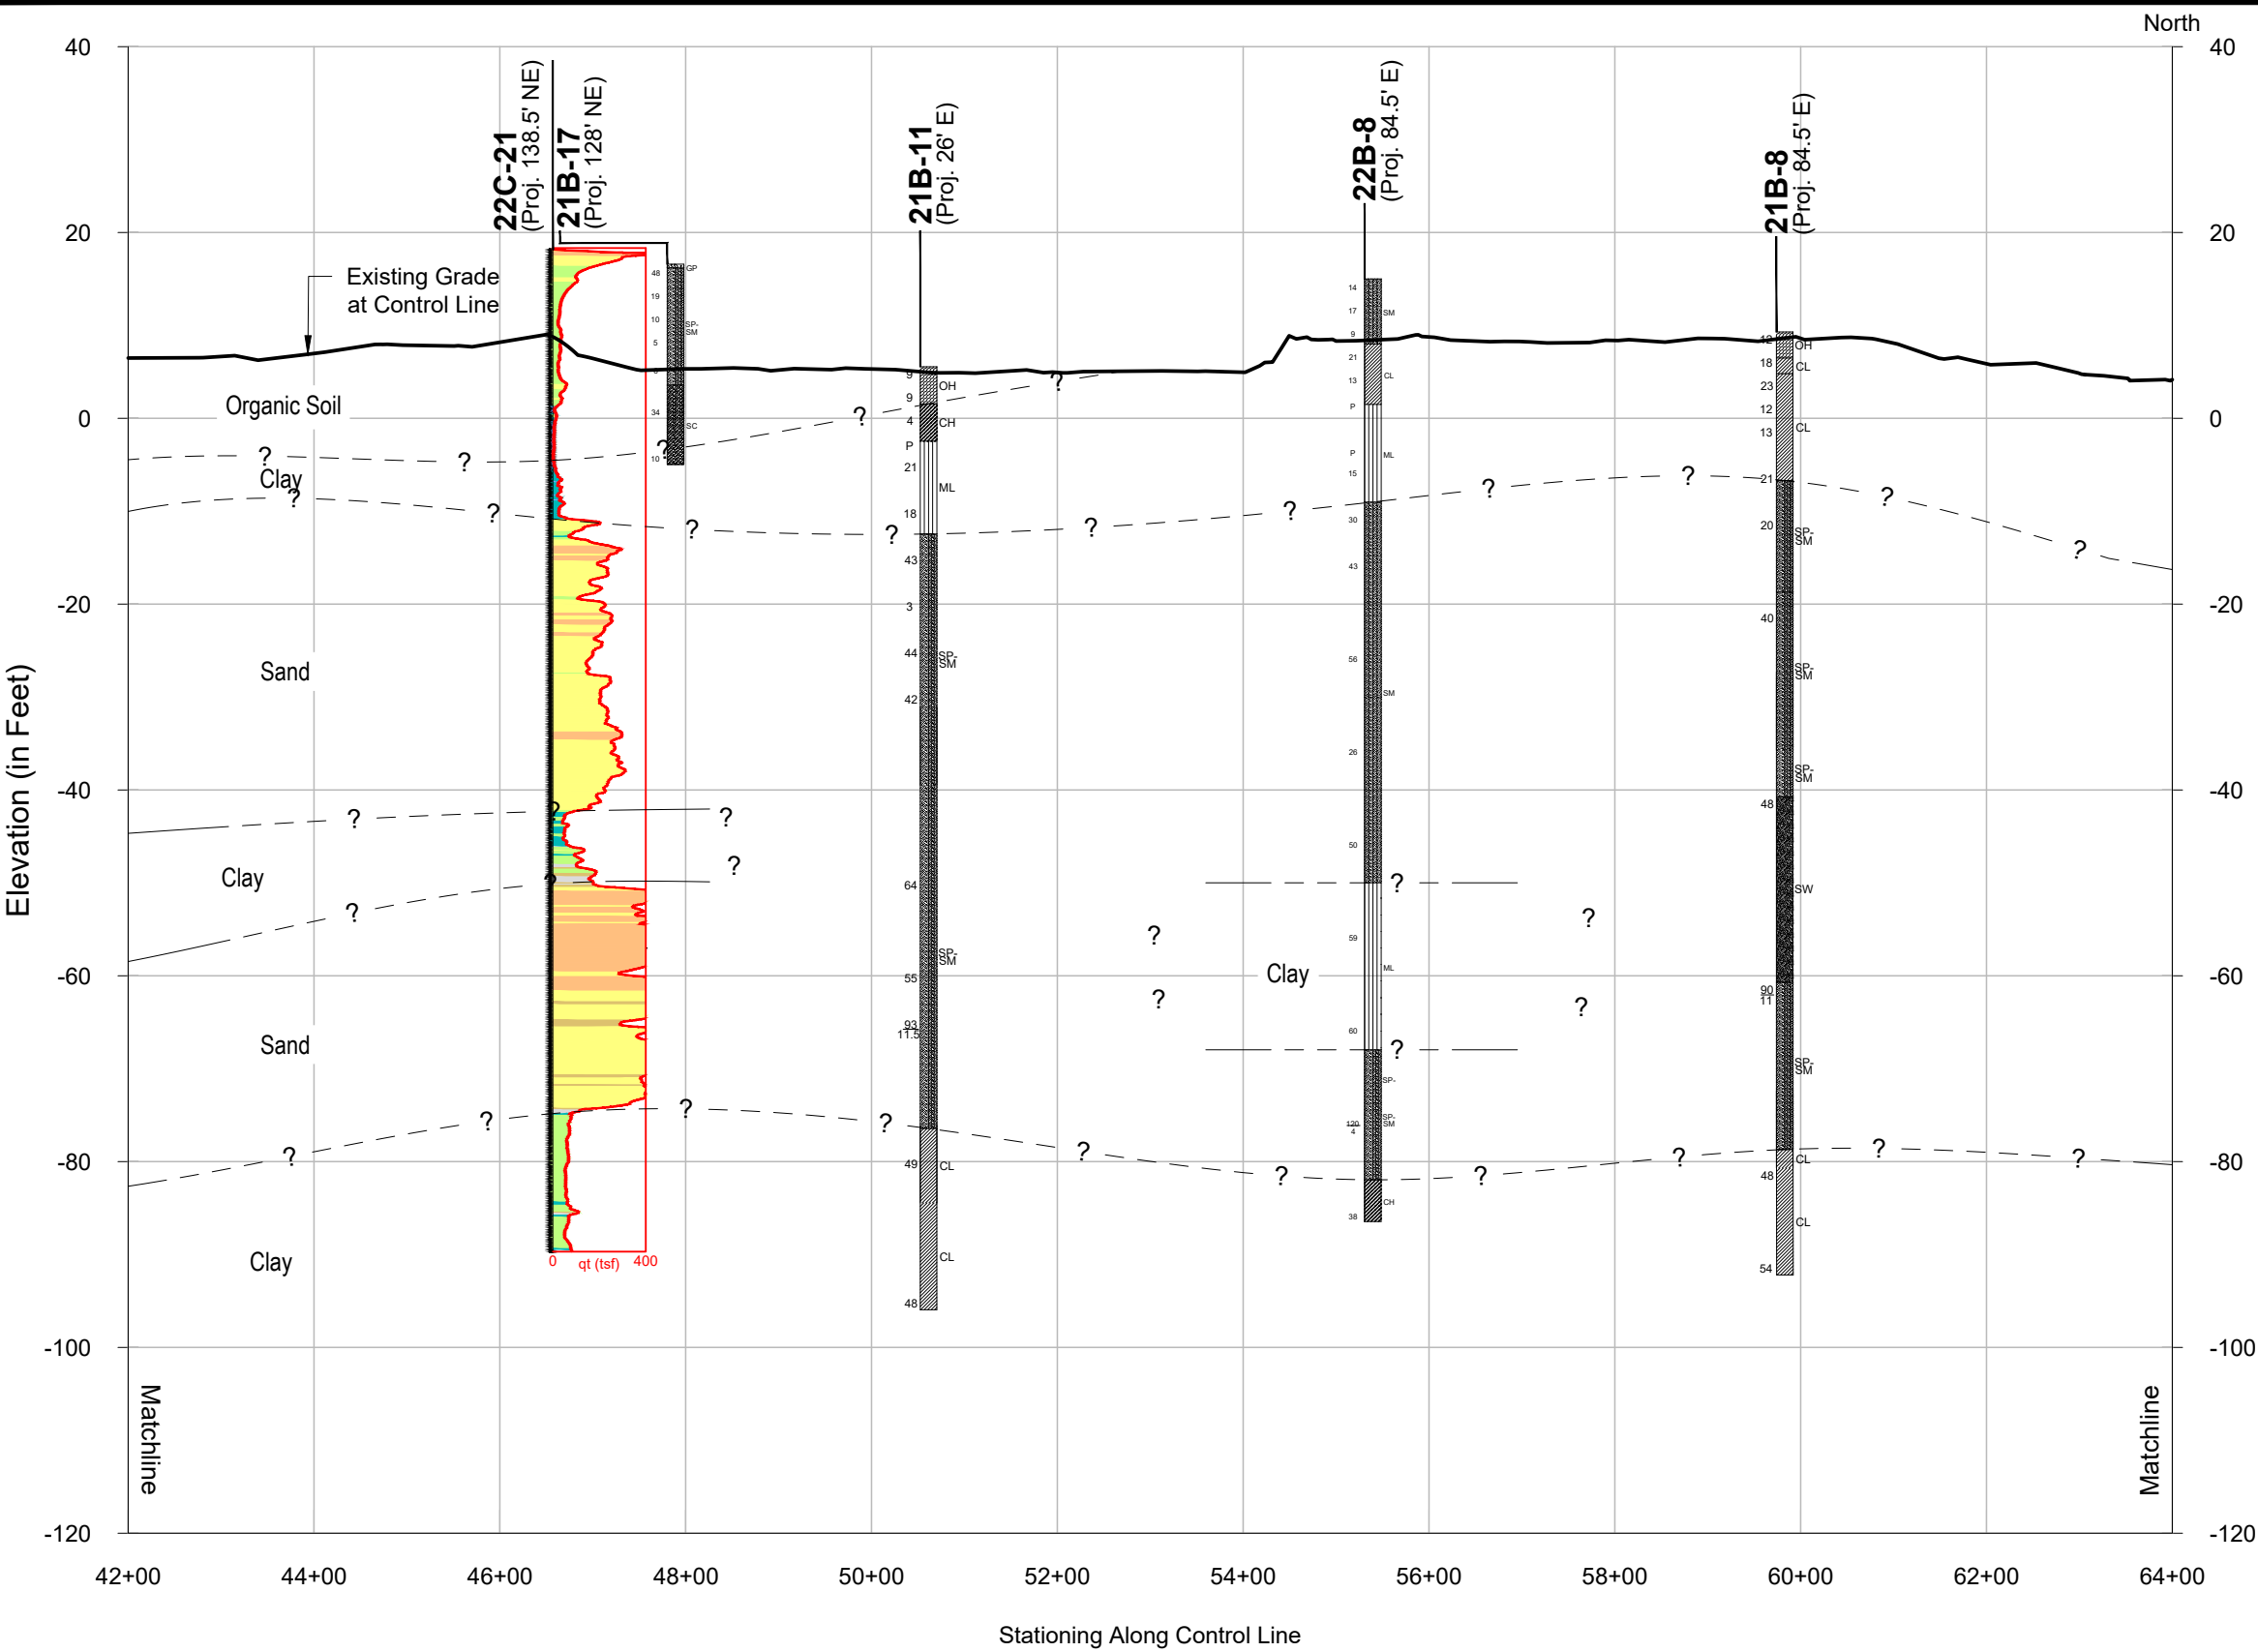
IDEALIZED GEOLOGIC PROFILE
CACHE SLOUGH MITIGATION BANK
STATION 42+00 to 64+00

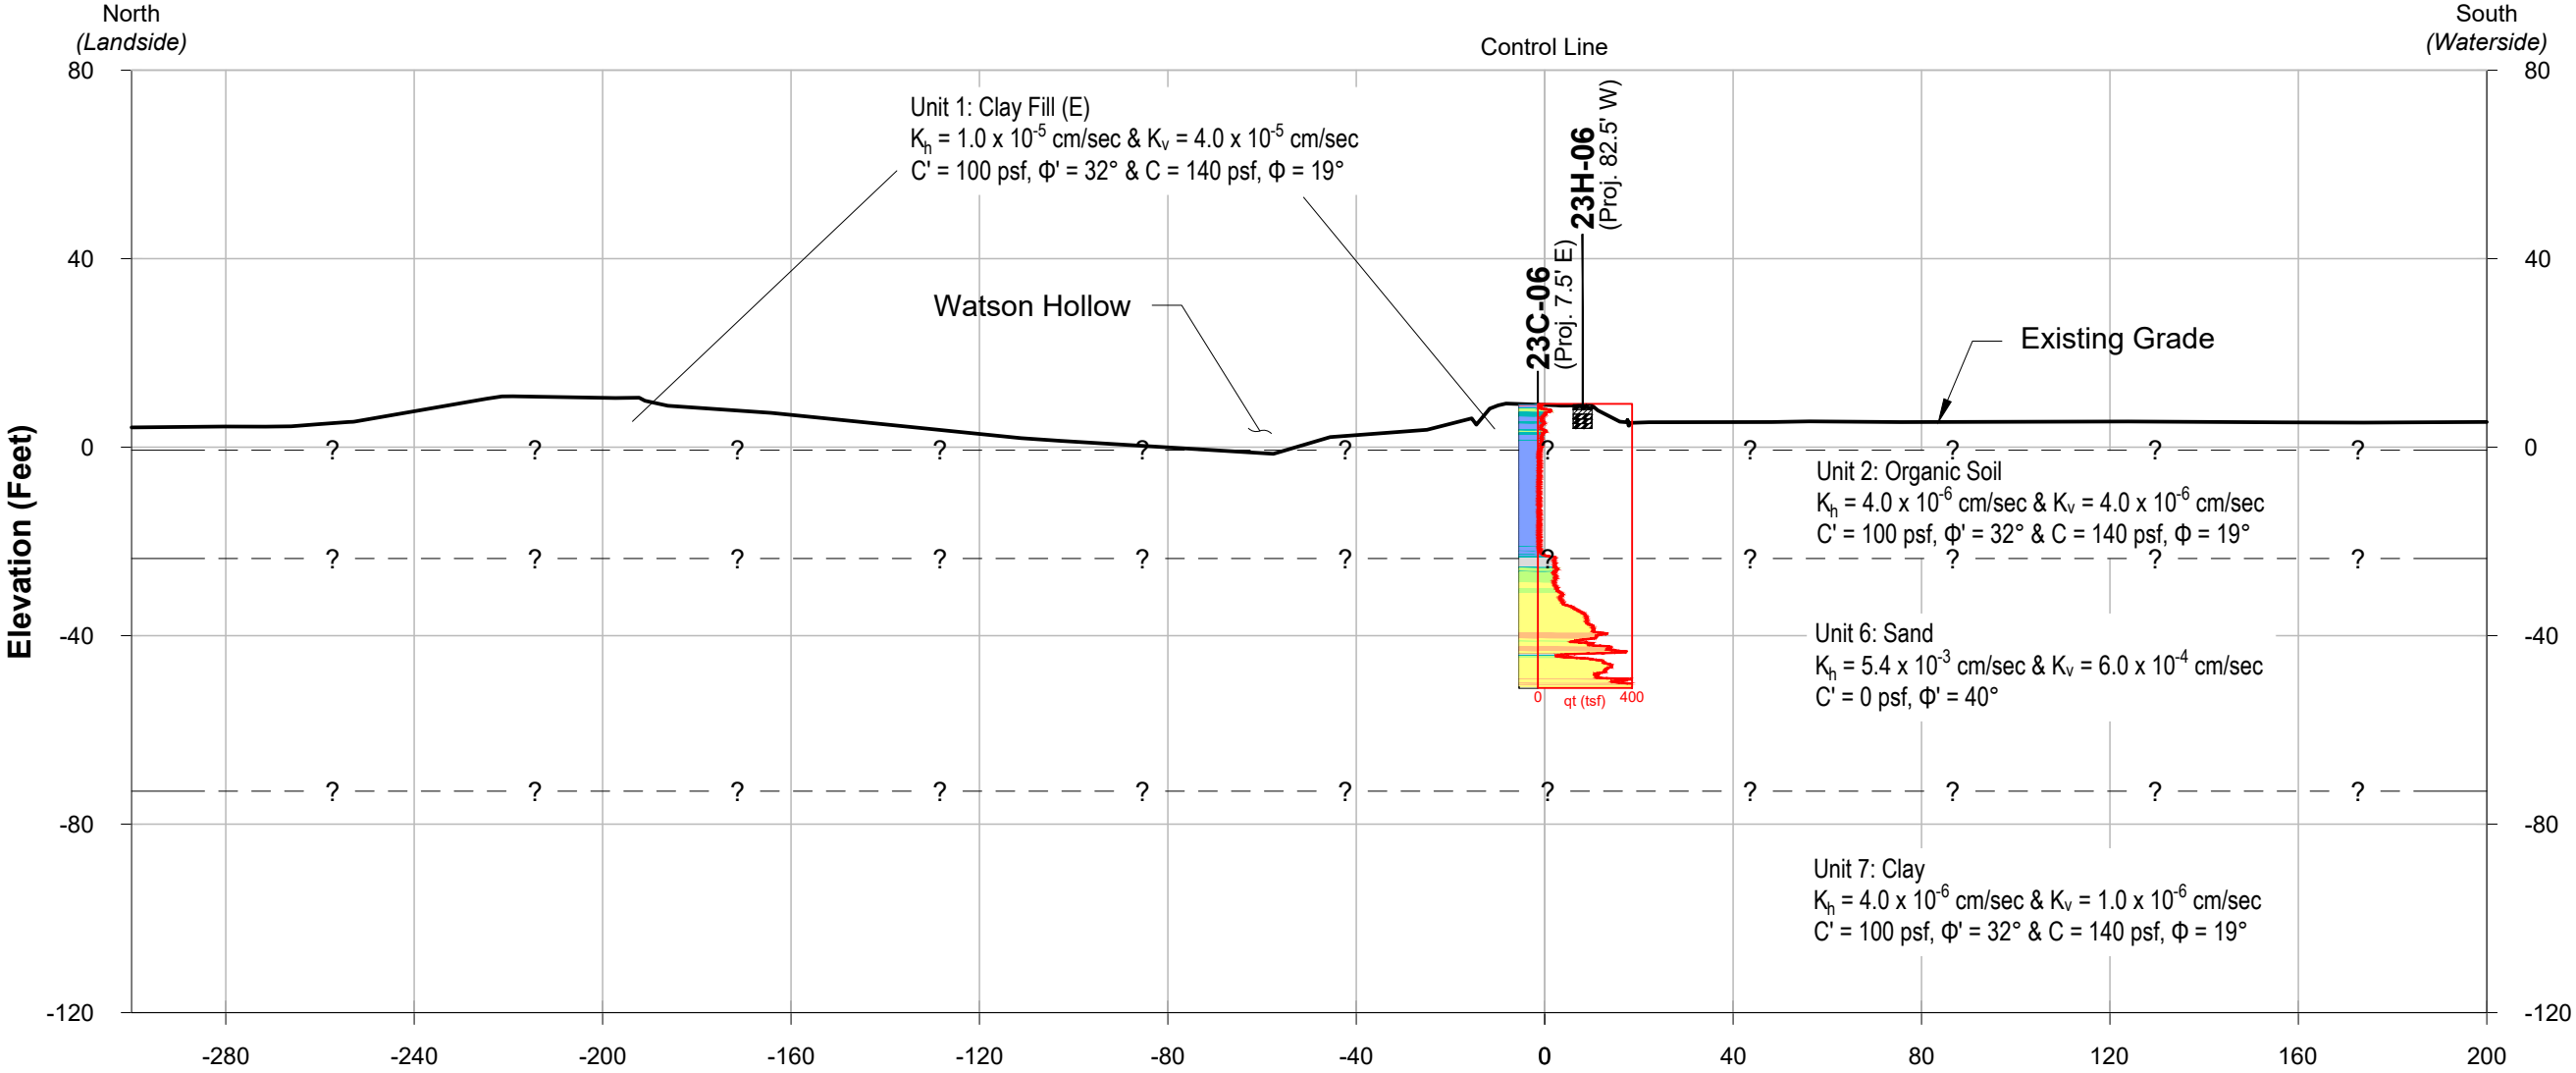
Cache Slough Mitigation Bank Solano County, California	
IDEALIZED GEOLOGIC CROSS SECTIONS CACHE SLOUGH MITIGATION BANK STATION 97+32	
April 2024	110926
SHANNON & WILSON, INC. GEOTECHNICAL AND ENVIRONMENTAL CONSULTANTS	FIG. B-6

The selected cross sections are presented above in Exhibit 4-1 and are intended to represent the range of existing levee geometry and geologic conditions for the site. The idealized subsurface cross-sections at each station are presented in Appendix B.

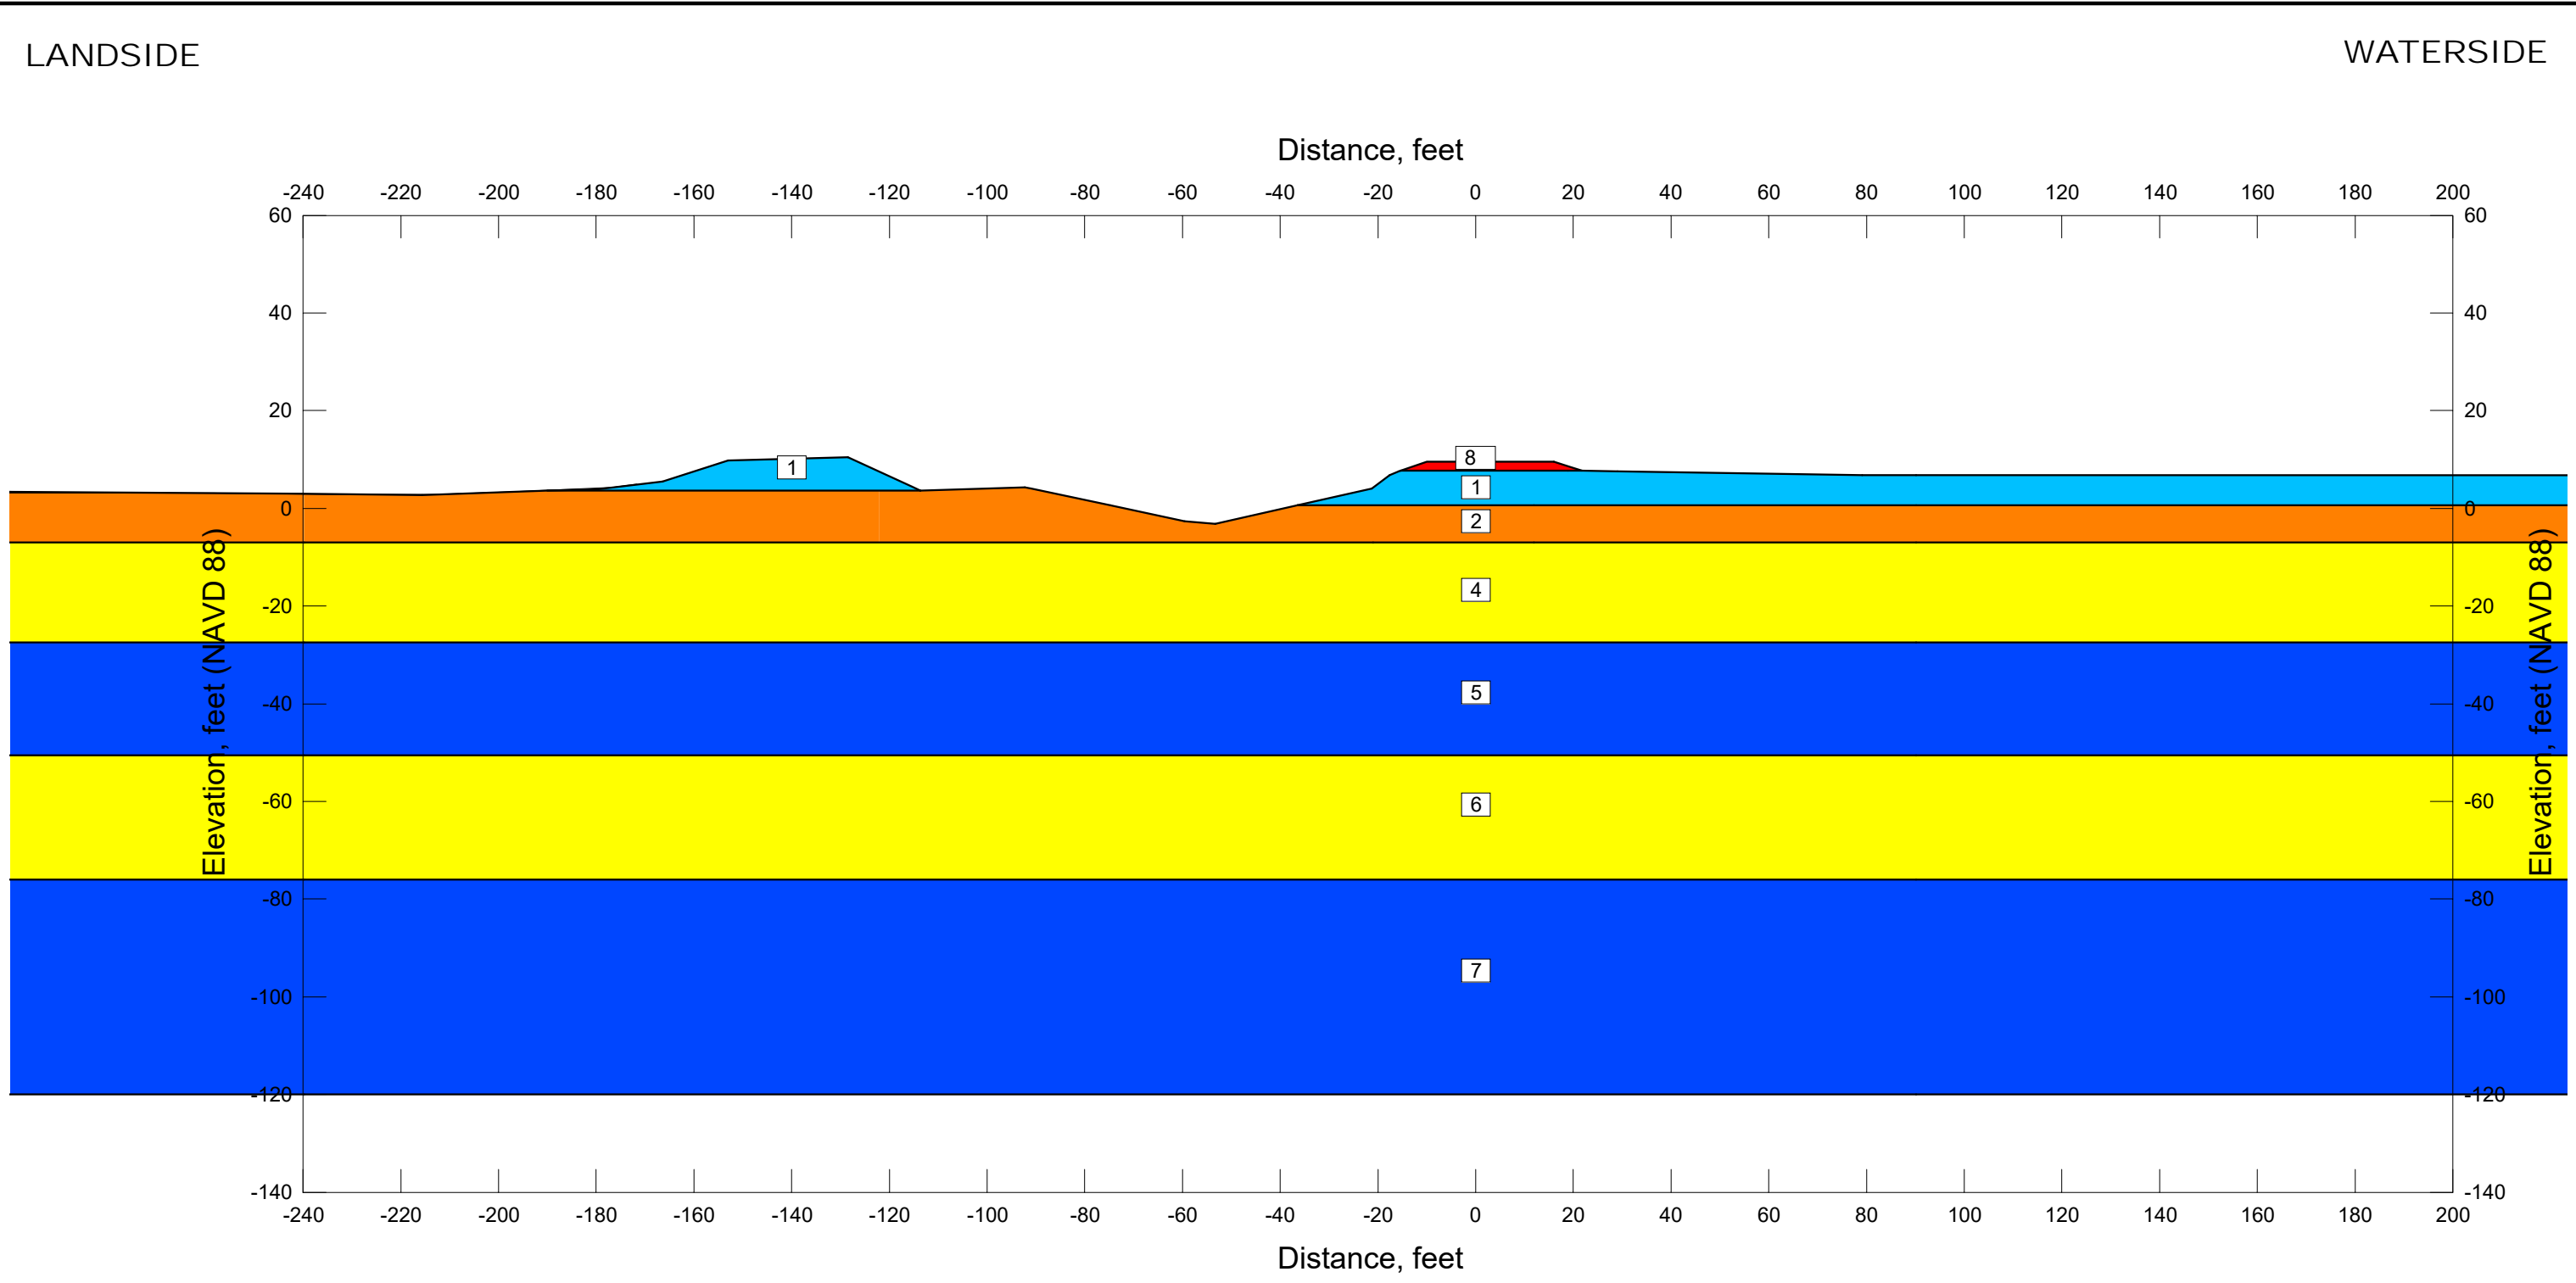
Cache Slough Mitigation Bank Solano County, California	
Seepage Analysis Profile Station 90+32 Steady State Conditions	
April 2024	110926
SHANNON & WILSON, INC. Geotechnical and Environmental Consultants	FIG. C-8
