GEOTECHNICAL INVESTIGATION: REVISION 1
Cache Slough Mitigation Bank
SOLANO COUNTY, CALIFORNIA

Subject: GEOTECHNICAL INVESTIGATION: REVISION 1, CACHE SLOUGH
MITIGATION BANK, SOLANO COUNTY, CALIFORNIA

We performed a geotechnical investigation for the Cache Slough Mitigation Bank in Solano County, California in accordance with the proposal dated January 11, 2023. The results of the investigation are presented in the attached report.

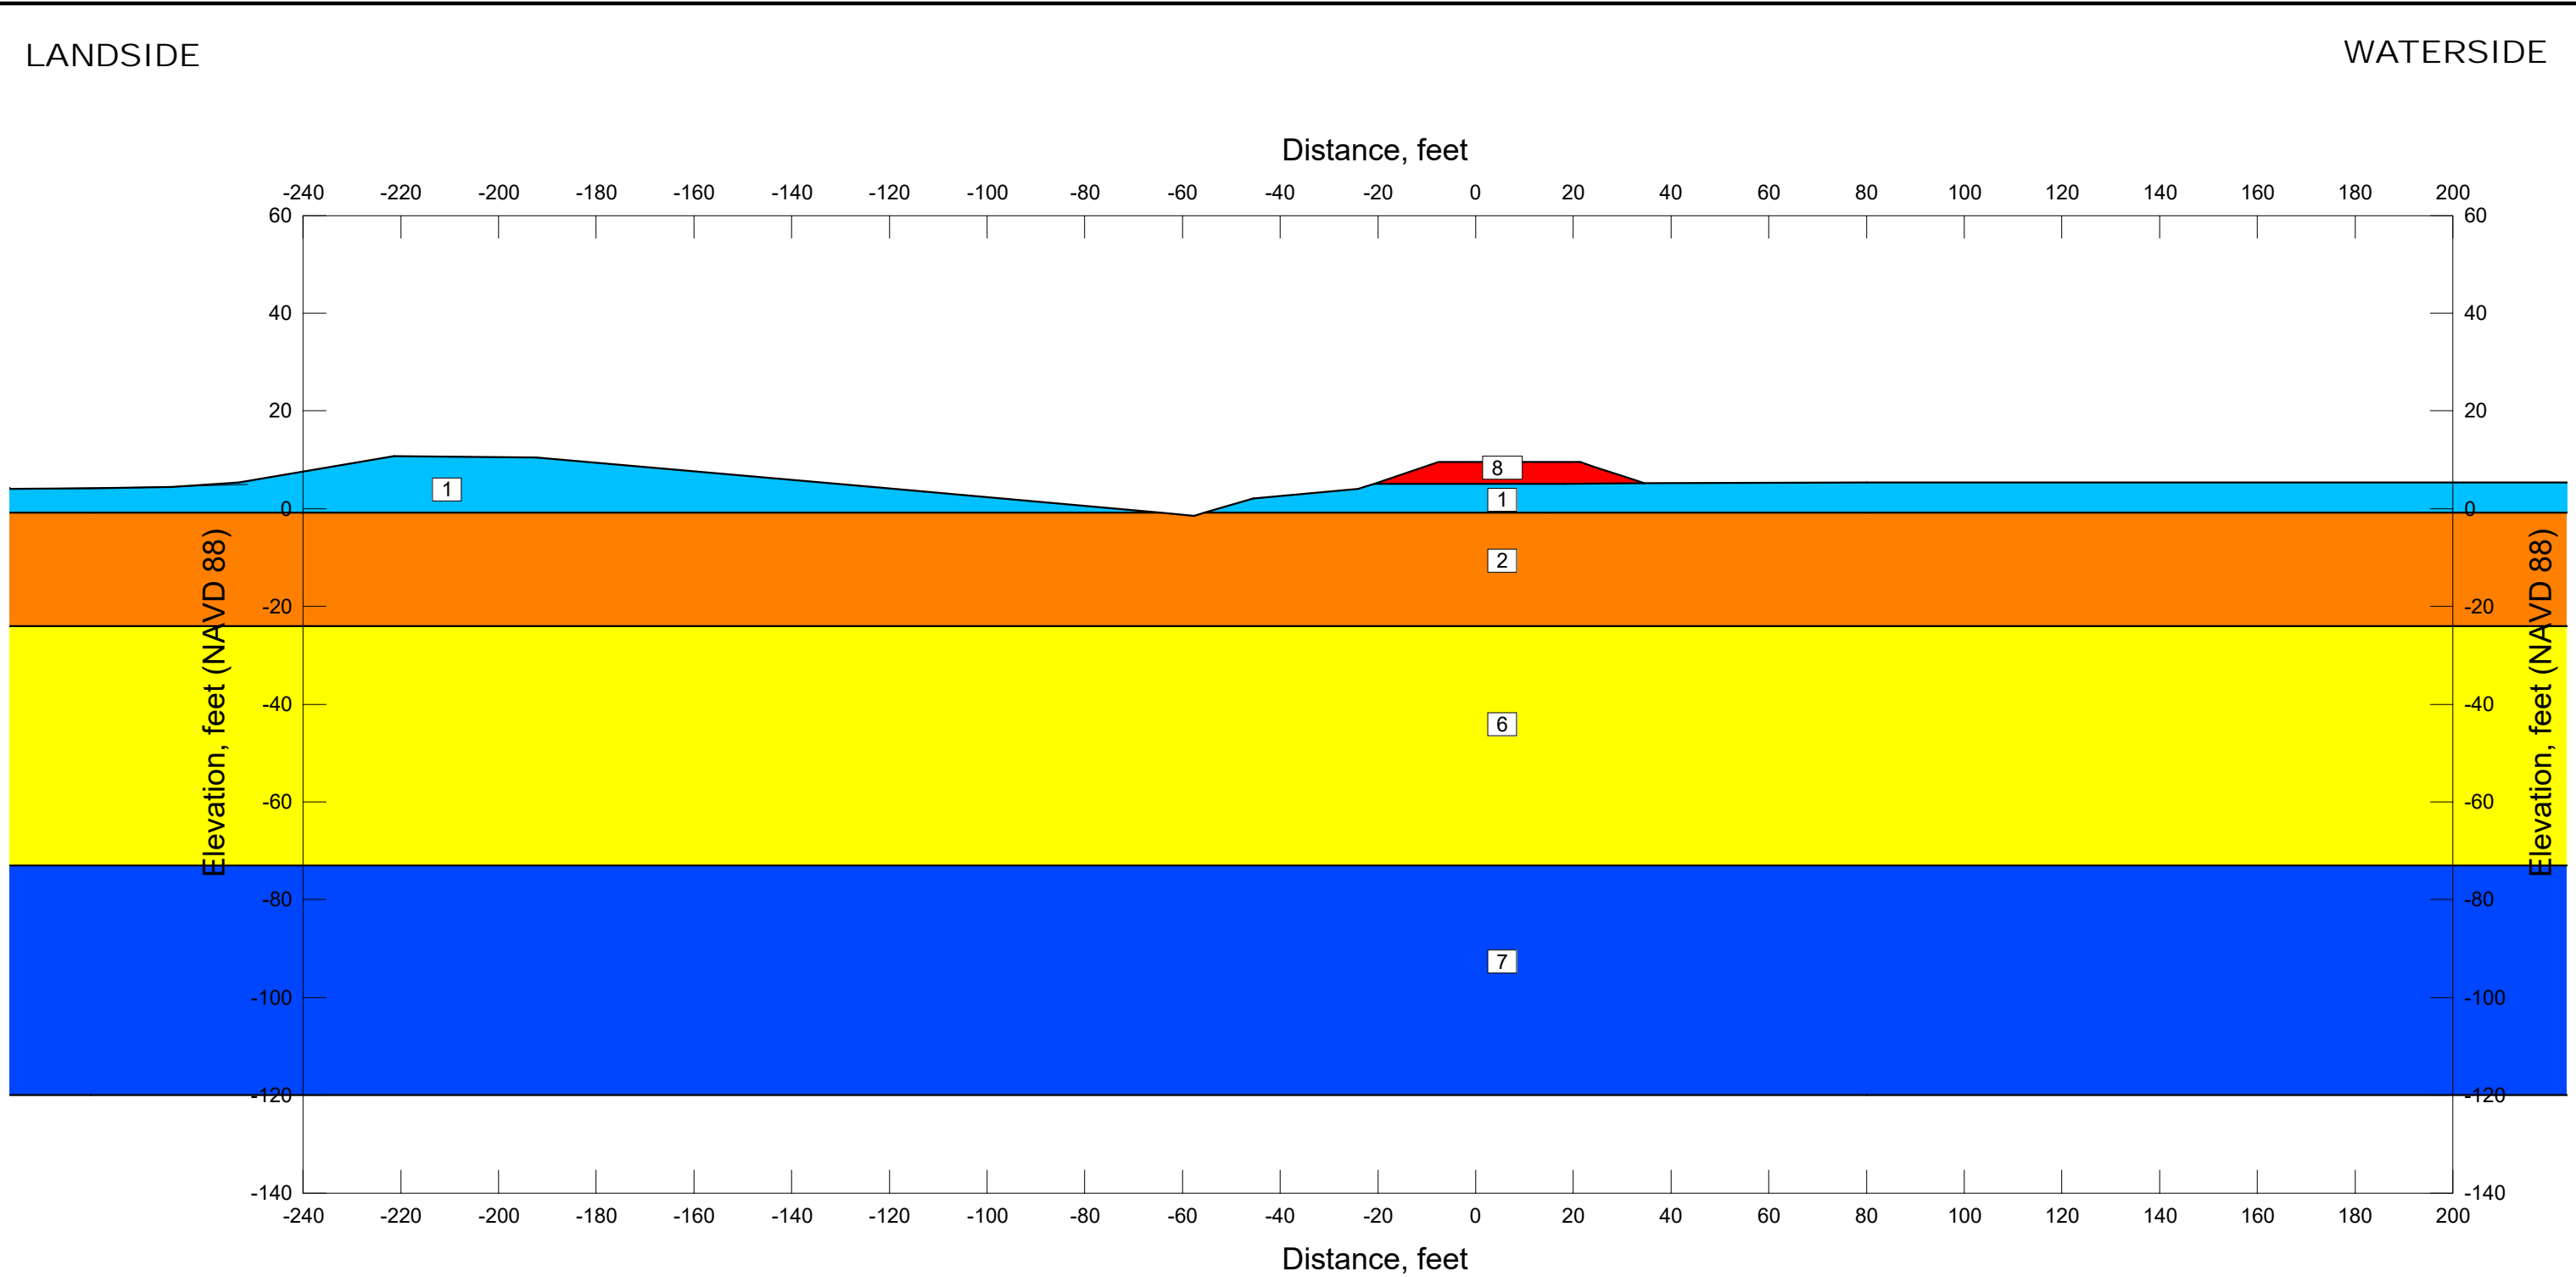
Cache Slough Mitigation Bank Solano County, California	
Seepage Analysis Profile Station 97+32 Steady State Conditions	
April 2024	110926
SHANNON & WILSON, INC. Geotechnical and Environmental Consultants	FIG. C-10

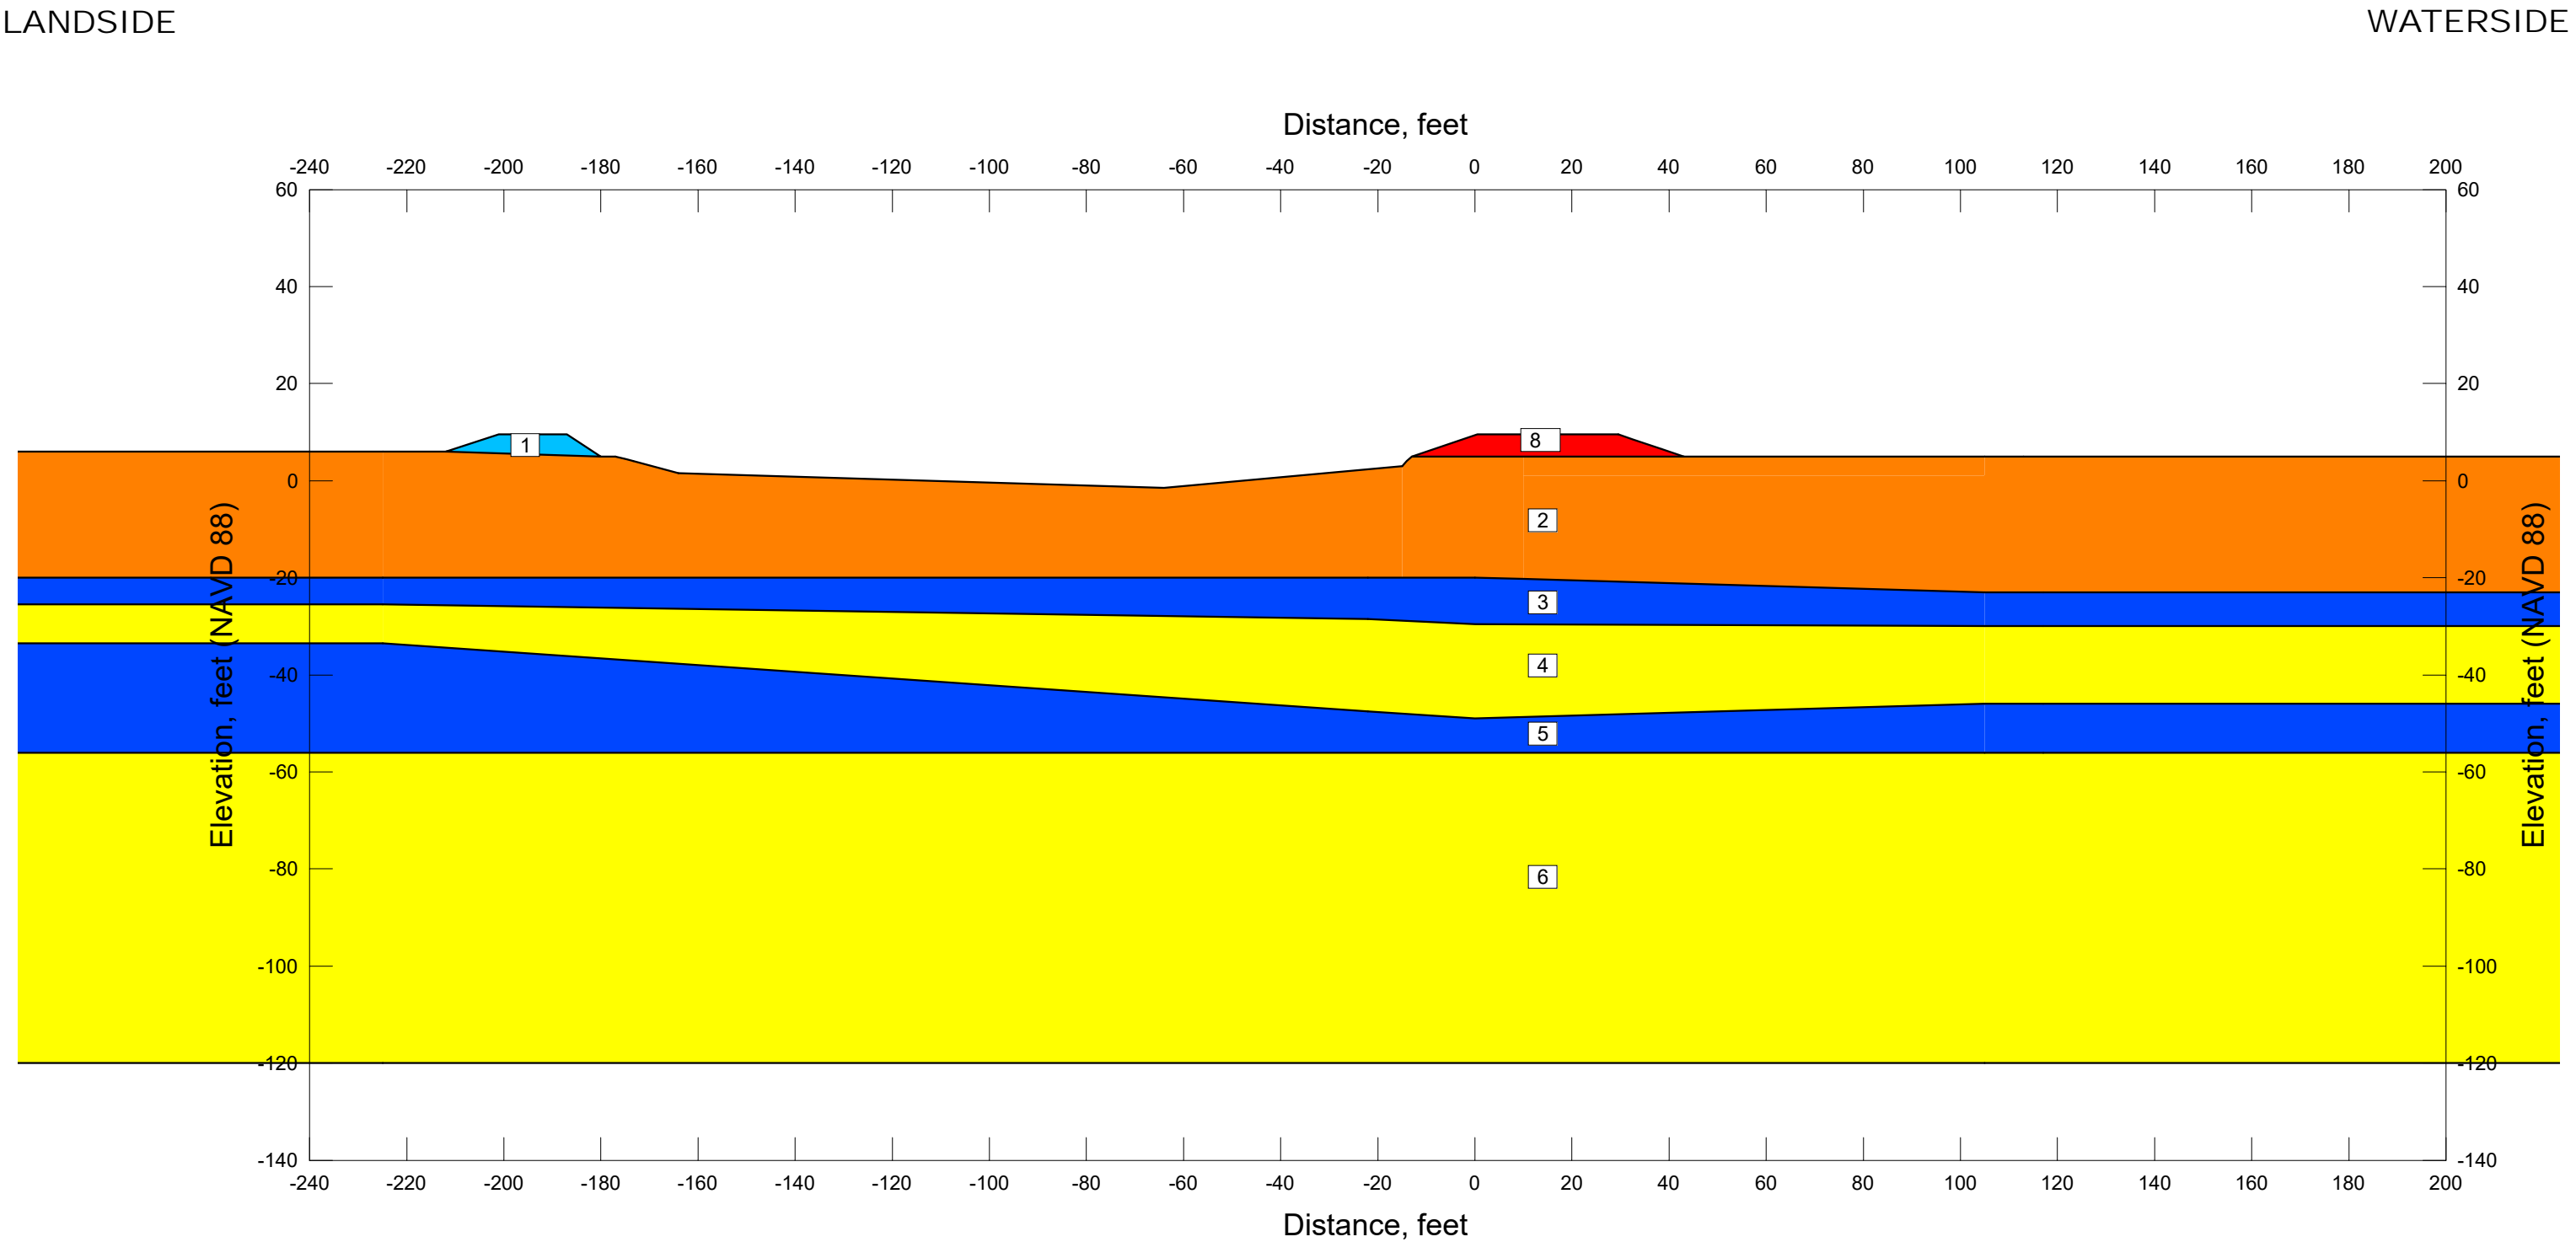
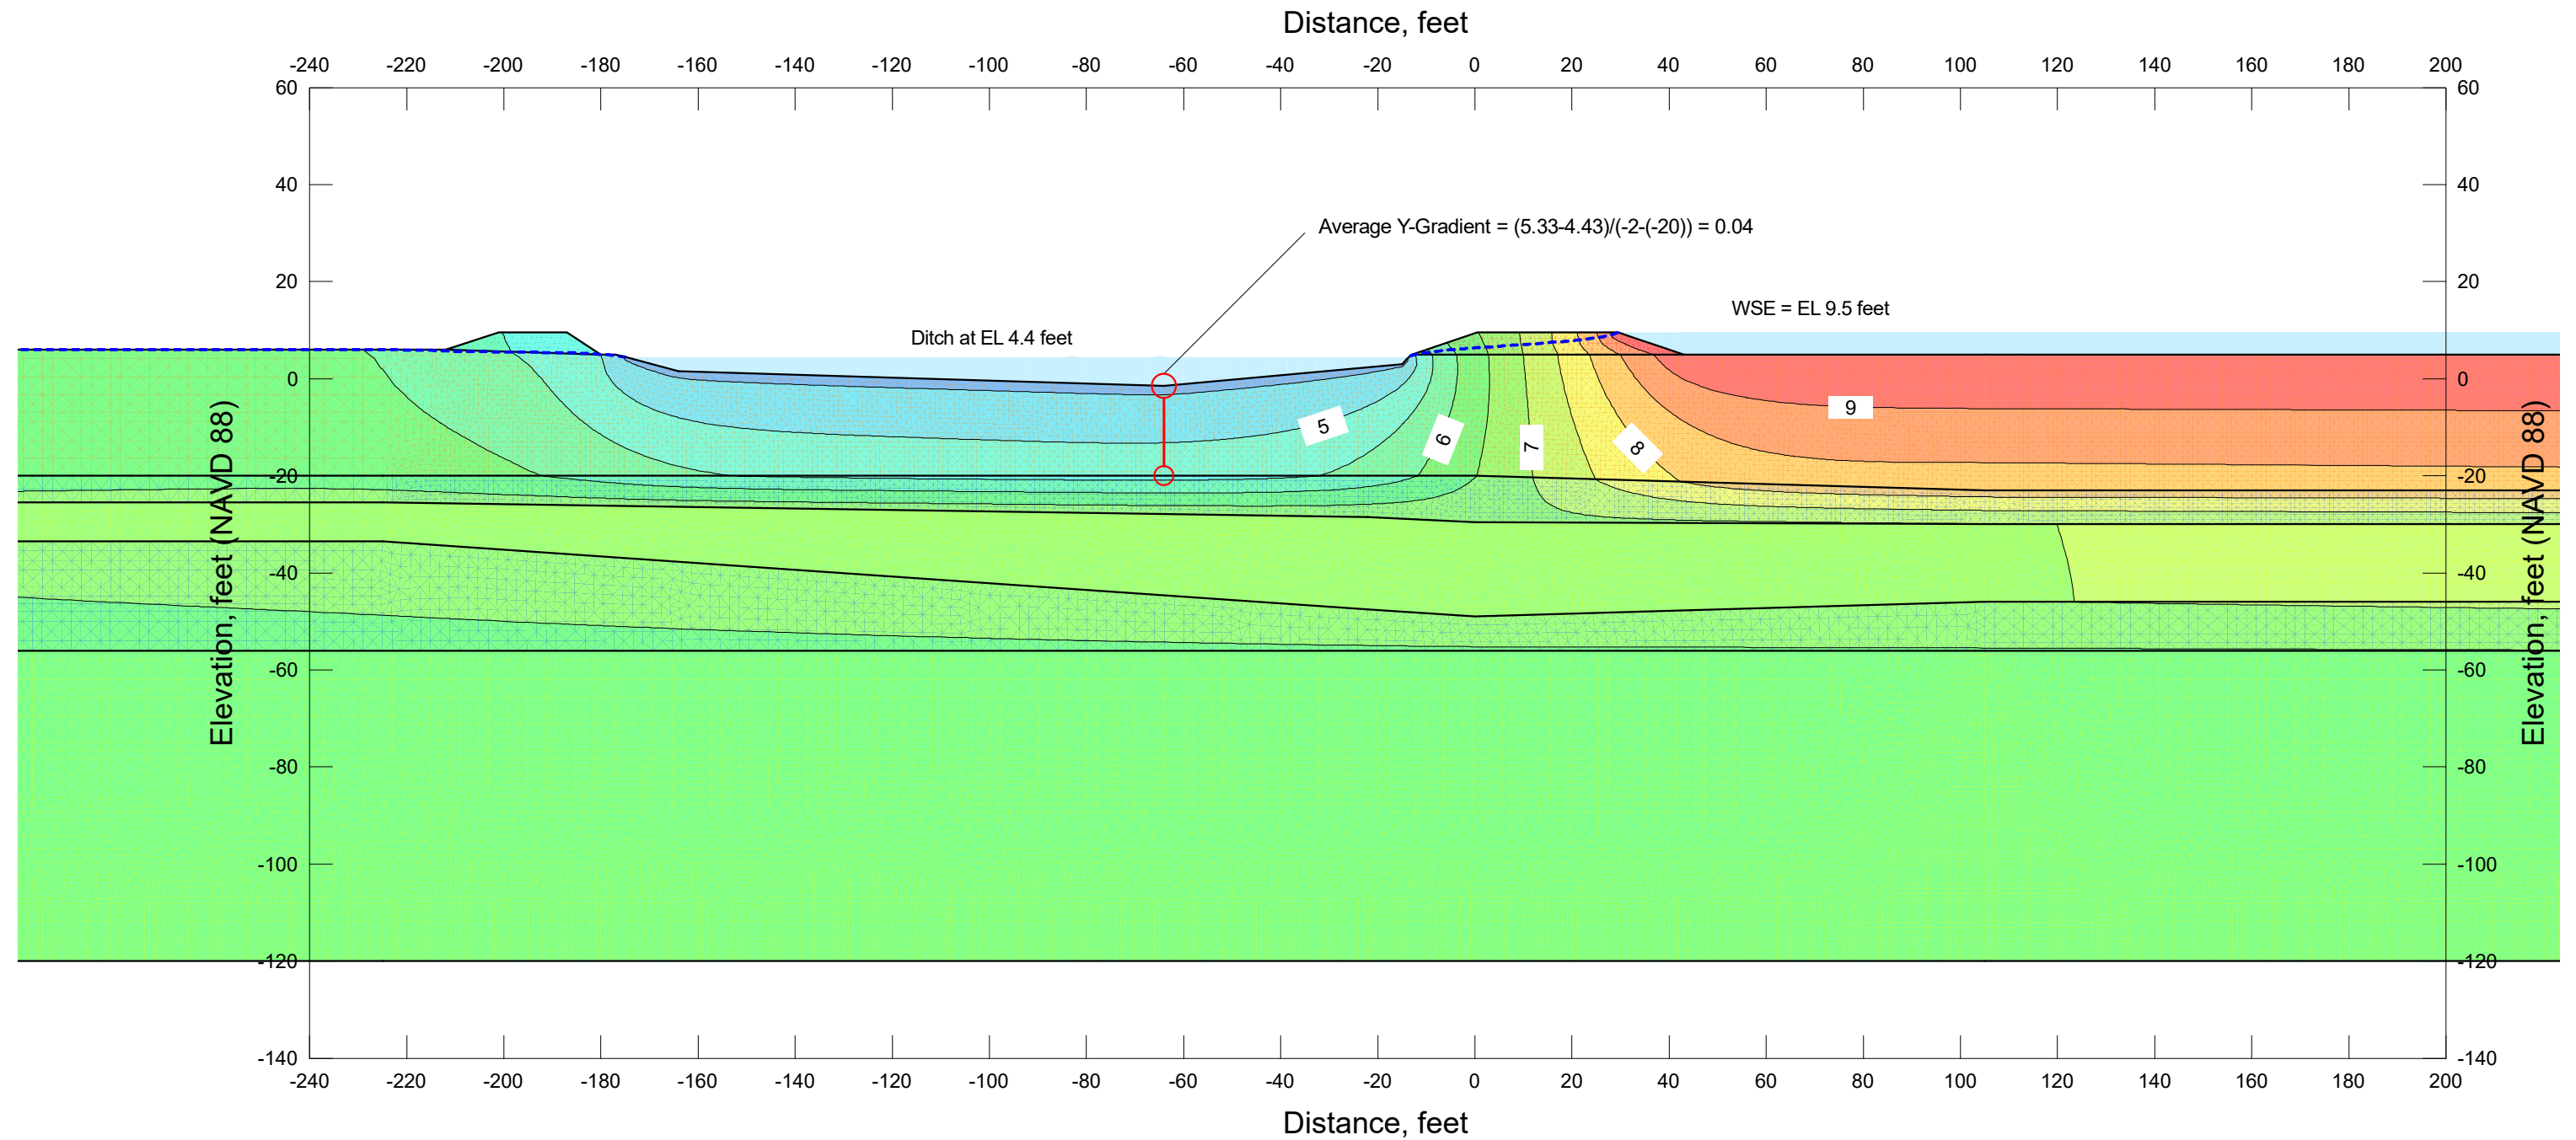
Notes:
1. See Figure C-1 for material properties.
2. Contours represent total head in feet of water.

Cache Slough Mitigation Bank Solano County, California	
Seepage Analysis Station 122+32 Steady State Conditions	
April 2024	110926
SHANNON & WILSON, INC. Geotechnical and Environmental Consultants	FIG. C-15

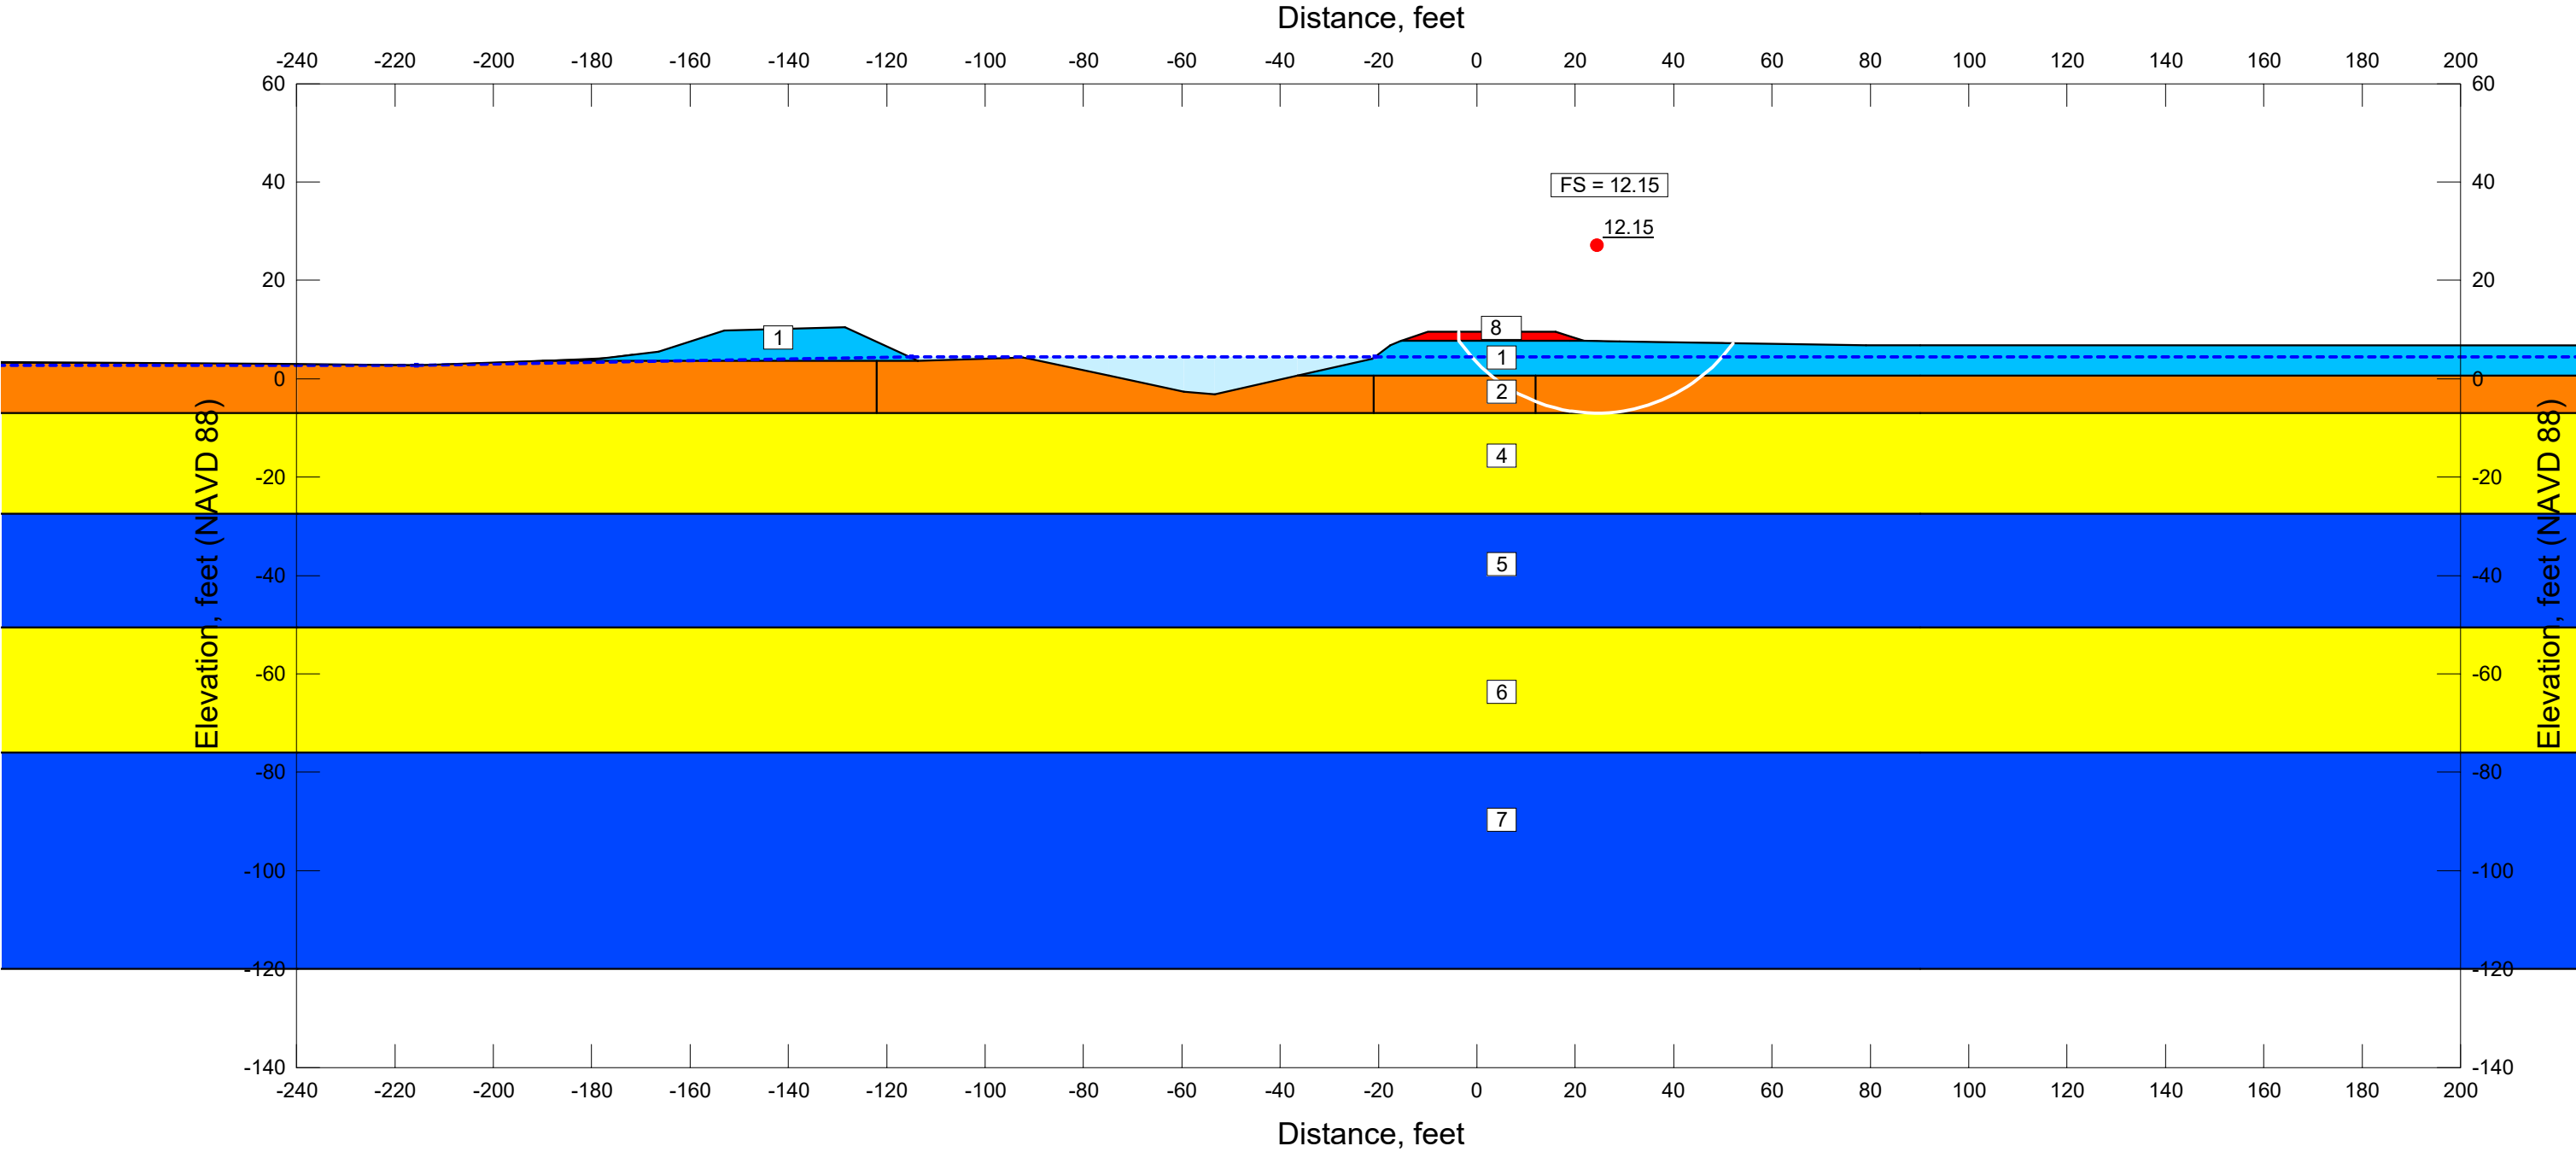
Cache Slough Mitigation Bank Solano County, California	
Slope Stability Analysis Station 90+32 End-of-Construction - Waterside	
April 2024	110926
SHANNON & WILSON, INC. Geotechnical and Environmental Consultants	FIG. D-15

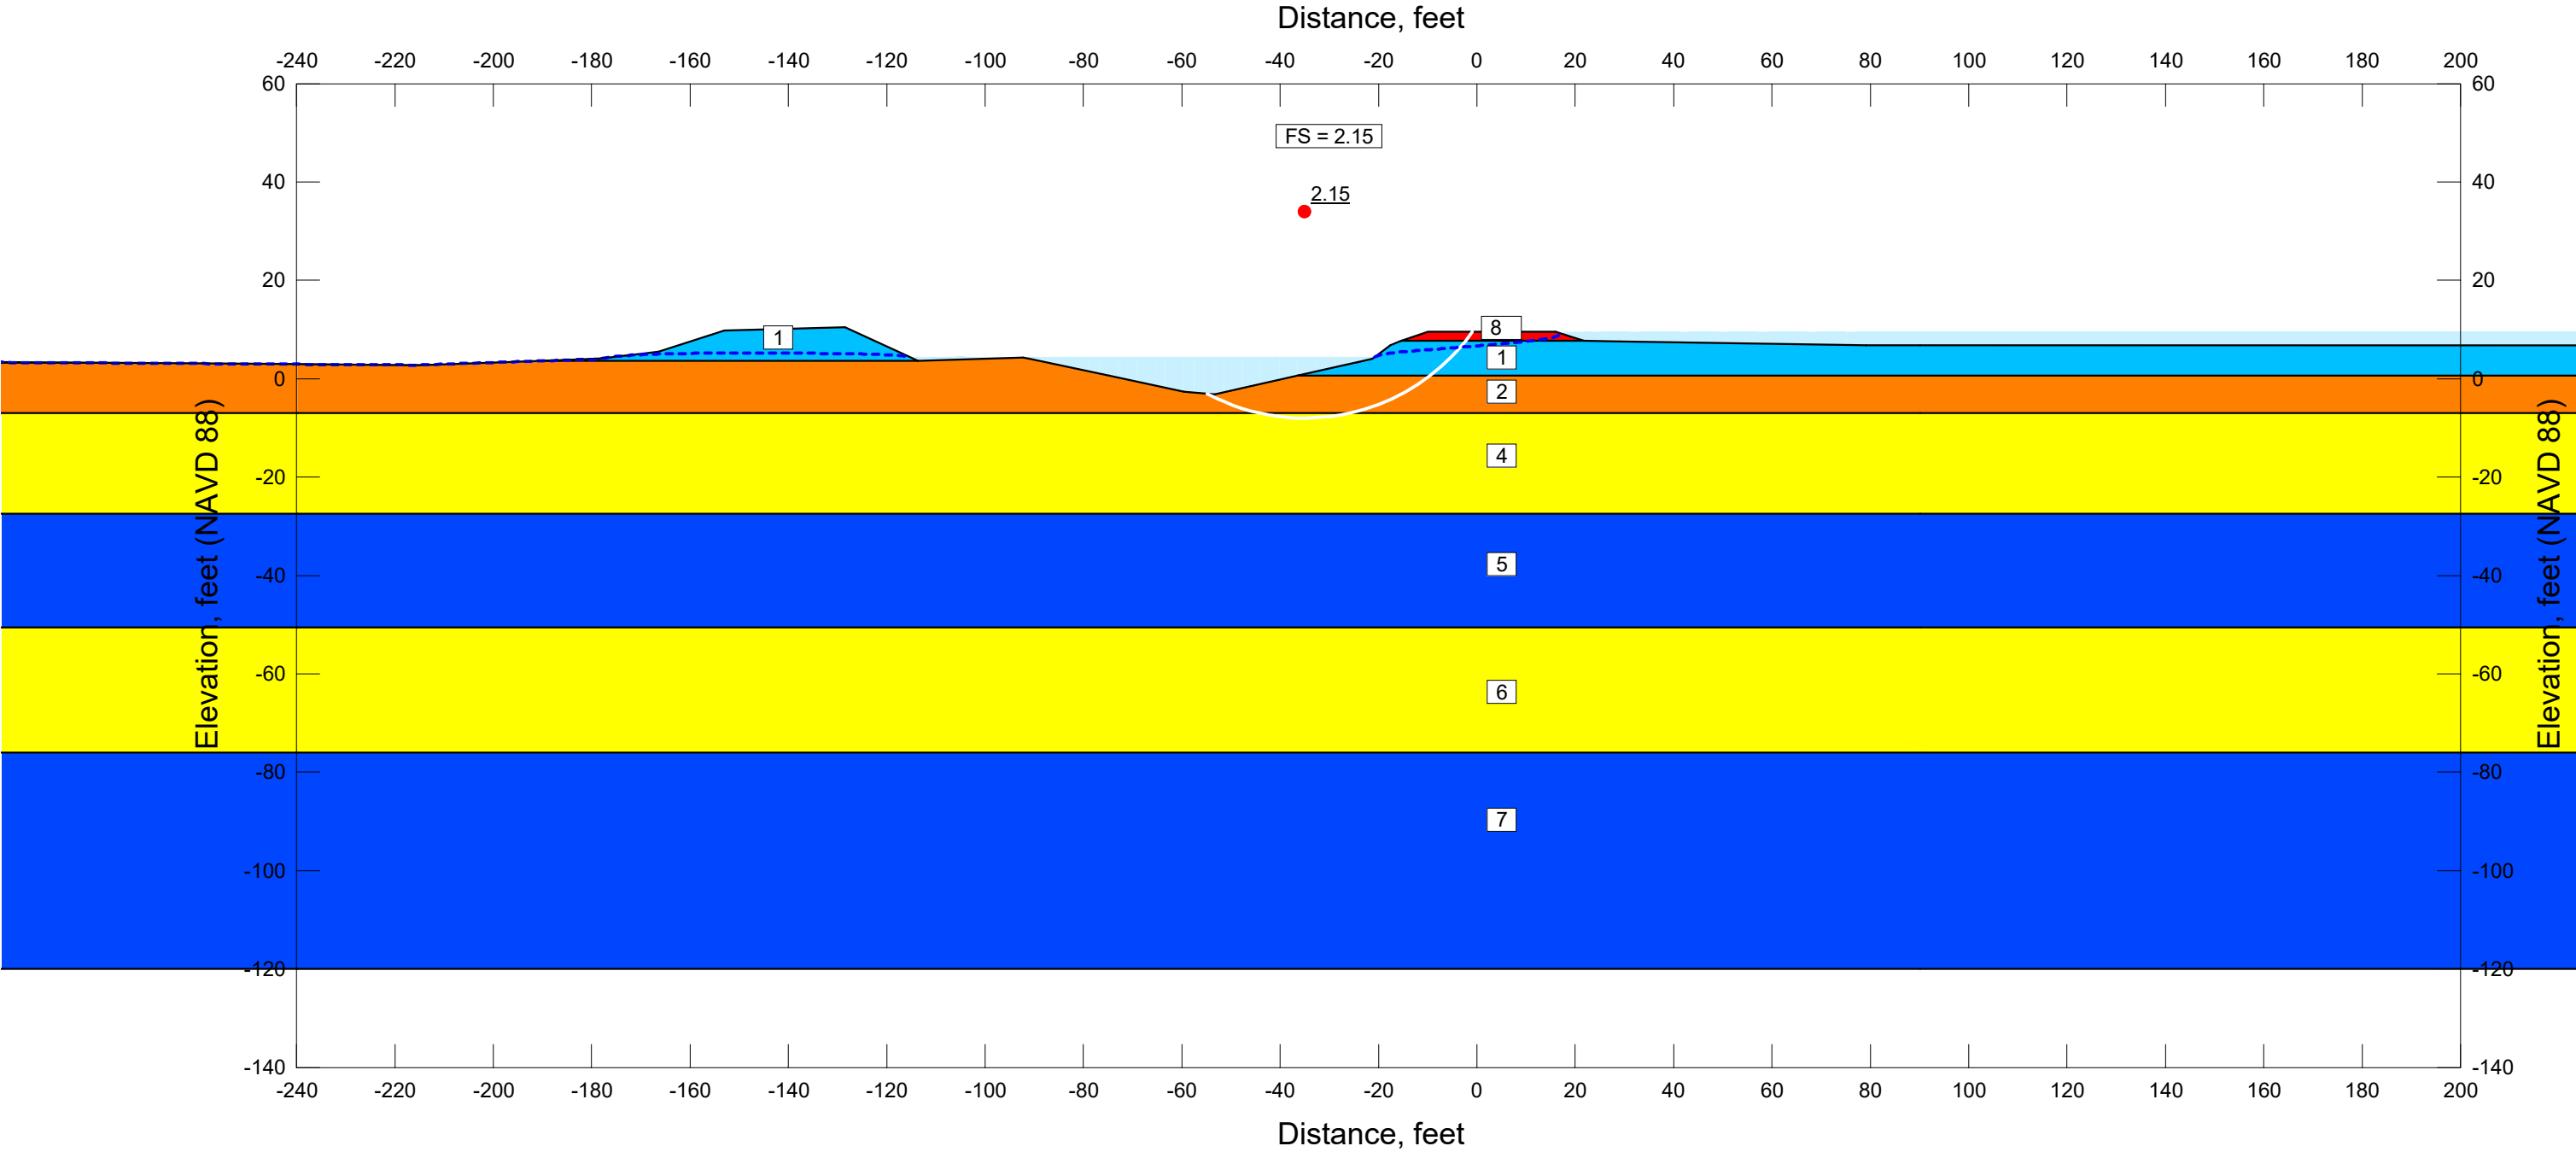
Cache Slough Mitigation Bank Solano County, California	
Slope Stability Analysis Station 90+32 Long-Term Steady State	
April 2024	110926
SHANNON & WILSON, INC. Geotechnical and Environmental Consultants	FIG. D-16

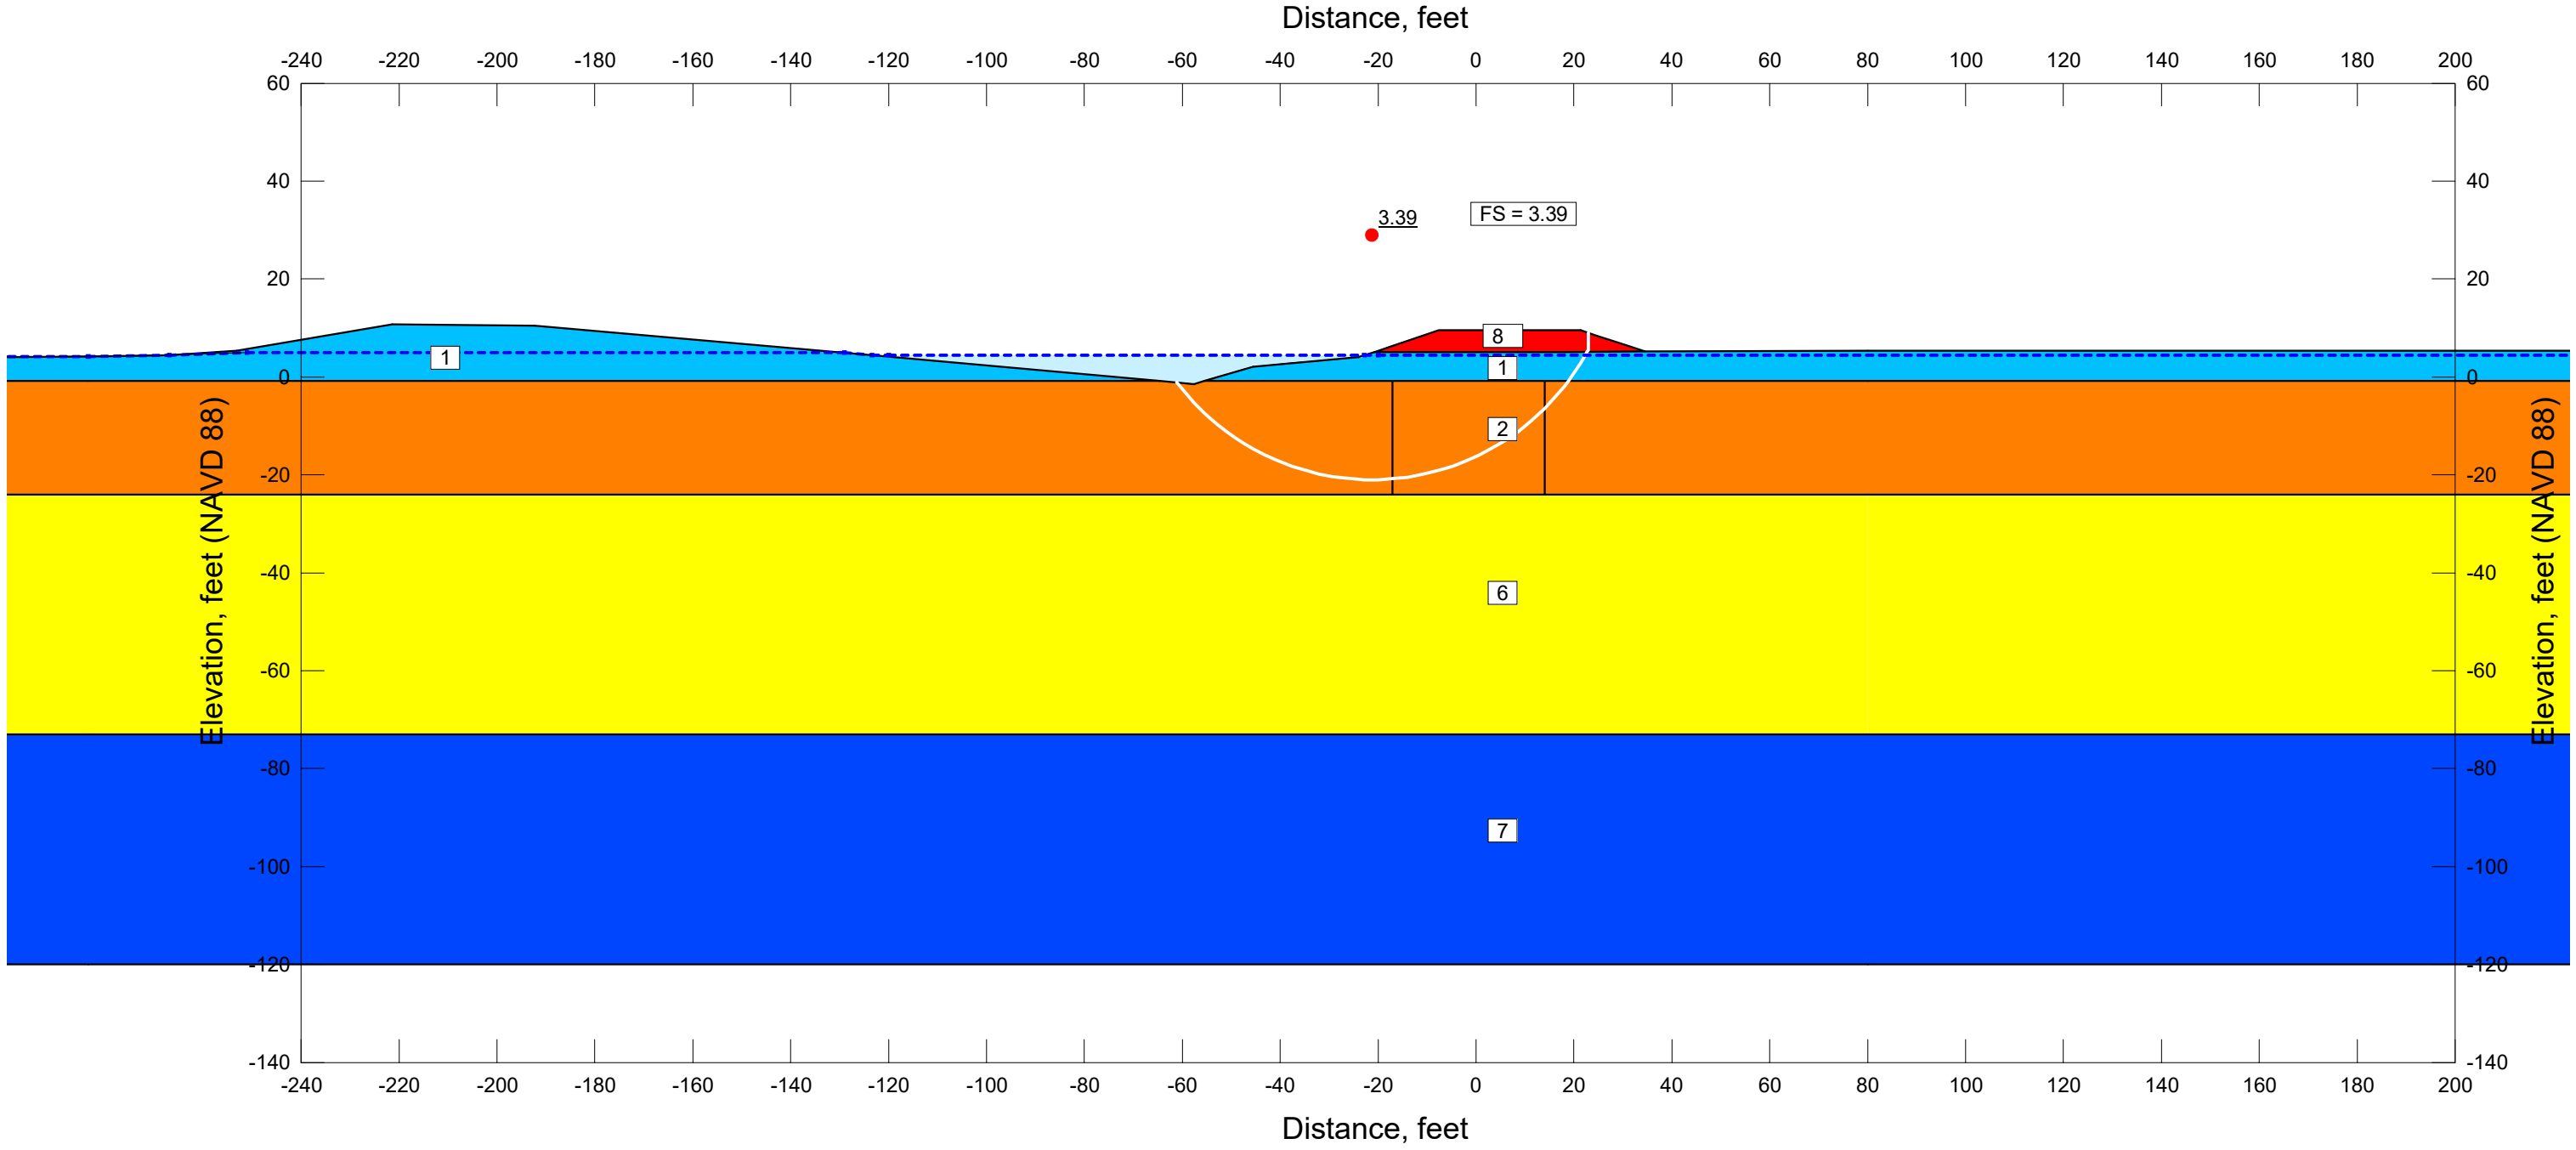
Cache Slough Mitigation Bank Solano County, California	
Slope Stability Analysis Station 97+32 End-of-Construction - Landside	
April 2024	110926
SHANNON & WILSON, INC. Geotechnical and Environmental Consultants	FIG. D-18

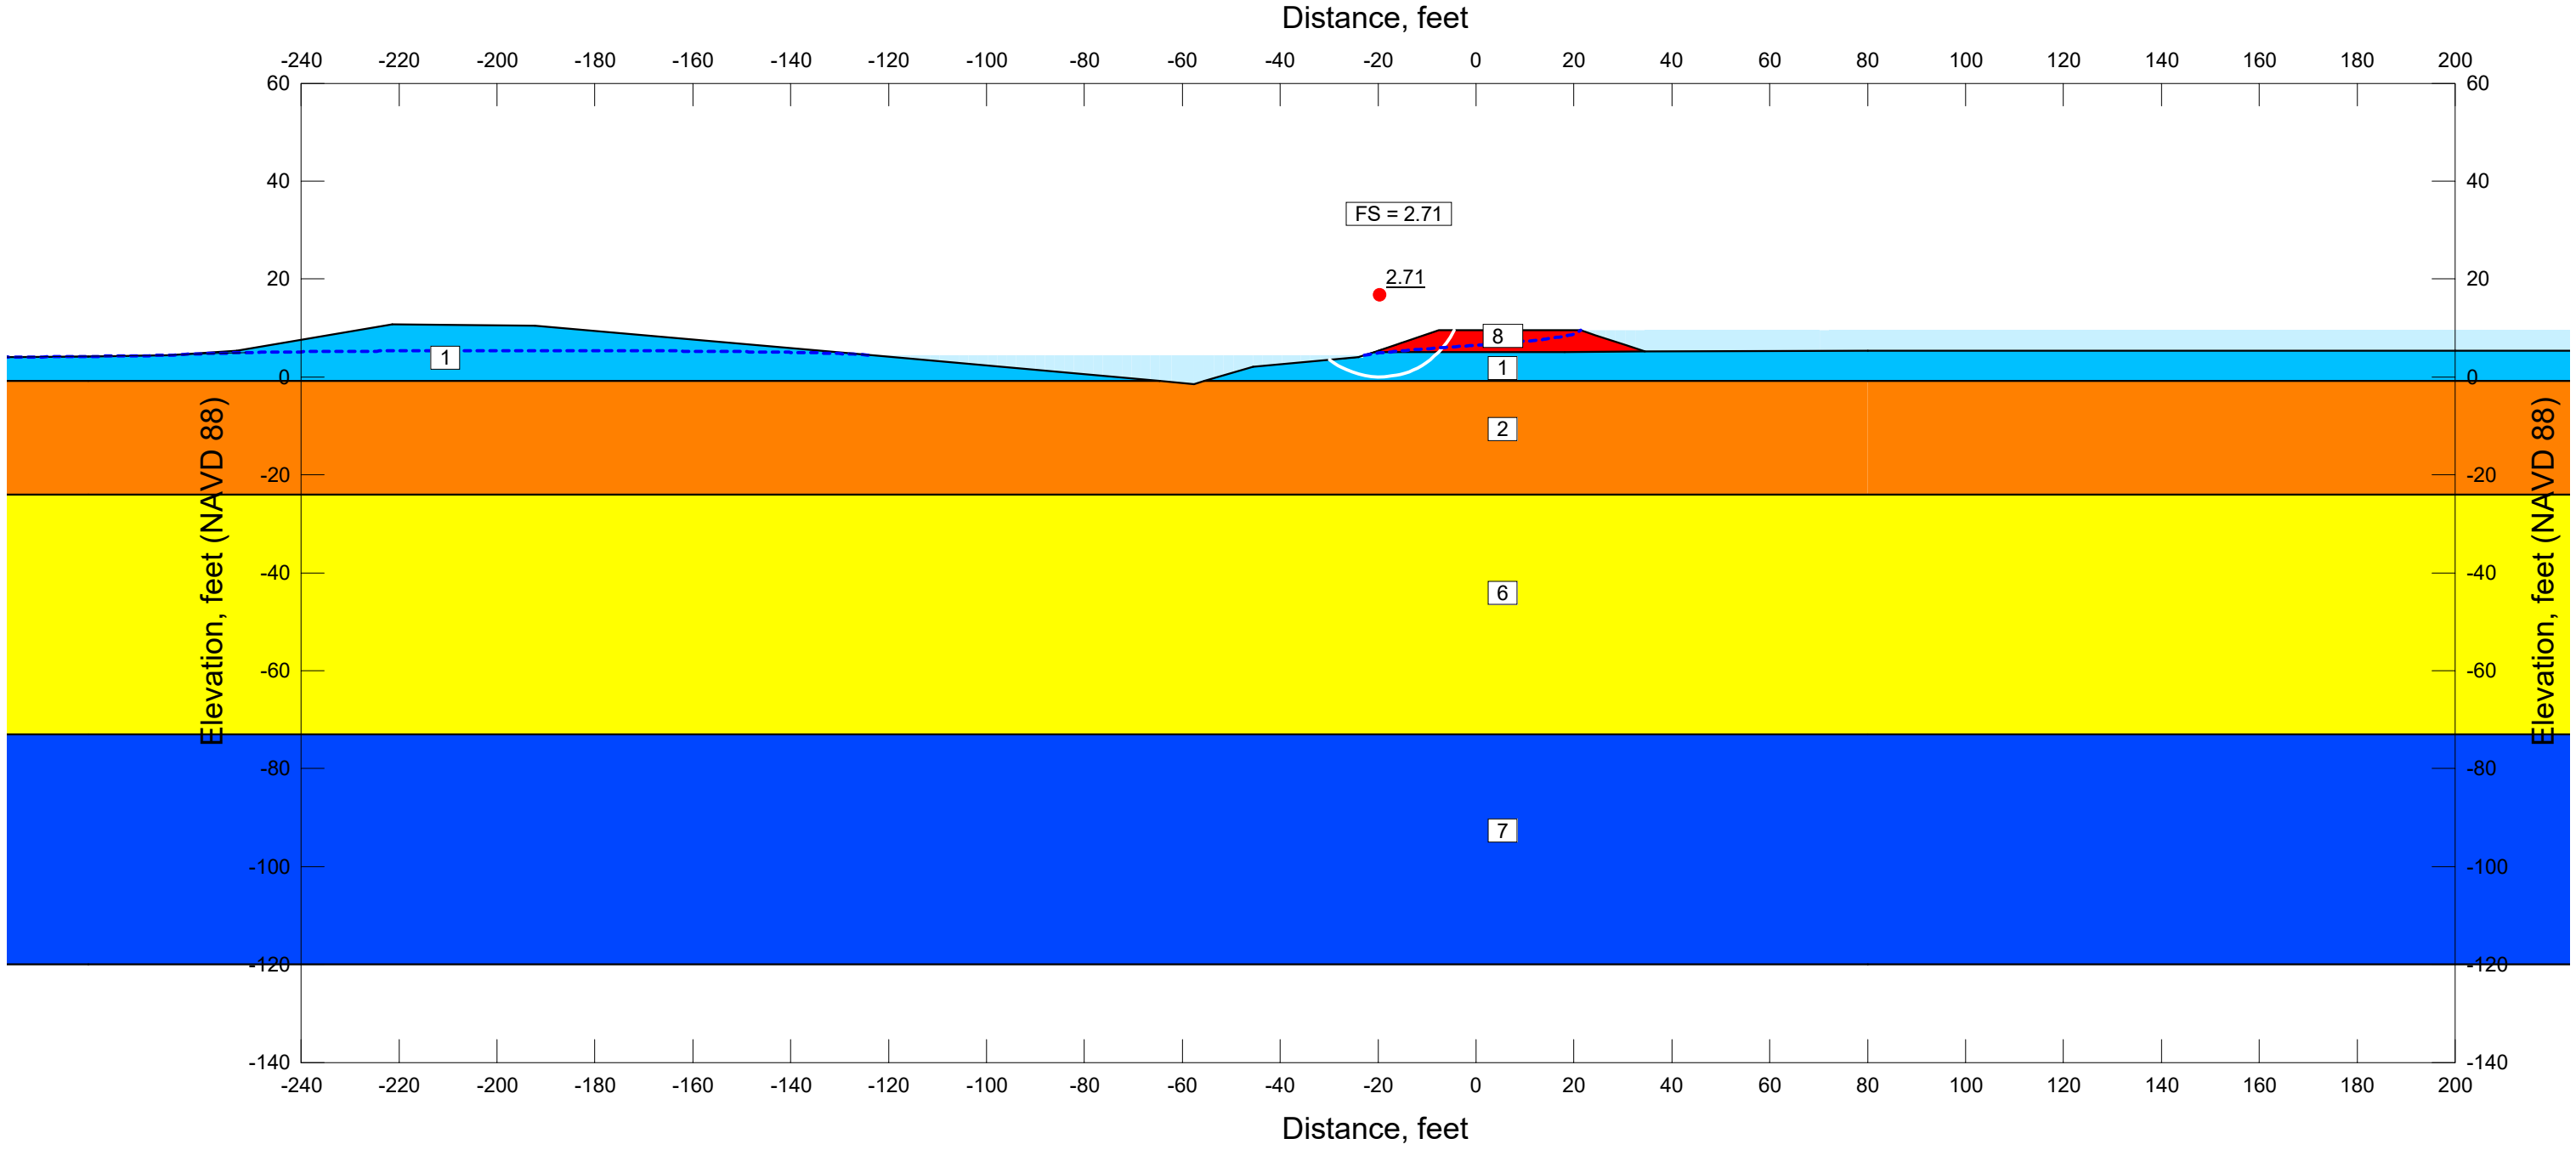
Cache Slough Mitigation Bank Solano County, California	
Slope Stability Analysis Station 97+32 Long-Term Steady State	
April 2024	110926
SHANNON & WILSON, INC. Geotechnical and Environmental Consultants	FIG. D-20
