GEOTECHNICAL INVESTIGATION: REVISION 1
Cache Slough Mitigation Bank
SOLANO COUNTY, CALIFORNIA

Subject: GEOTECHNICAL INVESTIGATION: REVISION 1, CACHE SLOUGH
MITIGATION BANK, SOLANO COUNTY, CALIFORNIA

We performed a geotechnical investigation for the Cache Slough Mitigation Bank in Solano County, California in accordance with the proposal dated January 11, 2023. The results of the investigation are presented in the attached report.

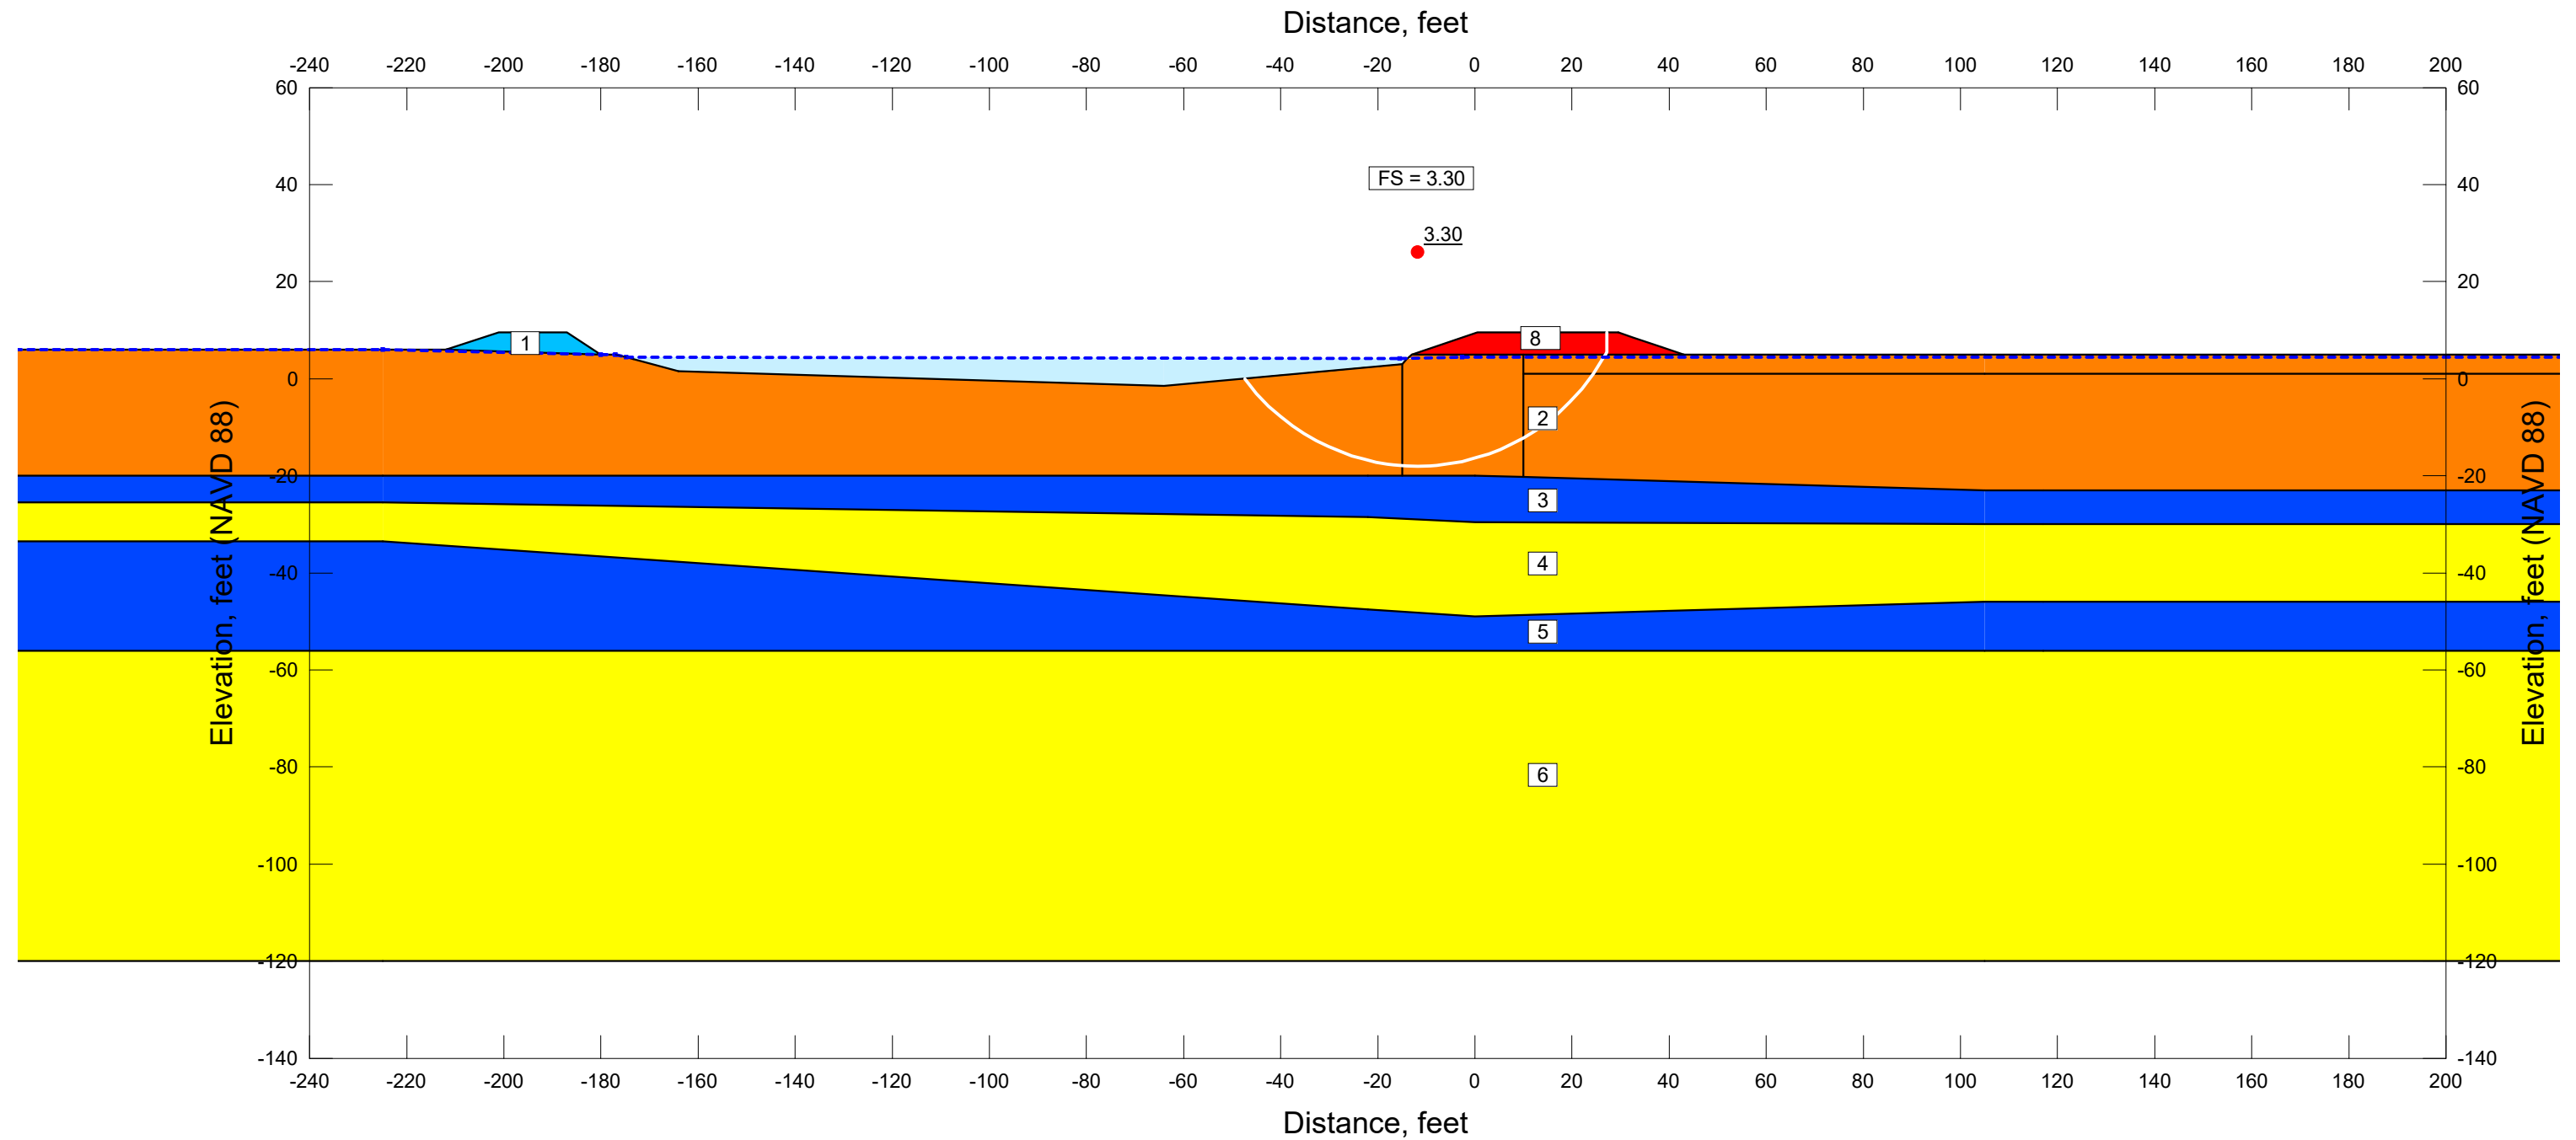
Cache Slough Mitigation Bank Solano County, California	
Slope Stability Analysis Station 122+32 End-of-Construction - Landside	
April 2024	110926
SHANNON & WILSON, INC. Geotechnical and Environmental Consultants	FIG. D-26

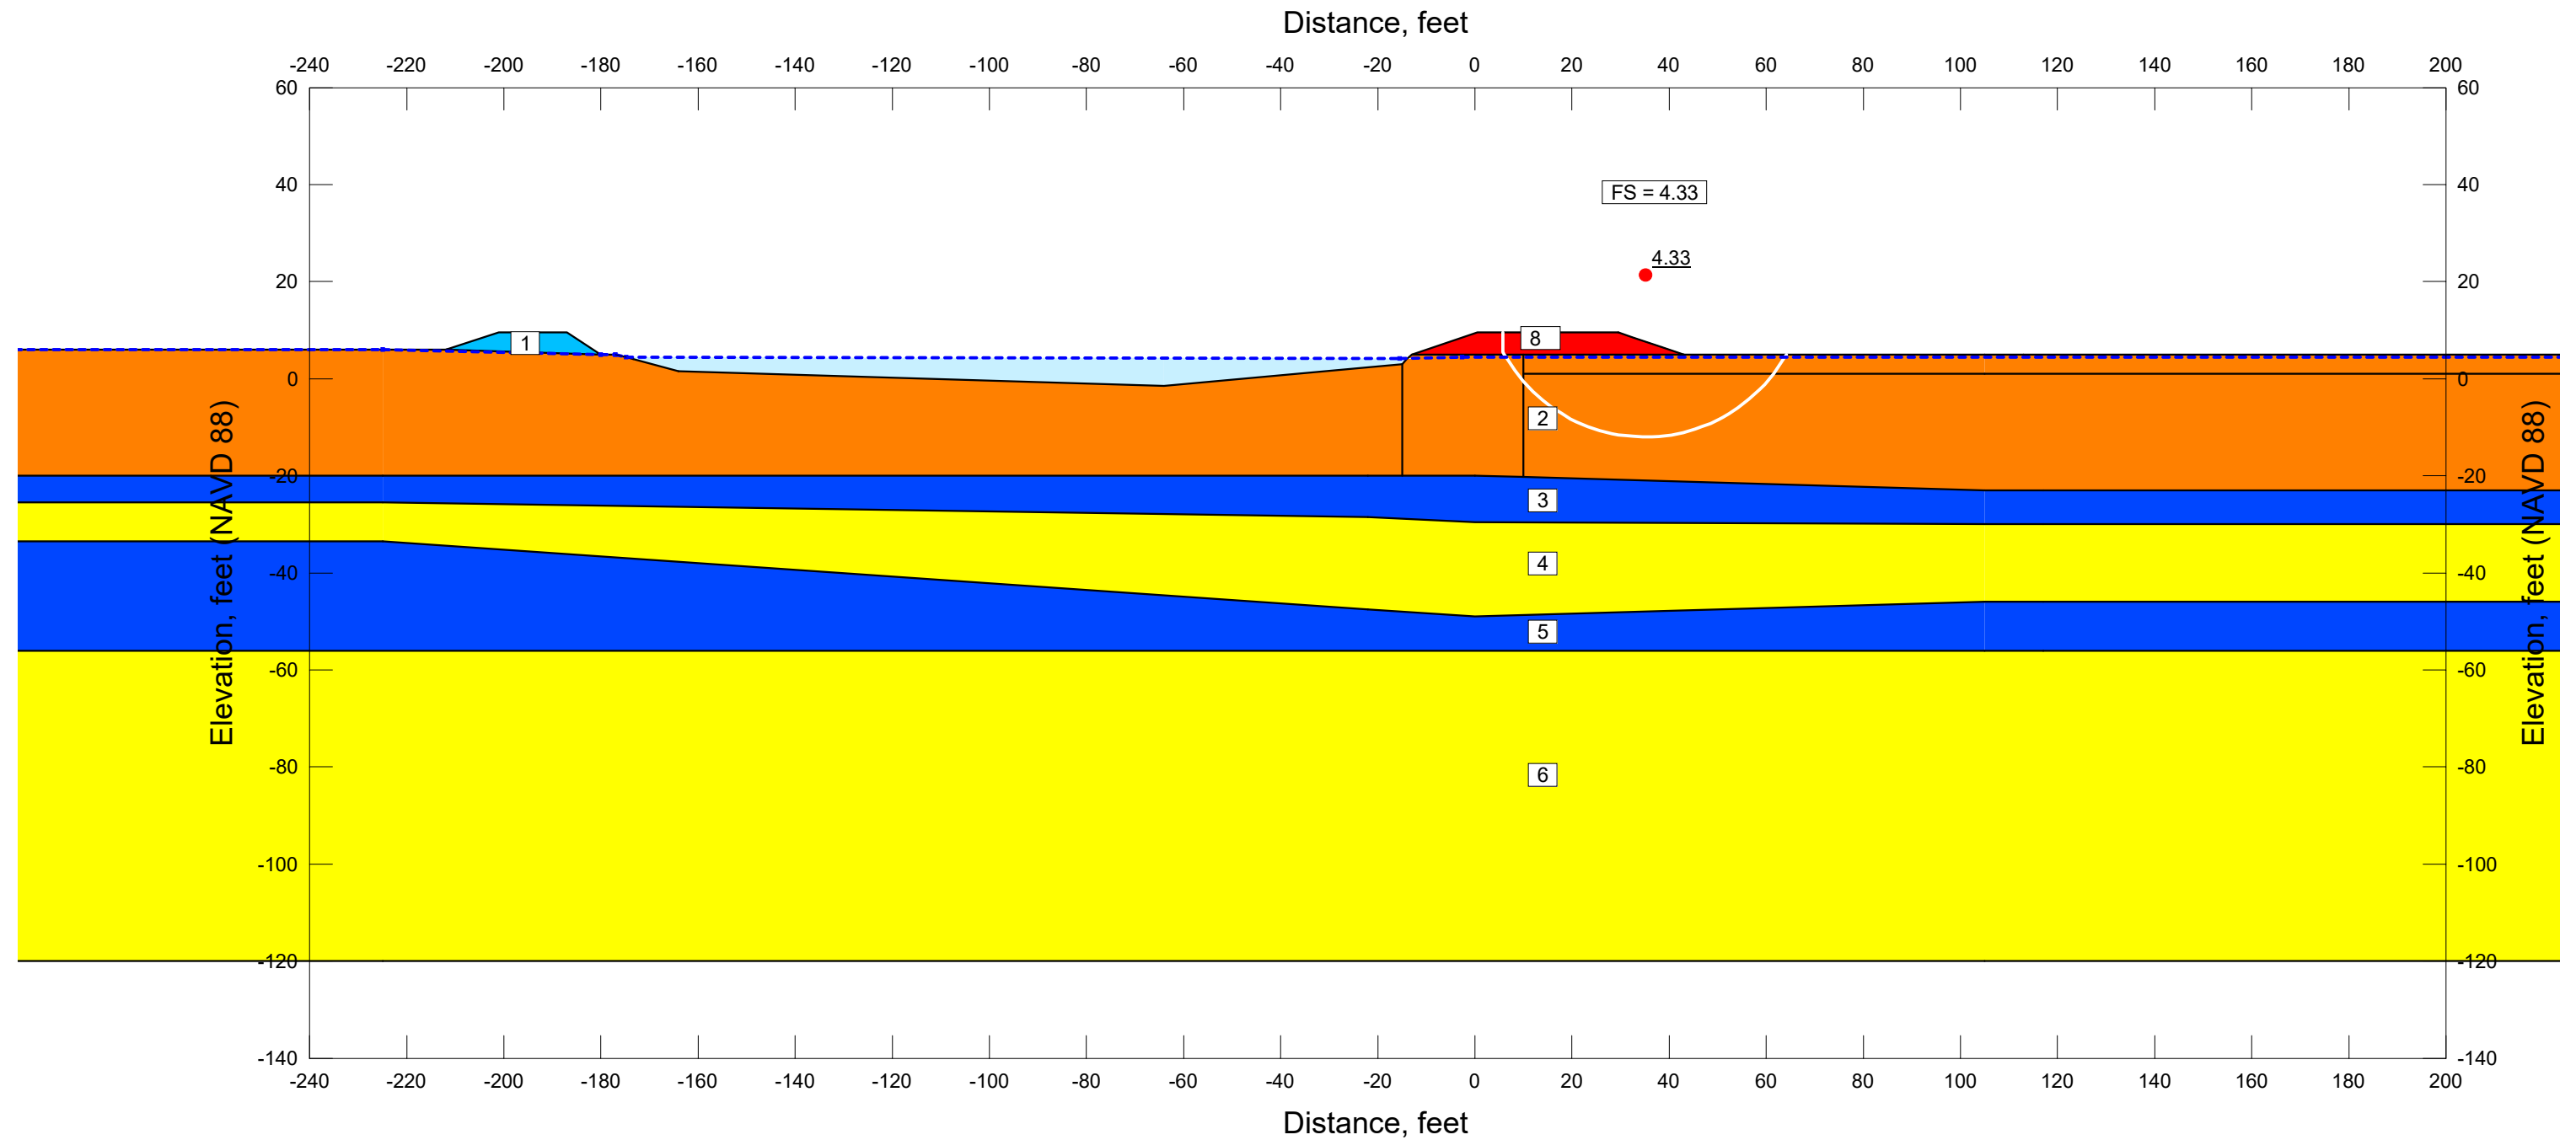
Cache Slough Mitigation Bank Solano County, California	
Slope Stability Analysis Station 122+32 End-of-Construction - Waterside	
April 2024	110926
SHANNON & WILSON, INC. Geotechnical and Environmental Consultants	FIG. D-27

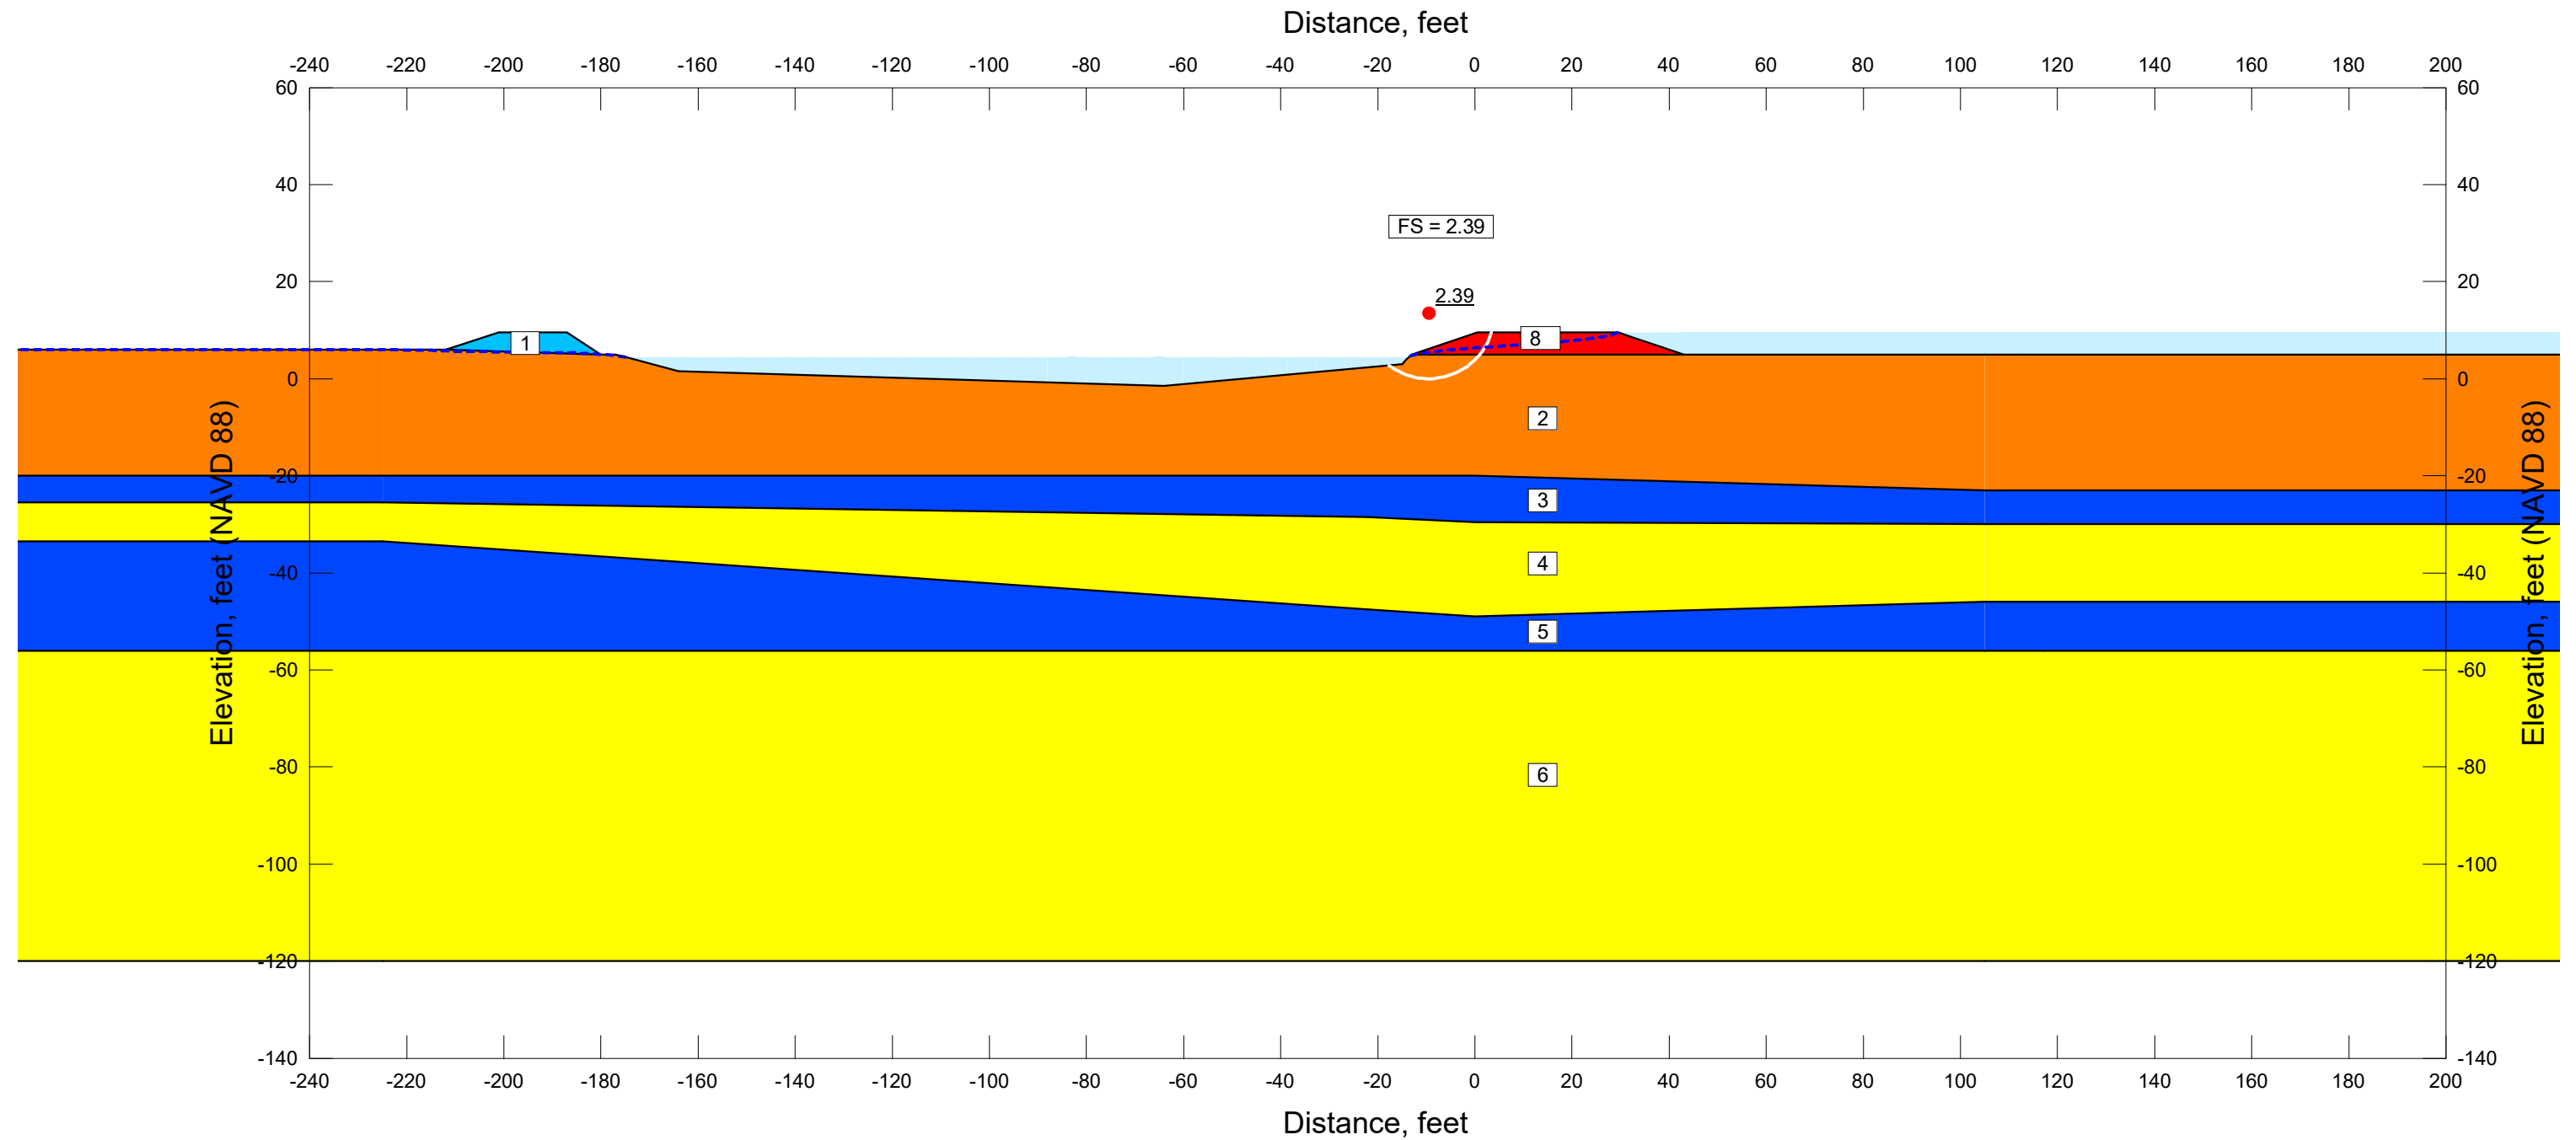
Cache Slough Mitigation Bank Solano County, California	
Slope Stability Analysis Station 122+32 Long-Term Steady State	
April 2024	110926
SHANNON & WILSON, INC. Geotechnical and Environmental Consultants	FIG. D-28

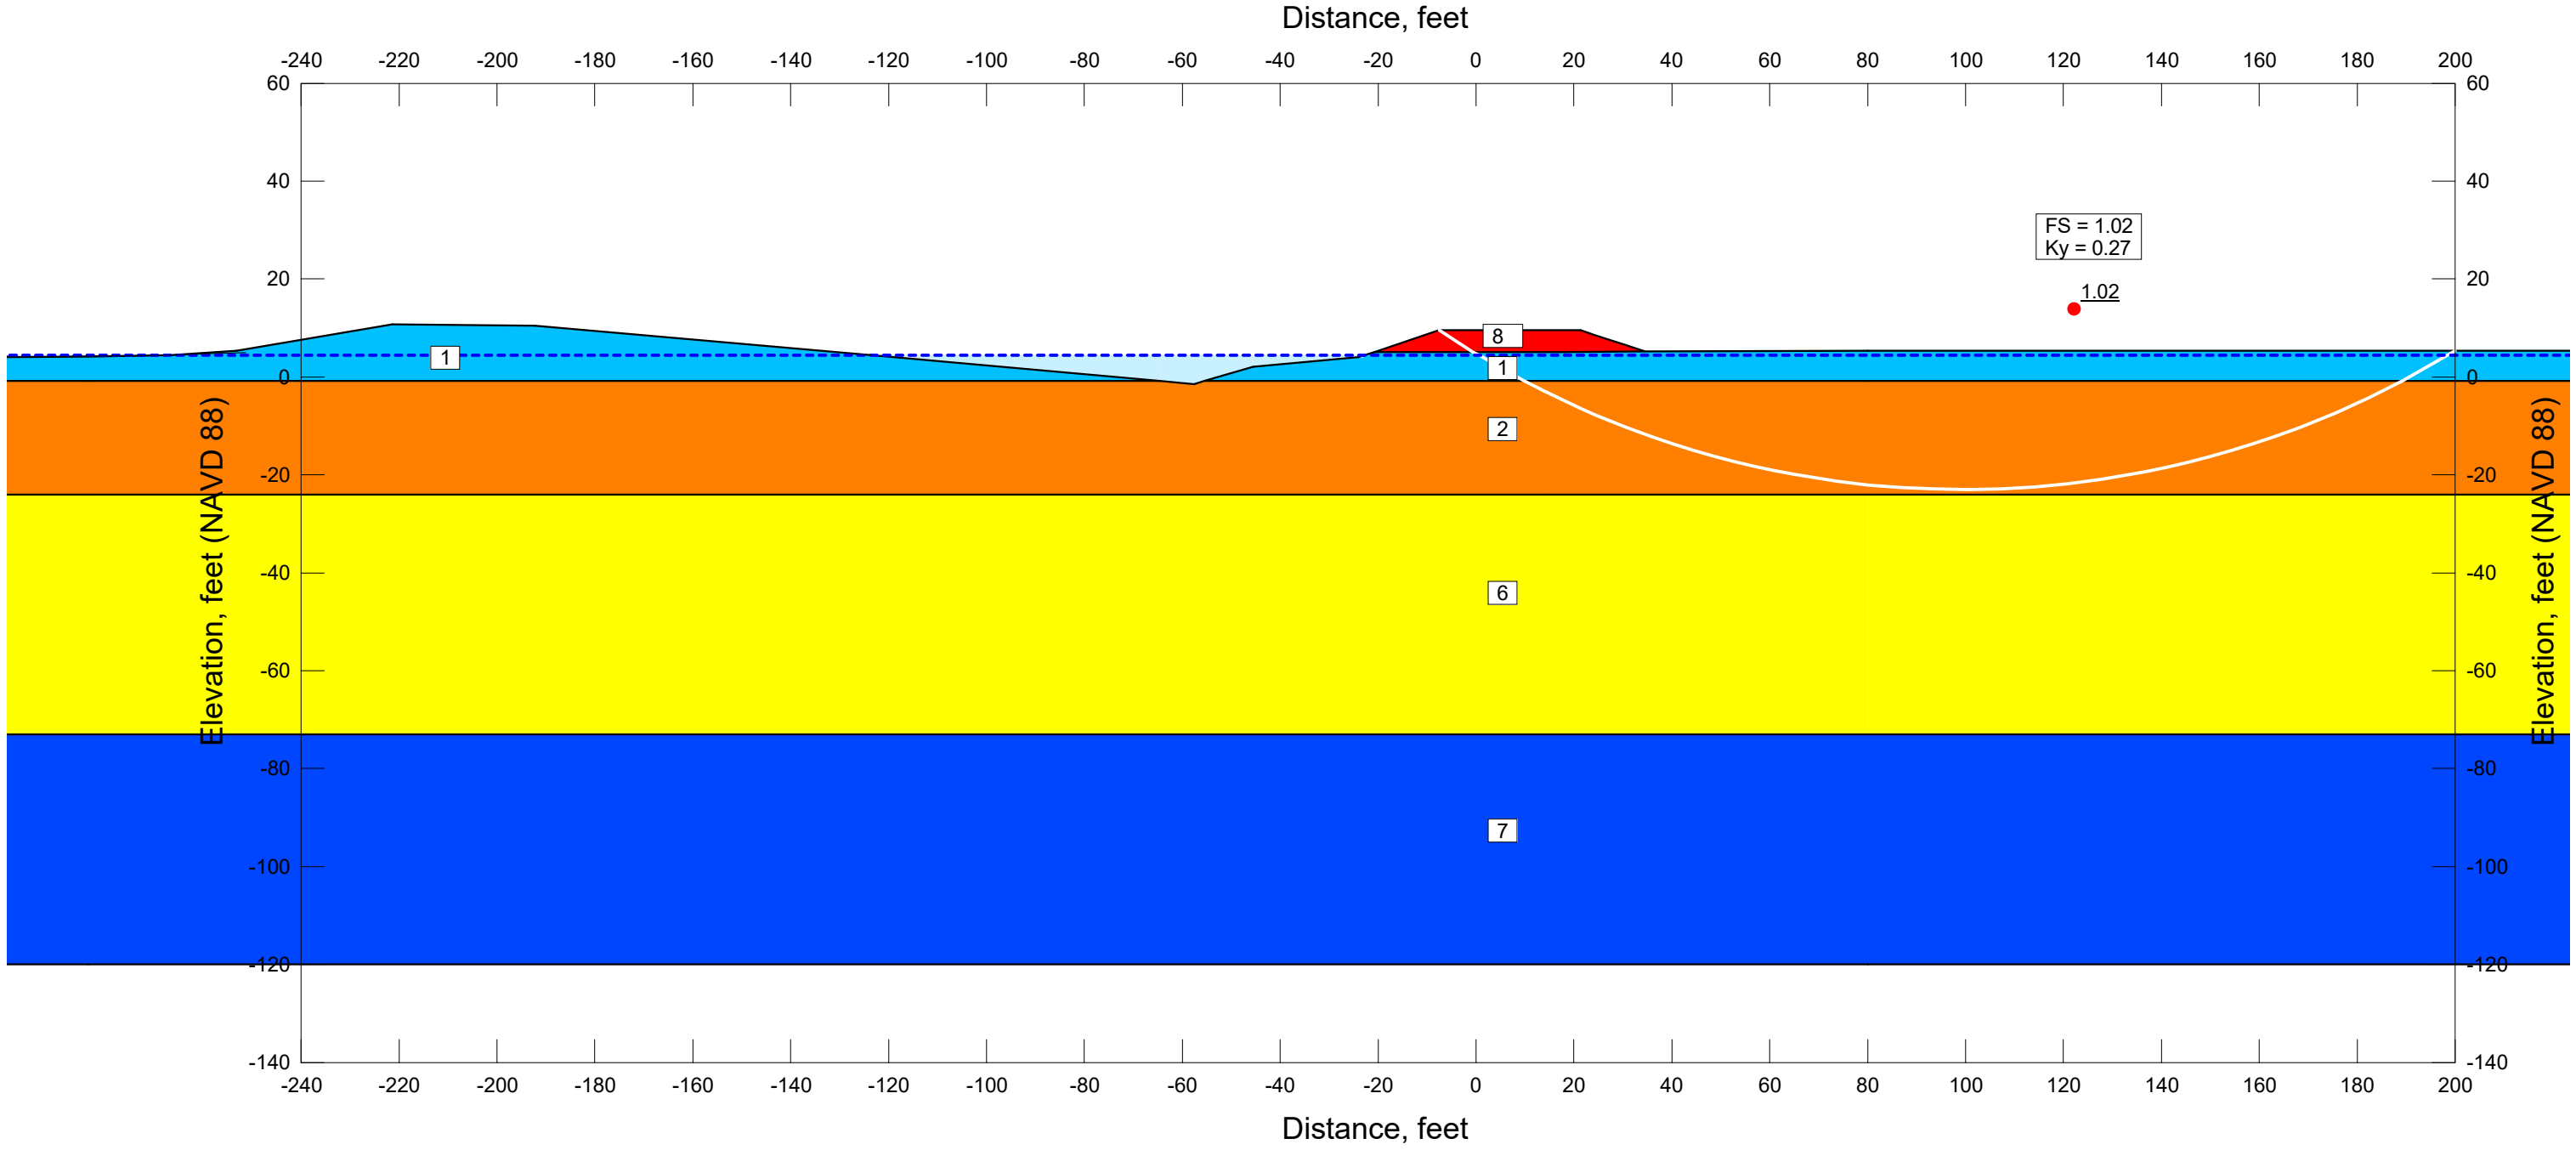
Cache Slough Mitigation Bank Solano County, California	
Slope Stability Analysis Station 97+32 Pseudo-Static - Waterside	
April 2024	110926
SHANNON & WILSON, INC. Geotechnical and Environmental Consultants	FIG. D-39

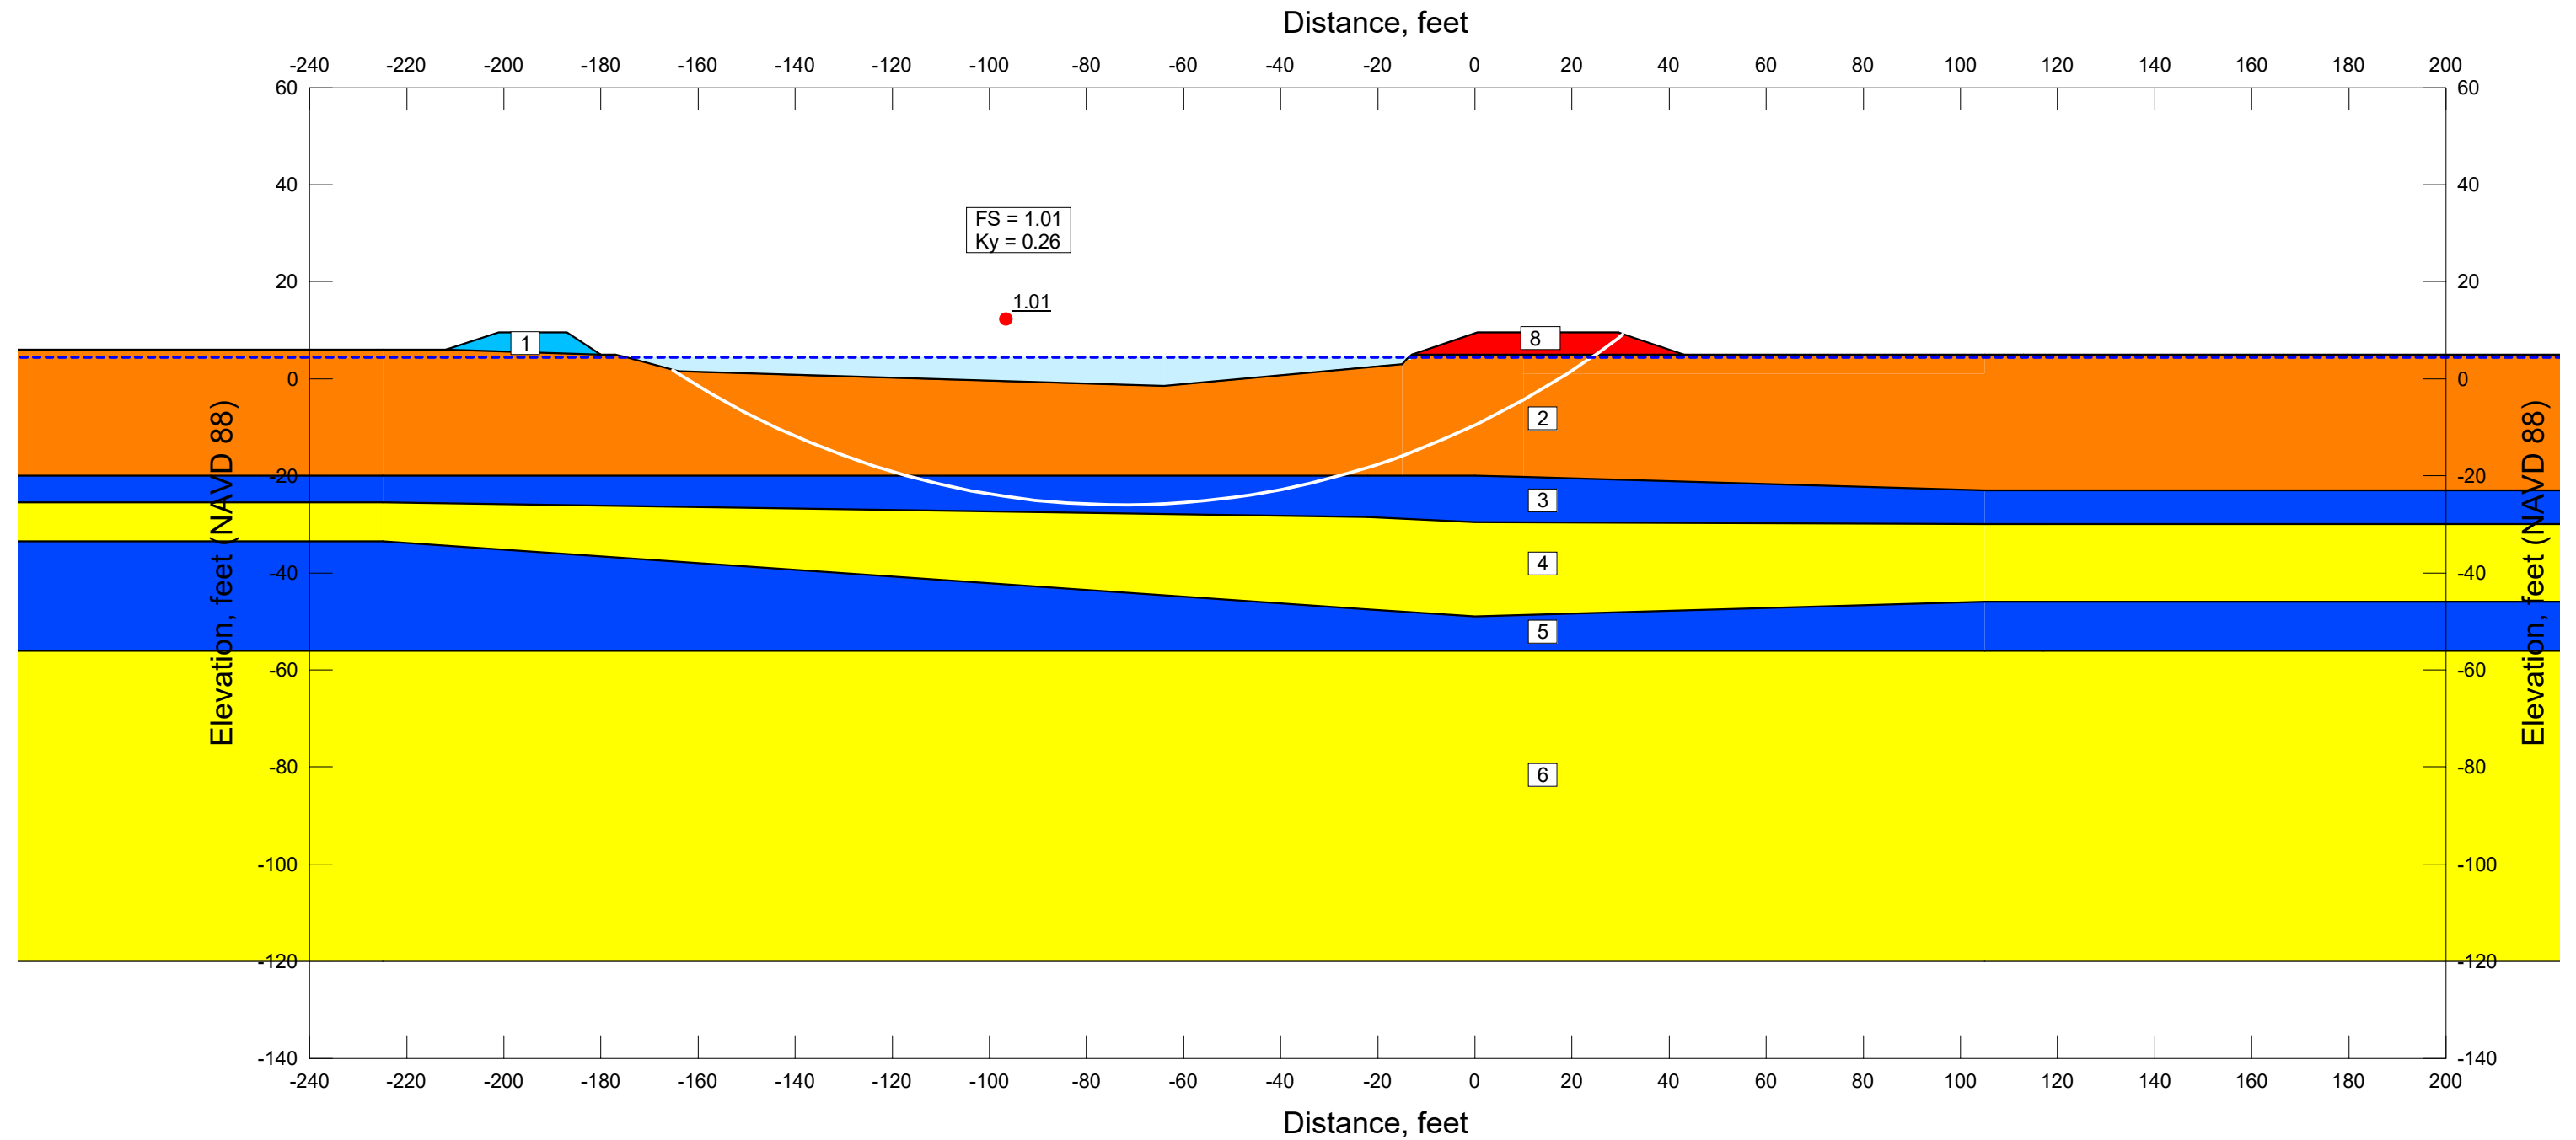
Cache Slough Mitigation Bank Solano County, California	
Slope Stability Analysis Station 122+32 Pseudo-Static - Landside	
April 2024	110926
SHANNON & WILSON, INC. Geotechnical and Environmental Consultants	FIG. D-42

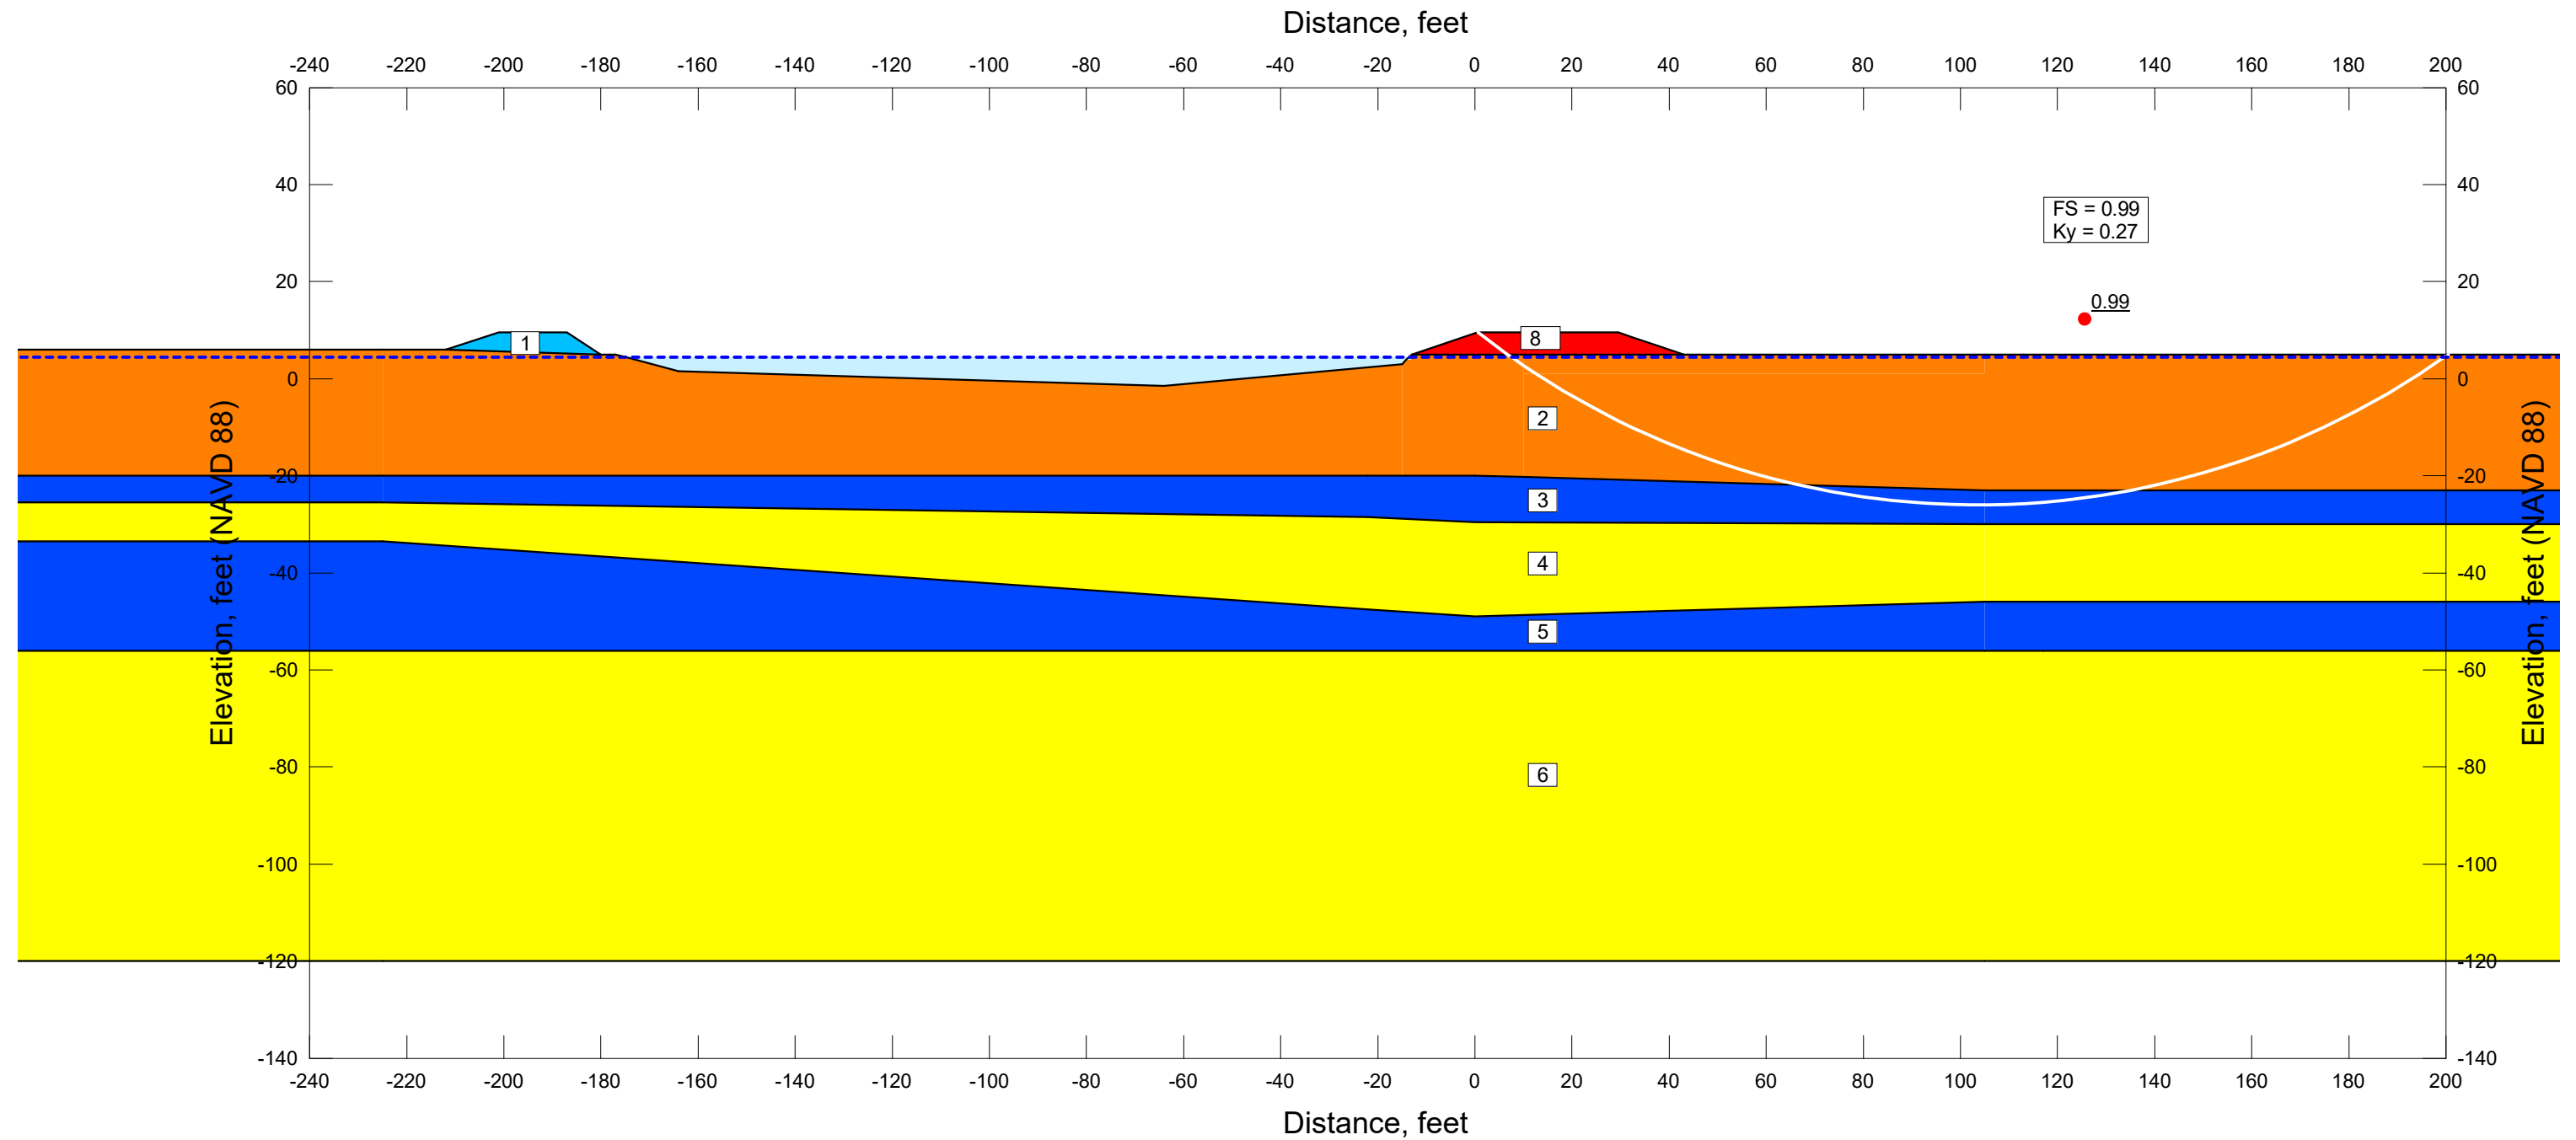
Notes:
1. See Figure D-1 for material properties.

Cache Slough Mitigation Bank Solano County, California	
Slope Stability Analysis Station 122+32 Pseudo-Static - Waterside	
April 2024	110926
SHANNON & WILSON, INC. Geotechnical and Environmental Consultants	FIG. D-43

We performed analysis to check the factors of safety for the landside and waterside slopes for steady state seepage and rapid drawdown loading conditions before and after the levee rehabilitation. We also analyzed the factor of safety for the landside and waterside slopes for the end-of-construction condition. The stability analysis was performed on the same cross sections that were analyzed for seepage. We used the computer program SLOPE/W and Spencer's method of analysis. We used effective stress strength parameters for analyzing the factors of safety under steady-state seepage conditions. We analyzed the stability of the landslide slope for steady state seepage conditions by importing pore water pressures calculated in the seepage analysis using the waterside water level at Elevation 9.5. We analyzed the stability of the waterside slope for rapid drawdown using the waterside water level at Elevation 9.5. For the rapid drawdown analysis, we used the feature in SLOPE/W that used the Staged Rapid Drawdown Analysis option based on the Duncan et al., 1990 procedure and both the effective stress and undrained strength envelopes. For the end-of-construction analysis we used undrained strength parameters. We modeled a tension crack through the levee fill for the end-of-construction case.

The Guidance Document (2015) provides minimum factors of safety for different loading conditions on the land- and waterside levee slopes, which are presented in Exhibit D-1.

Loading Condition	Levee Slope	Minimum Factor of Safety
Steady State Seepage	Landside	1.5
Rapid Drawdown	Waterside	1.2
End of Construction	Landside and Waterside	1.3
