AQUATIC RESOURCES DELINEATION

Realized Dreams Ranch Subdivision Project Solano County, CA | April 2025

Realized Dreams Ranch, LLC
8330 Tremont Road
Dixon, CA 95620

Acorn Environmental
5170 Golden Foothill Parkway
El Dorado Hills, CA 95762
916.235.8224
www.acorn-env.com

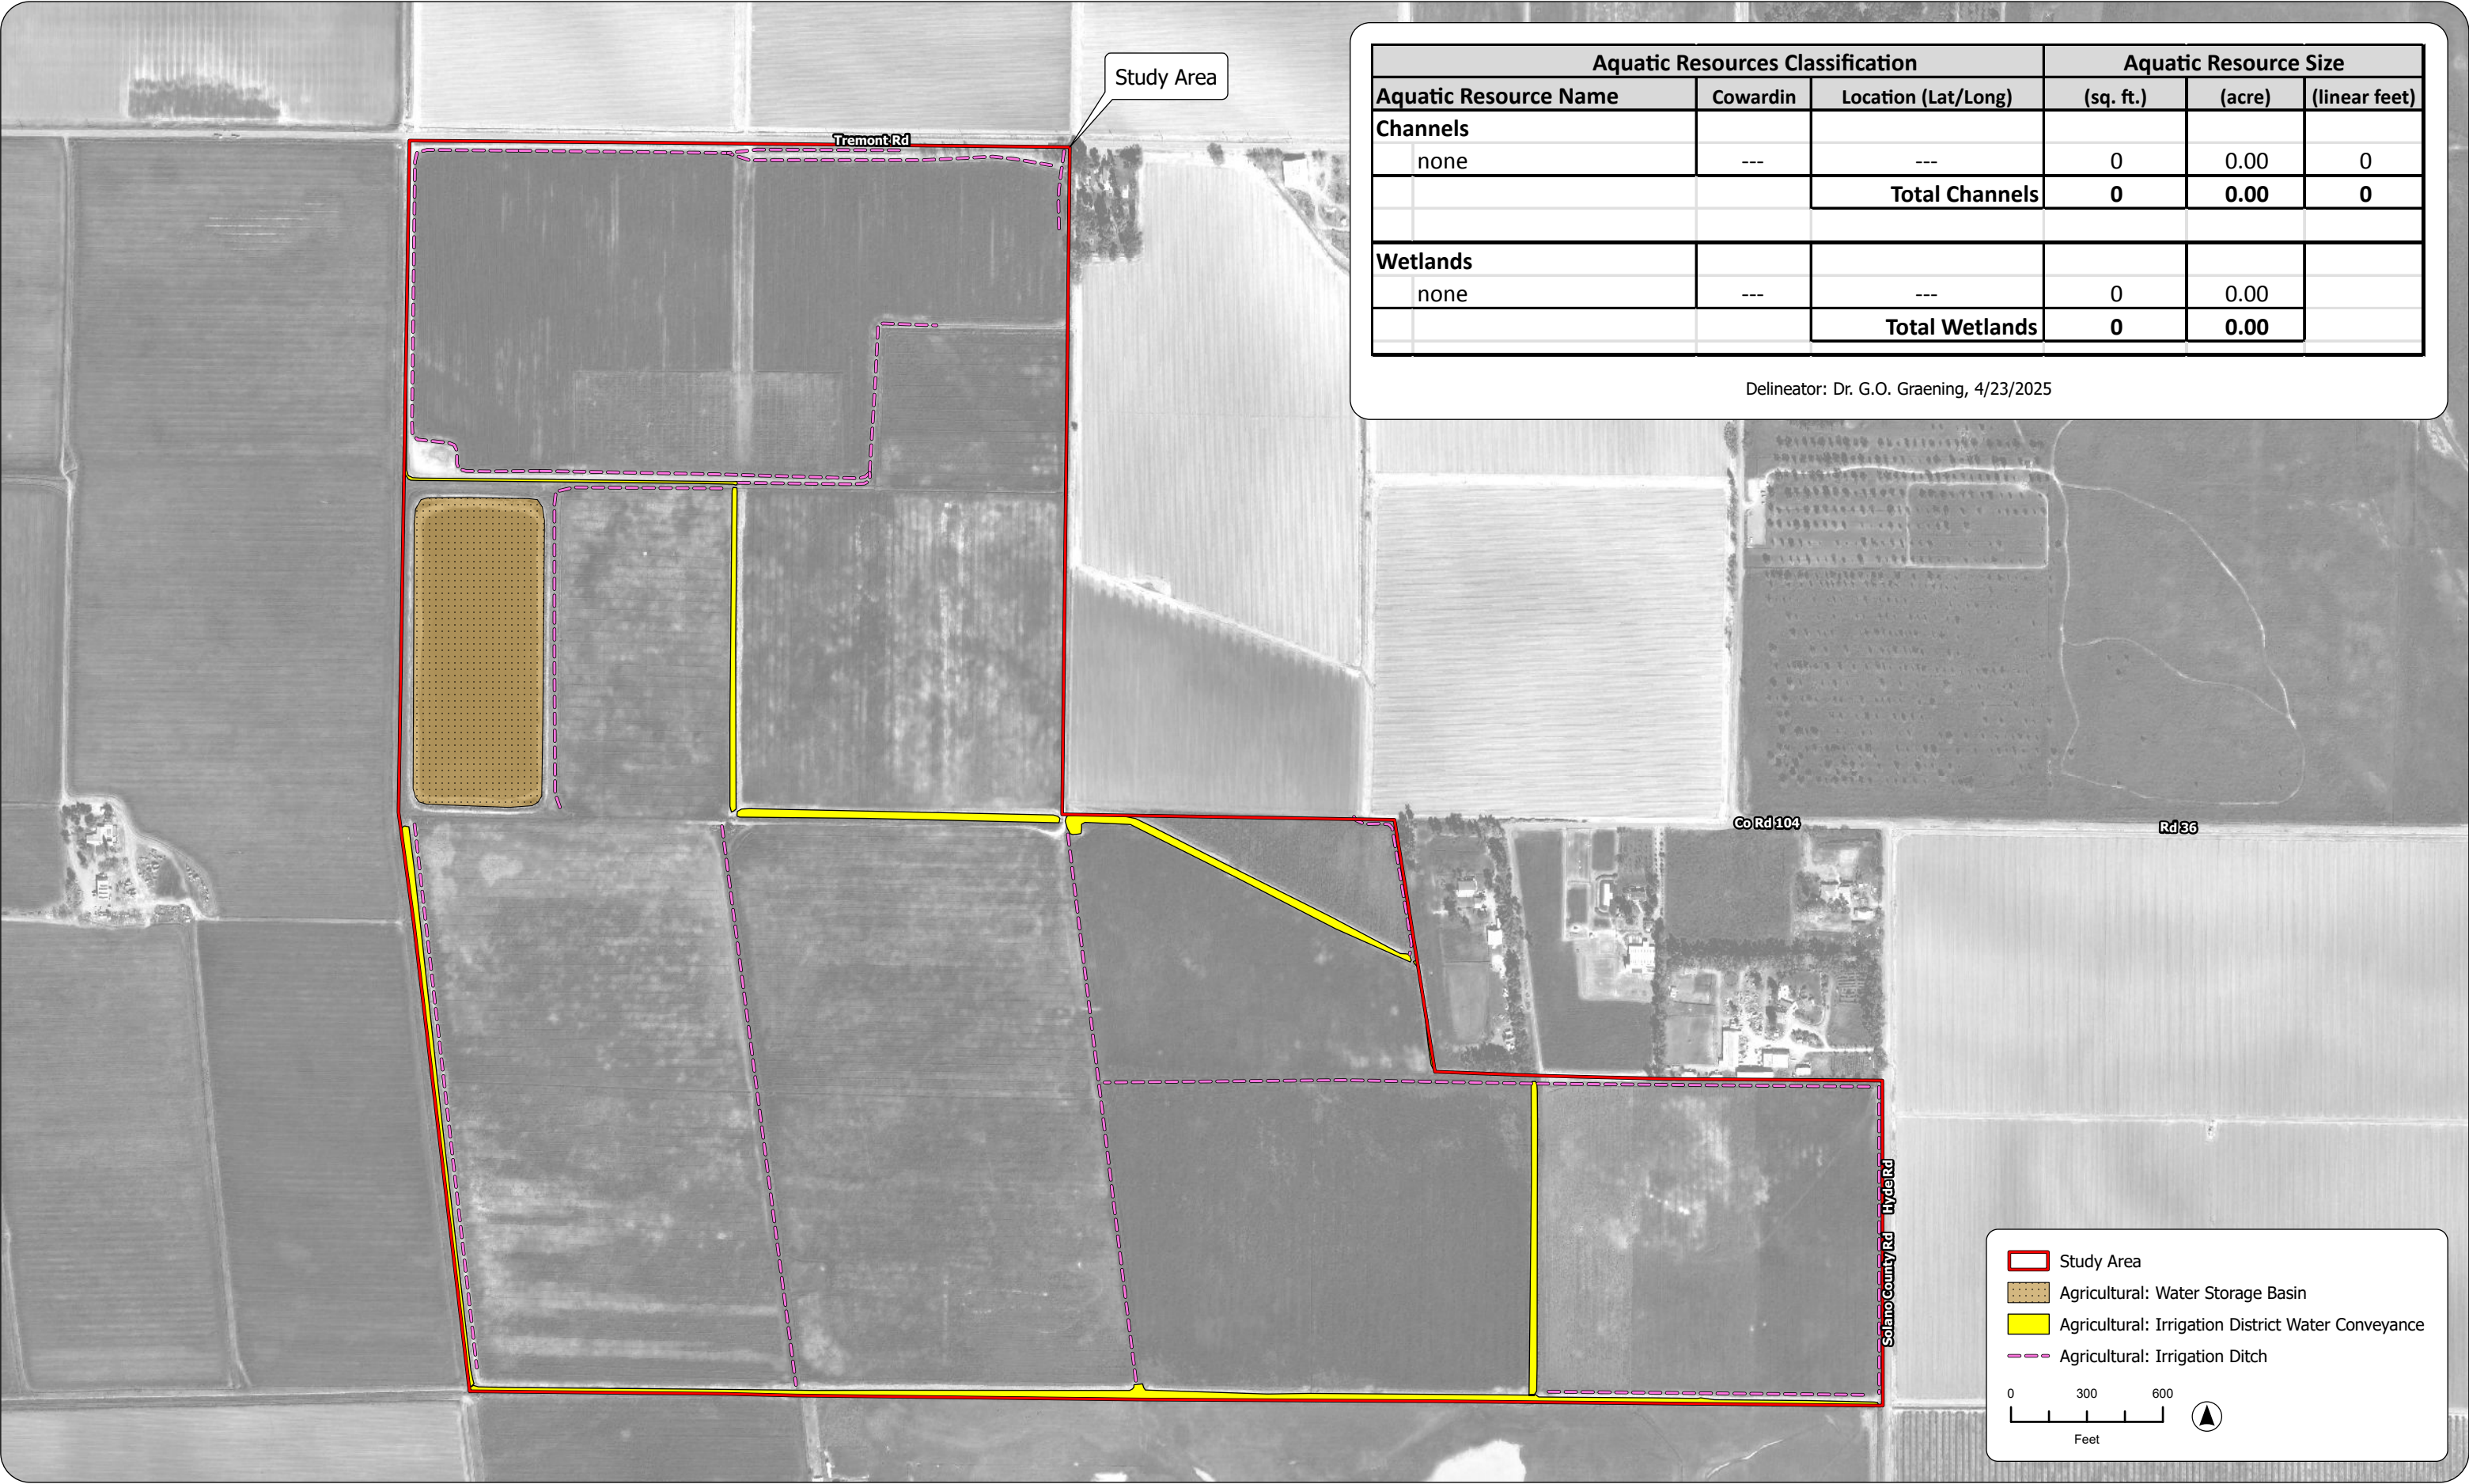
Figure 7
Aquatic Resources Delineation

Hydrologic features were identified and mapped within the Study Area. This map has not been verified by USACE or SWRCB and thus represents an unofficial demarcation of the potential limits of jurisdiction. Various survey points were established for the delineation and data sheets completed.

Identified hydrologic features were subjected to the 3-parameter test and guidance of current court decisions. Based upon these criteria, the following water features within the Study Area were determined to be potentially subject to USACE jurisdiction (**Figure 7**). As described in Section 5.1, the aquatic resources identified in the Study Area do not meet the definition of waters of the U.S. Therefore, there are no features considered potentially subject to USACE jurisdiction.

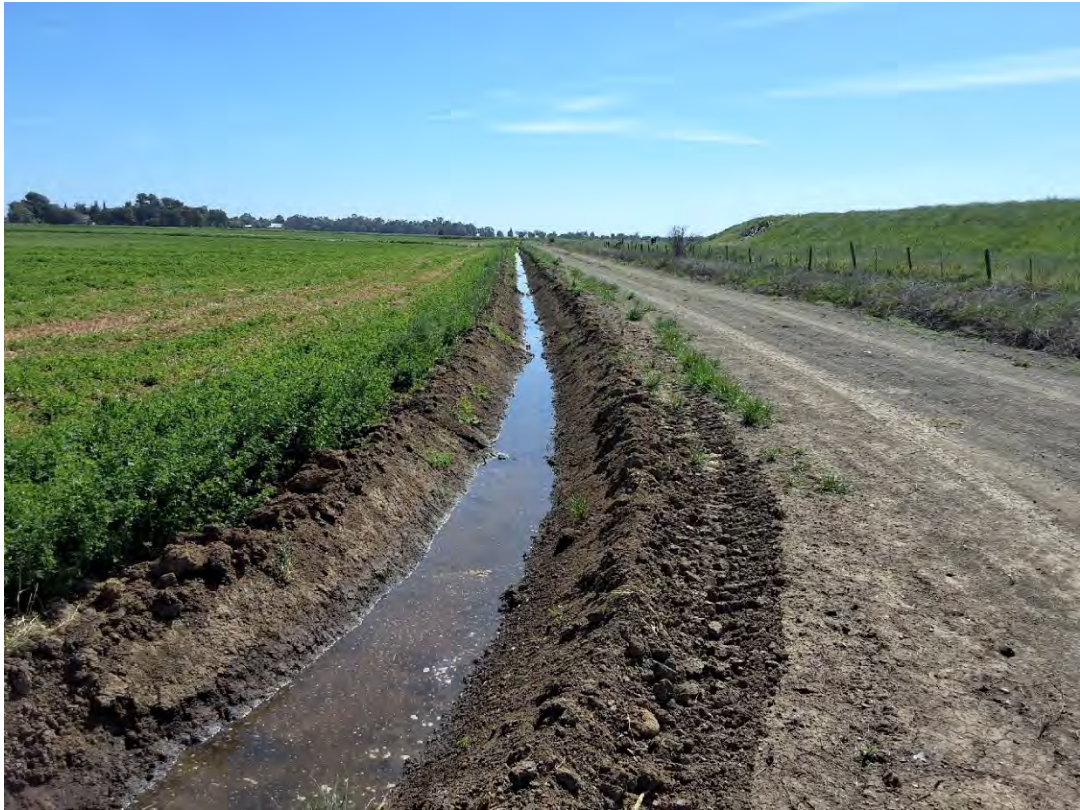
Representative photo of an agricultural irrigation ditch with unpaved farm road and berm of water storage basin on the right and flooded field agriculture on the left (alfalfa)

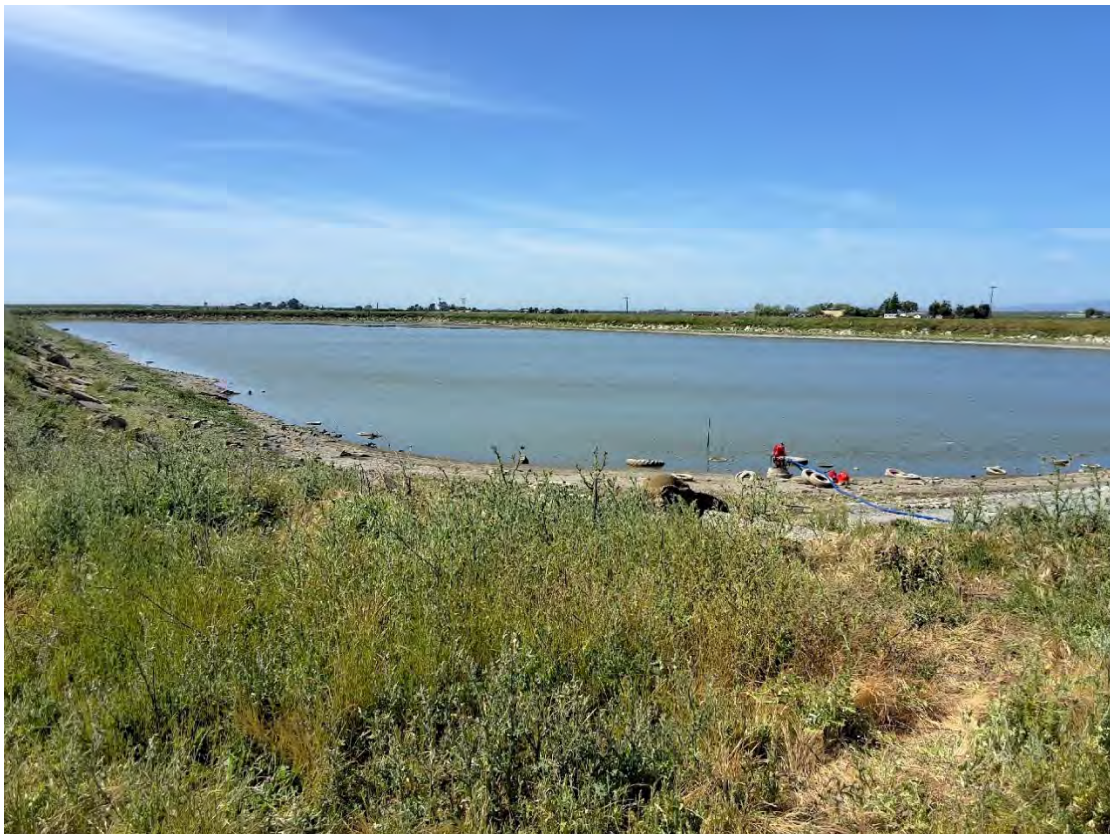
The agricultural water storage basin is a manmade feature created in uplands by installation of a berm above grade to retain water. This feature was initially constructed as part of a water right that allowed for use of tail water from the Solano Irrigation District's ditches and has since been used for agricultural irrigation and stock watering, primarily of sheep and cattle. The State Policy for Water Quality Control: State Wetland Definition and Procedures for Discharges of Dredged or Fill Material to Waters of the State generally considers artificial wetlands to be waters of the state but does provide an exemption in Section II 3(d)v. when the use is for agricultural irrigation and stock watering. Therefore, the agricultural water storage basin does not meet the definition of a water of the state. Further, permitting exceptions listed in Section IV.D(2c) include an exemption for "artificial, constructed lakes and ponds created in dry land such as farm and stock watering ponds, irrigation ponds, and settling basins." Thus, even though the agricultural water storage basin does not meet the definition of a water of the state, it also exempt from permitting requirements.

Agricultural water storage basin on the Study Area used for irrigation and stockwatering

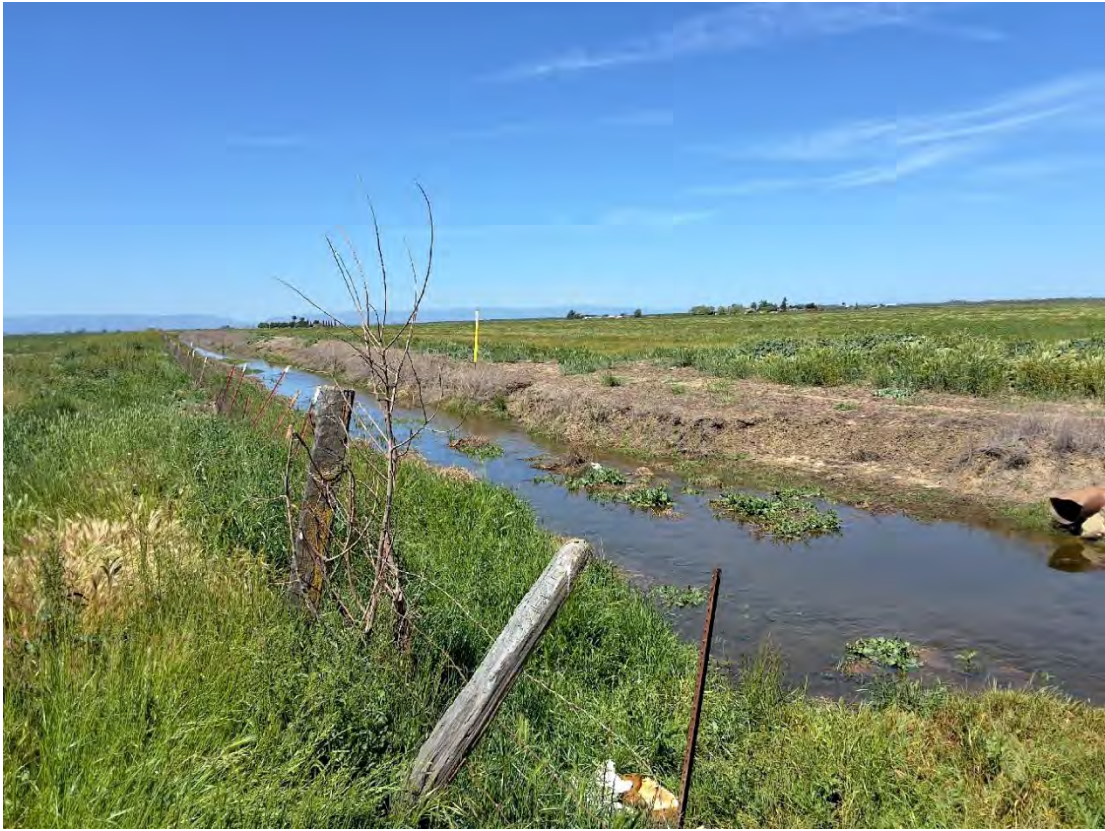
Based on this, the agricultural irrigation ditches, including the Solano Irrigation District water conveyance ditches, would likely be considered waters of the State that are exempt from Waste Discharge Requirement permitting.

Agricultural irrigation ditch that is part of the Solano Irrigation District's conveyance system

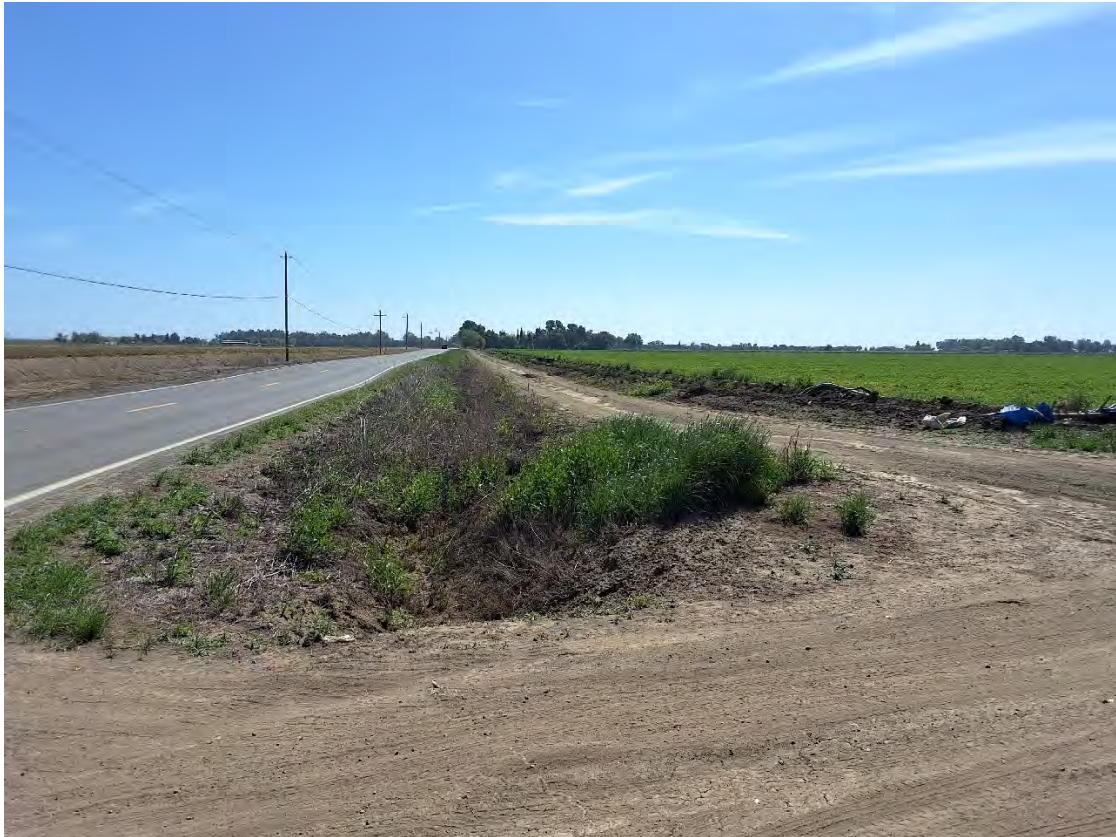
Site access off Tremont Road showing road ditch and feedcrop (alfalfa)

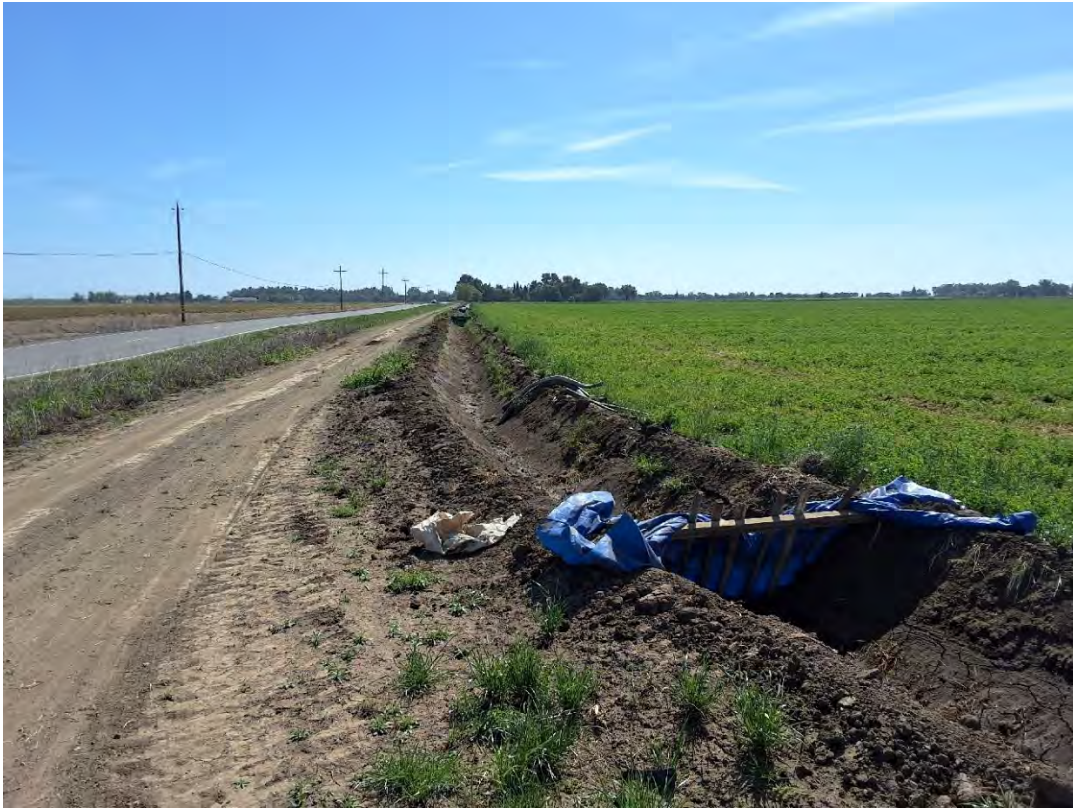
Site access off Tremont Road showing agricultural irrigation ditch and associated siphons and dams used to flood-irrigate the alfalfa

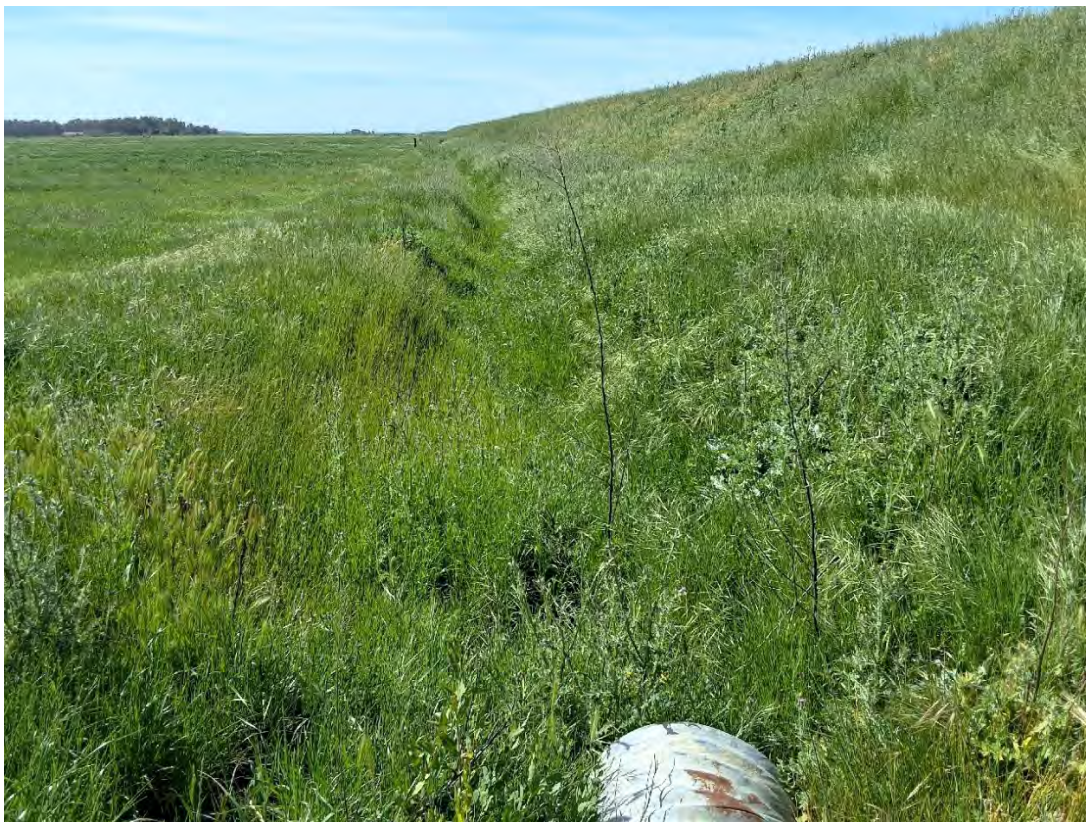
Berm of agricultural storage basin (on right) and hay crop (on left), with pipe culvert and irrigation ditch (center)

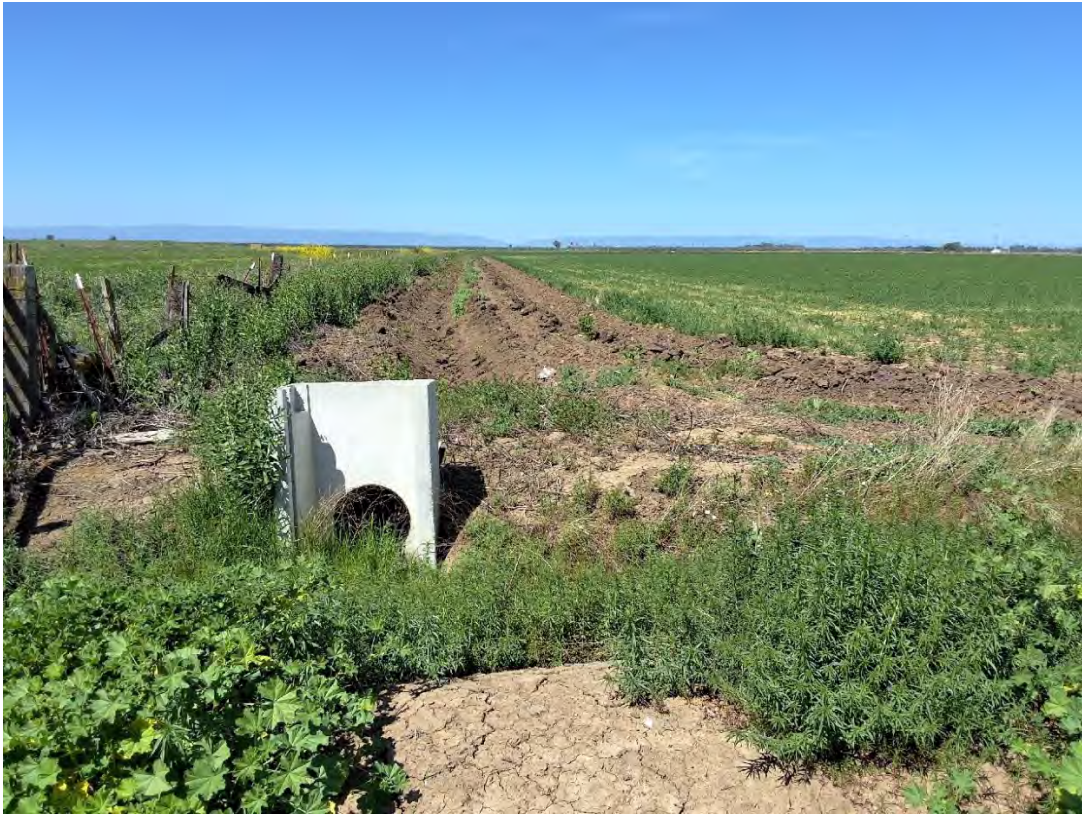
Concrete pipe culvert/lock and irrigation ditch (center), with hay crops on both sides.

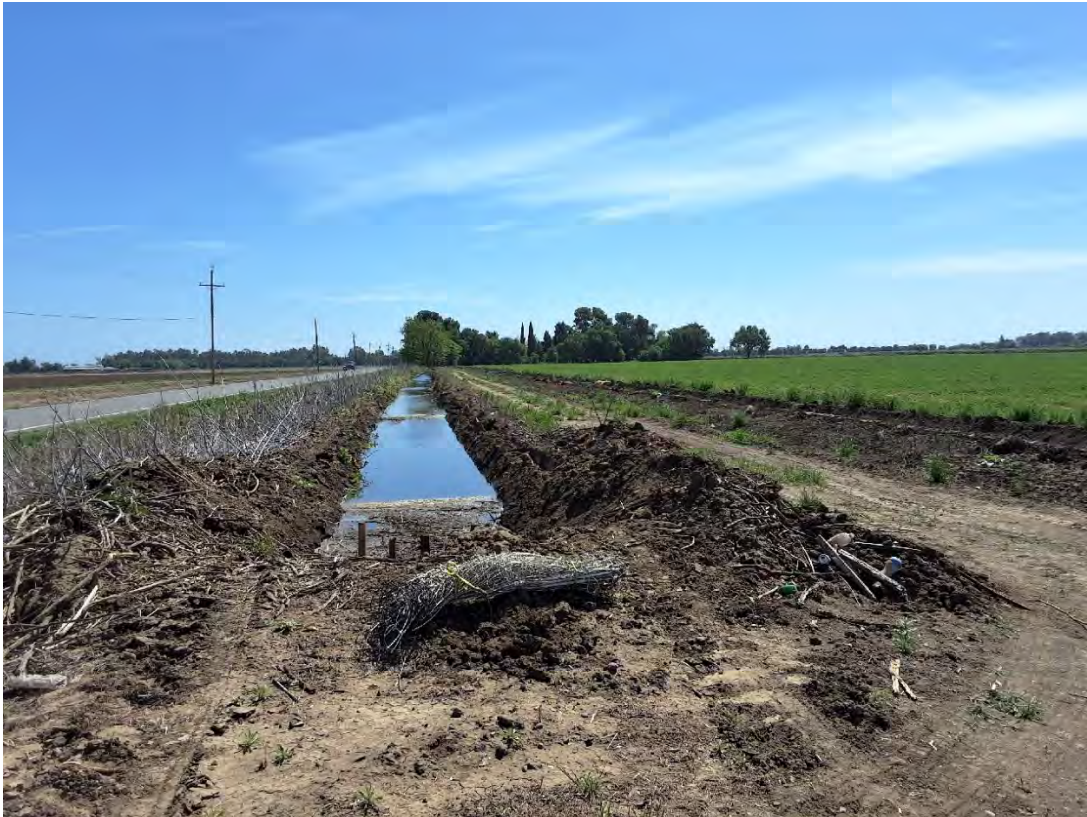
Irrigation ditch parallel to Tremont Road that is filled by groundwater pumped from a well.

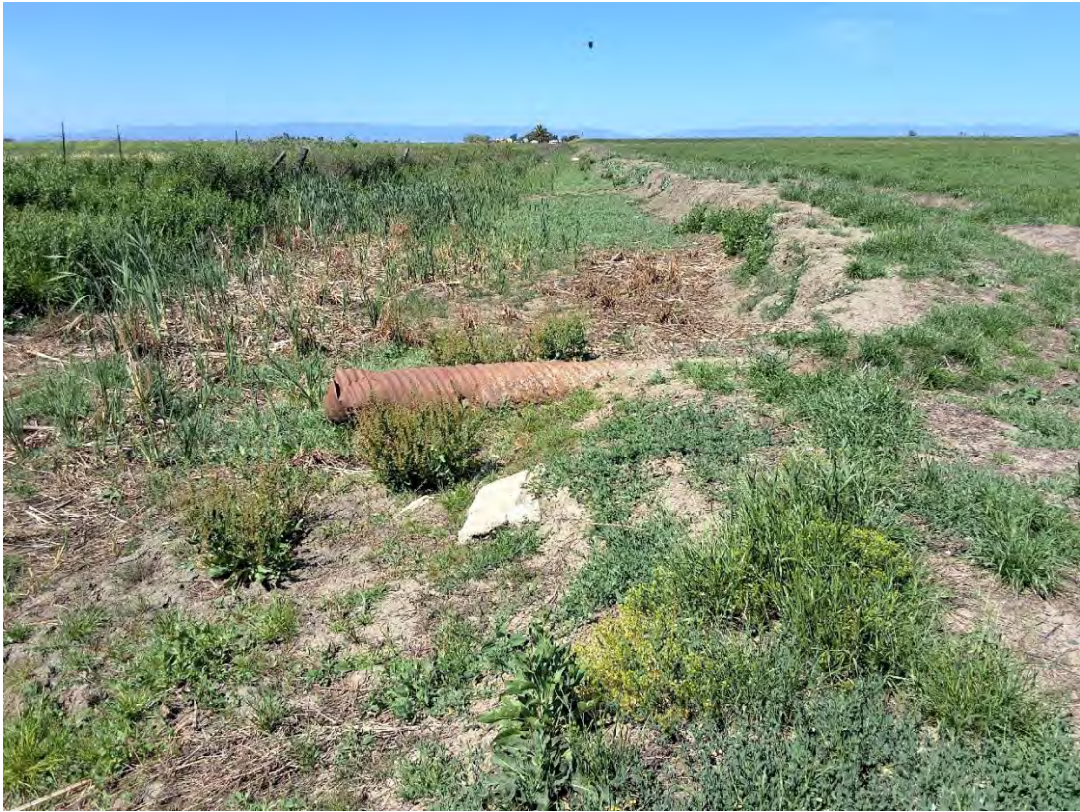
One of the Solano Irrigation District's canals in the center of the Study Area.

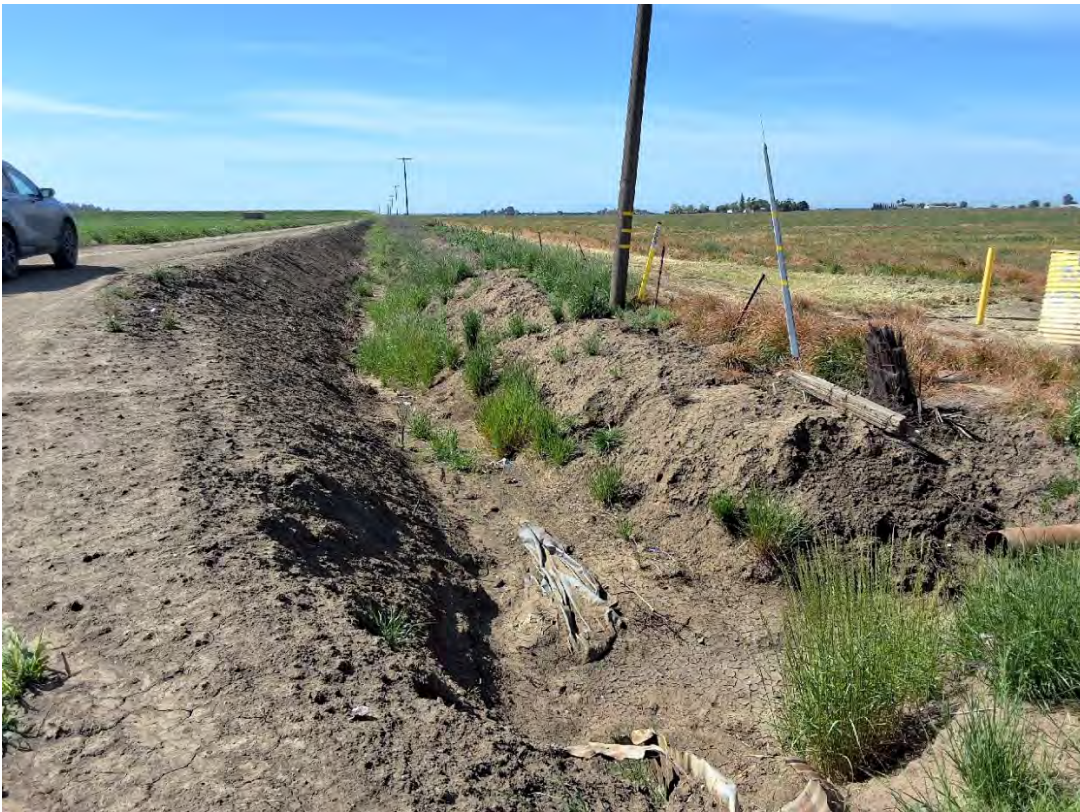
Site access off Tremont Road showing Solano Irrigation District's canal, with a sidewall that was recently scraped to remove vegetation.
